2007 XL Engine Guard Installation

As recently communicated in Service Bulletin M-1200A, there is a clearance issue on 2007 Sportster model motorcycles that have had the voltage regulator relocated by using the 0128 Recall kit #94507, which interferes with installation of engine guard #49060-04.

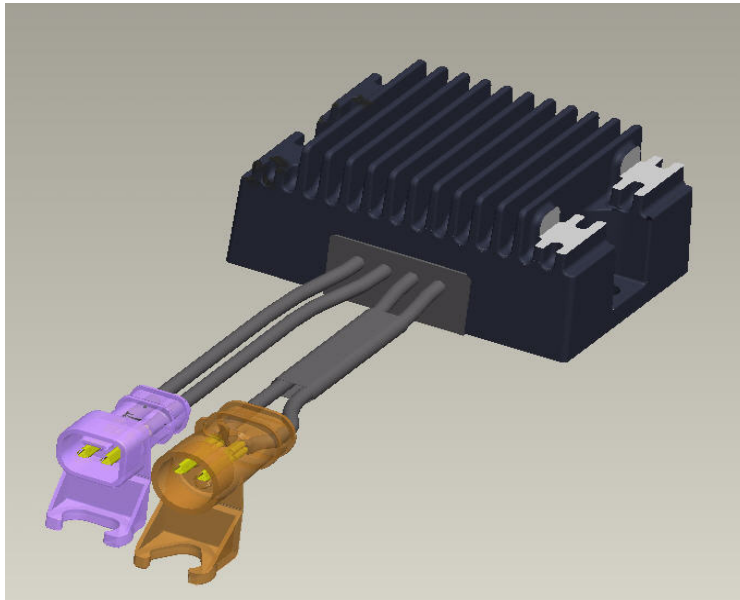
If you have the capabilities, you may remove the regulator and machine the bottom two cooling fins to a depth of .350", measured from the peak of the cooling fins, to provide clearance. Please refer to the attached drawing.

To remove material from the regulator case, we suggest the use of a mill, or another suitable method that will not make the part cosmetically displeasing to the customer. Removal of the material as described will have no impact on the performance or durability of the regulator. This procedure will allow proper fitment of the engine guard and takes less than ½ hour to complete.
