## 2004-Later Sportster Shifting Diagnosis

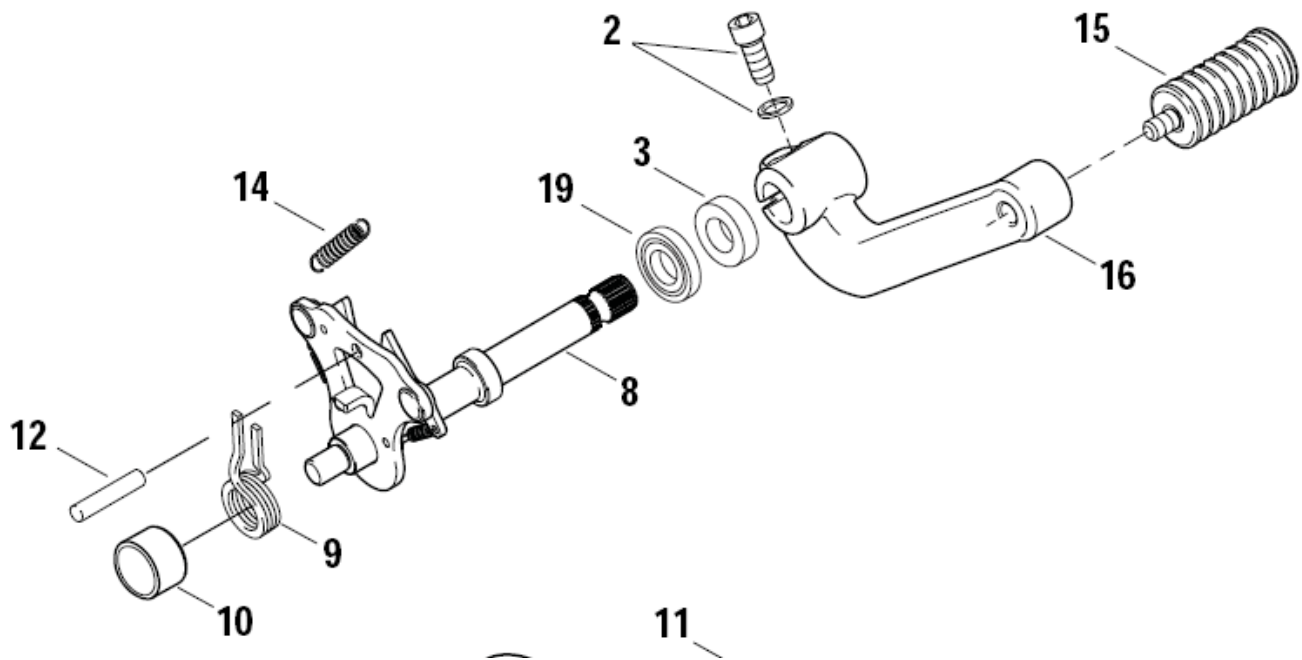
If you are experiencing a shift binding issue on 2004 and later XL models, before disassembly of the engine for transmission inspection, check for some end play on the shift shaft by removing the shift lever and moving the shift shaft inward and outward by hand. There should be perceptible end play on the shaft.

If not, the inboard bushing (**item 10** in the diagram below), which is mounted in the left side crankcase half, may have backed out slightly, taking up the end play between the step on the shift shaft and the outer primary cover. A tap on the end of the shift shaft with a deadblow hammer will reseat the bushing and provide the proper clearance of the shaft between the inboard bushing and the primary cover. Check for proper shifting after reseating the bushing.

If the bushing feels excessively loose in the case, replace bushing part number 34076-02, apply a drop of green Loctite to the replacement bushing and reseat within its bore.
