2007 XL Models with Discharged Batteries or Very Low Voltage

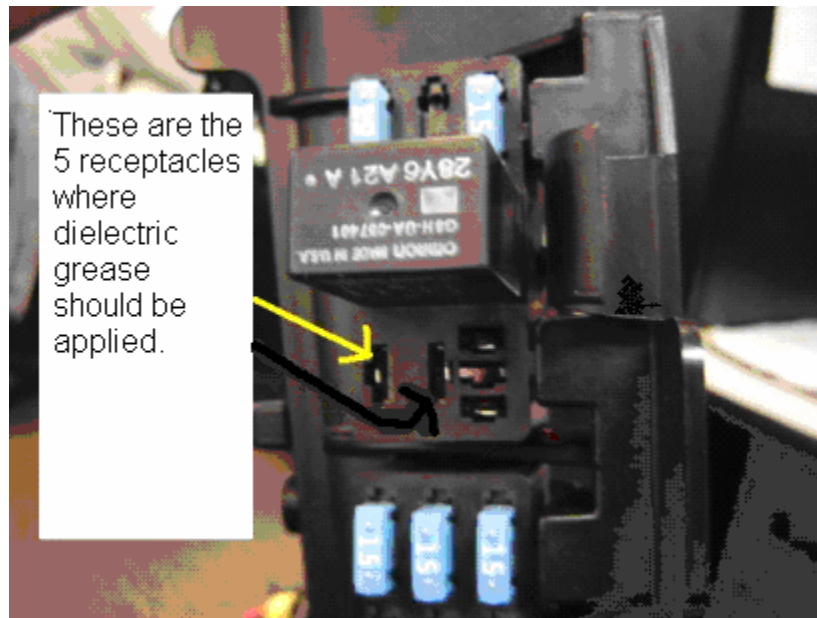
Harley-Davidson has found some '07 Sportsters where the batteries are going dead after a night of sitting. The root cause is water intrusion. Water can run down the harness, funnel into the fuse block area, and then bridge the system relay contacts. The system relay has constant power available on the 30 terminal.

When the system relay is activated, power goes to the ECM, and then the ECM sends power out to the IAC. The IAC will then run until the battery is fully discharged.

To prevent this issue, Electrical Contact Lubricant (p/n 99861-02) can be placed on the terminals and base of the system relay, and the receptacles at the fuse block. This will create a water barrier once the relay is installed into the fuse block.

Motorcycles exhibiting this condition could also have corrosion present, and if necessary, should have the relay terminals and receptacles cleaned with a wire brush or replaced.
