### 2007 Big Twin Clutch Release Plates

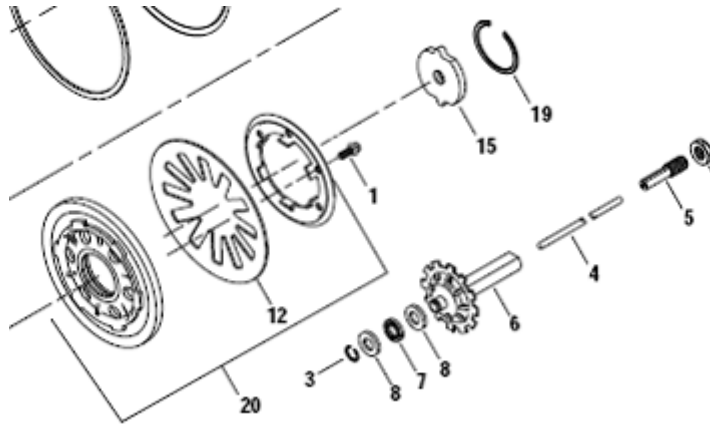
Between January and July of 2007 some Twin Cam Models were assembled with a Clutch Release Plate, (p/n 37903-90) that could have the adjuster screw threads not machined perpendicular to the plate. This would cause the adjuster screw (item 5) to not sit square in the Release Plate (item 15).

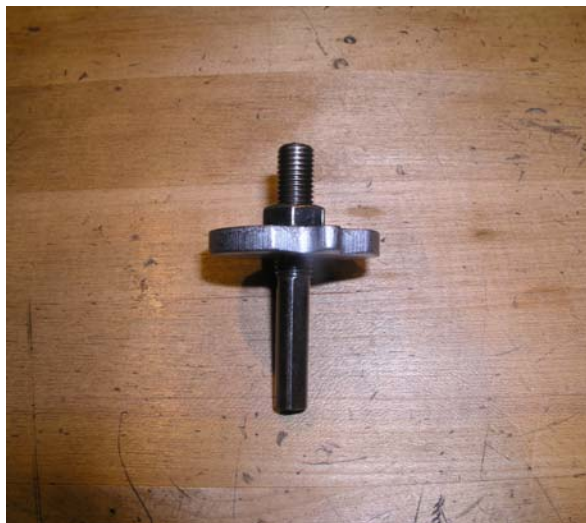
If the adjuster screw was held straight as the release plate was installed in the pressure plate, it could cause the release plate to be cocked, and the retaining ring may not be fully seated in its groove all the way around. However, if the plate and snap-ring are installed correctly the adjuster screw may not be contacting the push rod properly.

These conditions may result in difficulty adjusting the clutch release or a dragging clutch. If you experience either, please look carefully at the adjuster & release plate assembly for the condition shown below:
