Advanced Audio System Information

Since the introduction of the Advanced Audio System on 2006 Touring Models, there have been several Service, Warranty and P&A Bulletins and multiple Tech Tips. Some of the previous information provided is outdated or may no longer apply. This Tech Tip provides the most current information as of this date.

Advanced Audio System - AAS

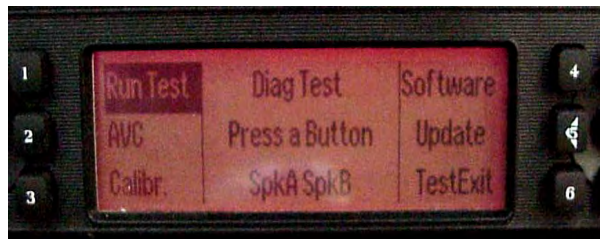
FIG. 1

Radio Self-Diagnostics – (fig.1) A quick check to see if there are currently detected issues or any DTC's recorded and the ability to check for proper operation of AAS handlebar & passenger switches.

NOTE: Radio Self Diagnostics will only show one DTC. Use Digital Technician to determine if there are multiple DTC's

>> Access by holding any two preset buttons (1-6) in while powering up the radio, wait for the diagnostics screen to appear. Perform switch functions and observe results on radio display.

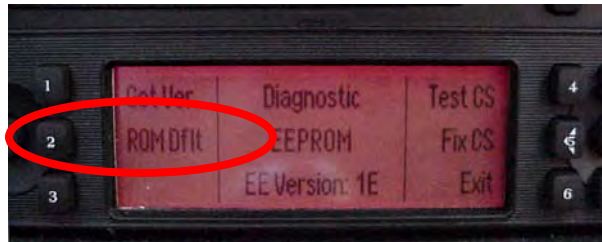
FIG.2

ROM Default Reset – (fig.2) Returns the radio to base settings, to eliminate possibility of user-induced issues. (i.e.: low volume, low or no display visibility, etc.) Always perform this reset before ordering a replacement radio to eliminate possible user-induced issues.

NOTE: If the issue was a blank screen and the problem is not corrected, perform this reset a second time to insure the proper steps were done. If the display recovers, immediately check the software version and if it is an earlier version number, perform the software update process.

>> With radio ON, press soft keys **1, 3 & OK** at the same time and release. Then press the **UP** arrow **Two times**. Then press soft key **#2** (once) and turn ignition off for 30 seconds.

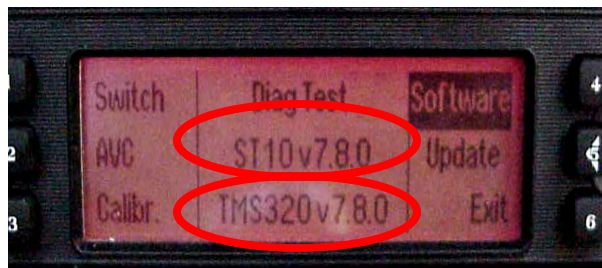
FIG.3

Software Update – (fig.3)

>> Access by holding any two preset buttons in while powering up the radio, wait for diagnostics screen to appear. Press button 4 to see the current software version (8.09, 8.11, etc) in the radio. Both ST10 & TMS320 lines should be the same software version.

If a software update is needed, press button 5 (Update) and insert the software update CD when prompted. The rest of the process is automatic and may take up to 10 minutes. After completion, always check the software version again to make sure the installation was successful. If both ST10 and TMS320 are not the same, you can update them individually by pressing the 1, 3 and O.K. soft keys at the same time after radio is powered up and on FM. Then press down arrow once, and select the area you want to update, insert CD and press Flash.

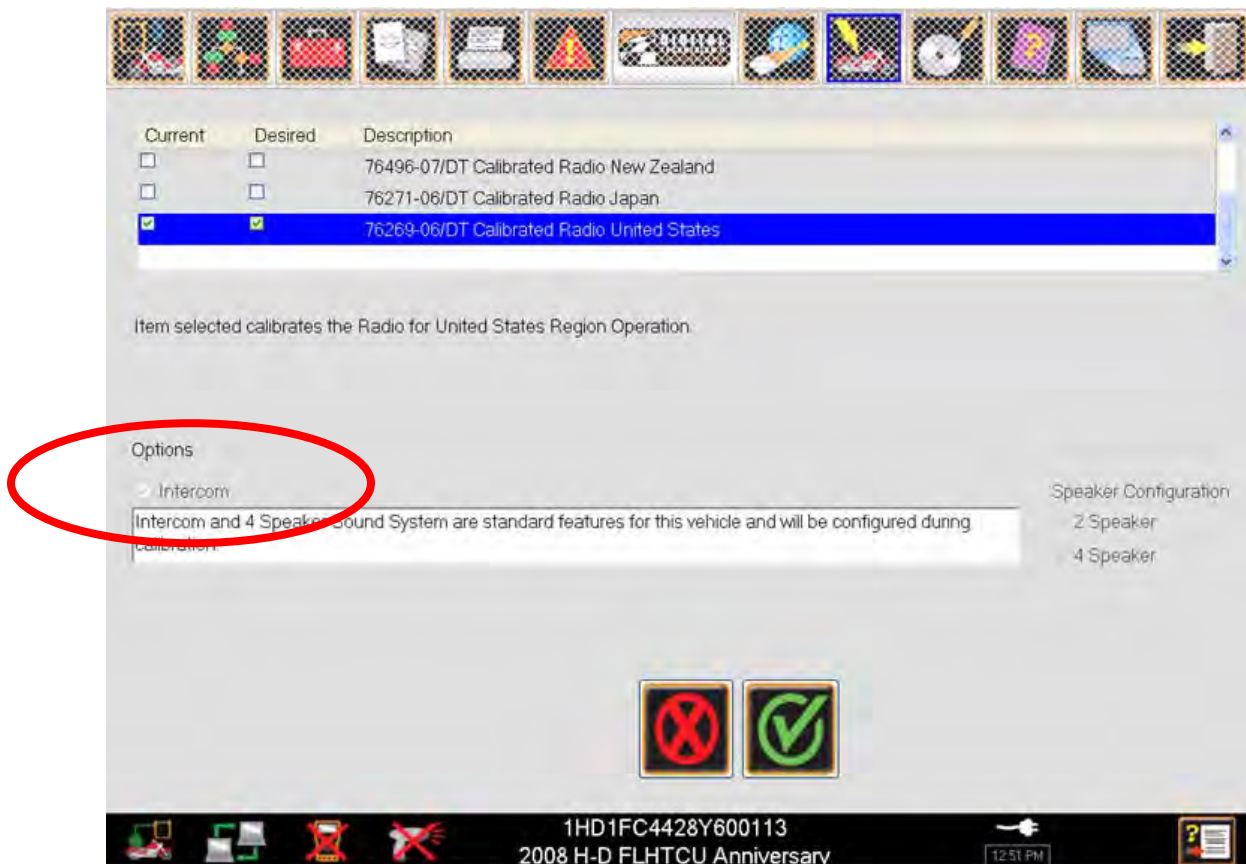
Fig.4

Setting Region Code ('Calibrating' Radio) – (fig.4) P&A and Replacement radios will 'BEEP' repeatedly and have a message displayed that says "Radio not Calibrated" until the Region Code has been set. You will need use DTII to Reflash the Radio. The proper way to reflash a 2006 and later radio is to enter the correct VIN in DTII and select Reflash > Radio.

When the correct VIN is used in DTII and the Calibrated Radio Download is selected the "Options" feature may become un-selectable, because the Intercom and 4 Speakers are standard features for some models and are configured with the radio download. When the "Options" section is un-selectable, it is NOT a chargeable download.
