TT345C: ADVANCED AUDIO SYSTEM INFORMATION

SB-10055746-7880

APPLIES TO	SYMPTOMS
All 2006-2013 Touring Models with Advanced Audio System	• Intermittent or Erratic Electrical Operation

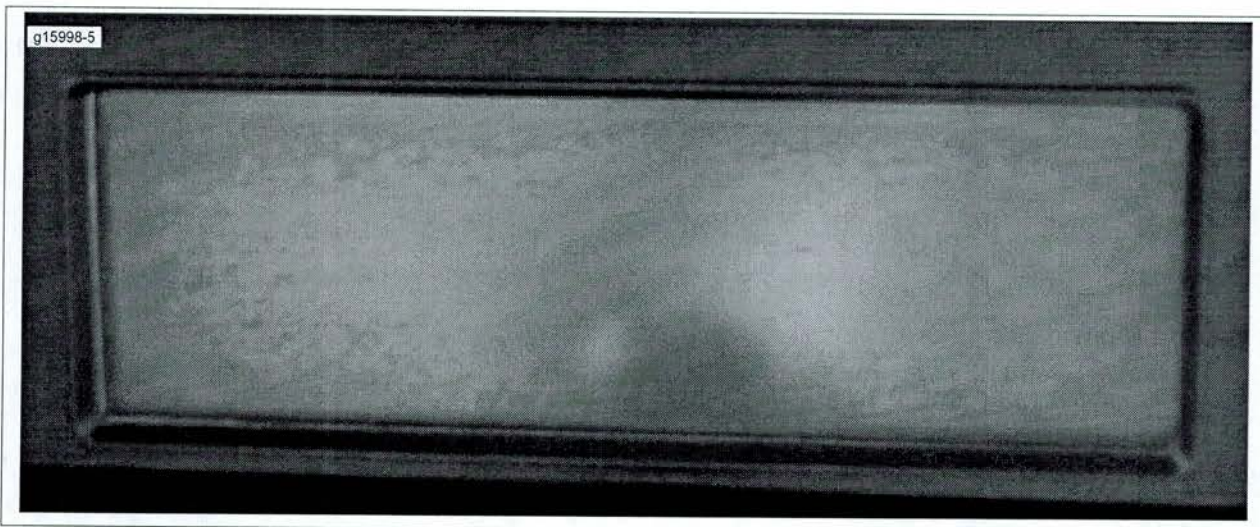
Figure 4. Damaged Display

- See Figure 4. Certain chemicals, including gasoline, when spilled or splashed on the display will cause the appearance of tiny spots or bubbles. This is not considered a warranty situation. Testing has shown that Novus No. 2 Scratch Remover (available through P&A) will remove the outer anti-glare coating and restore the appearance of the display. The display is coated on both sides, so glare should not be an issue.
