TT401: XL Mirror Stem Protective Cap

March 25, 2009

Tech Tip 401

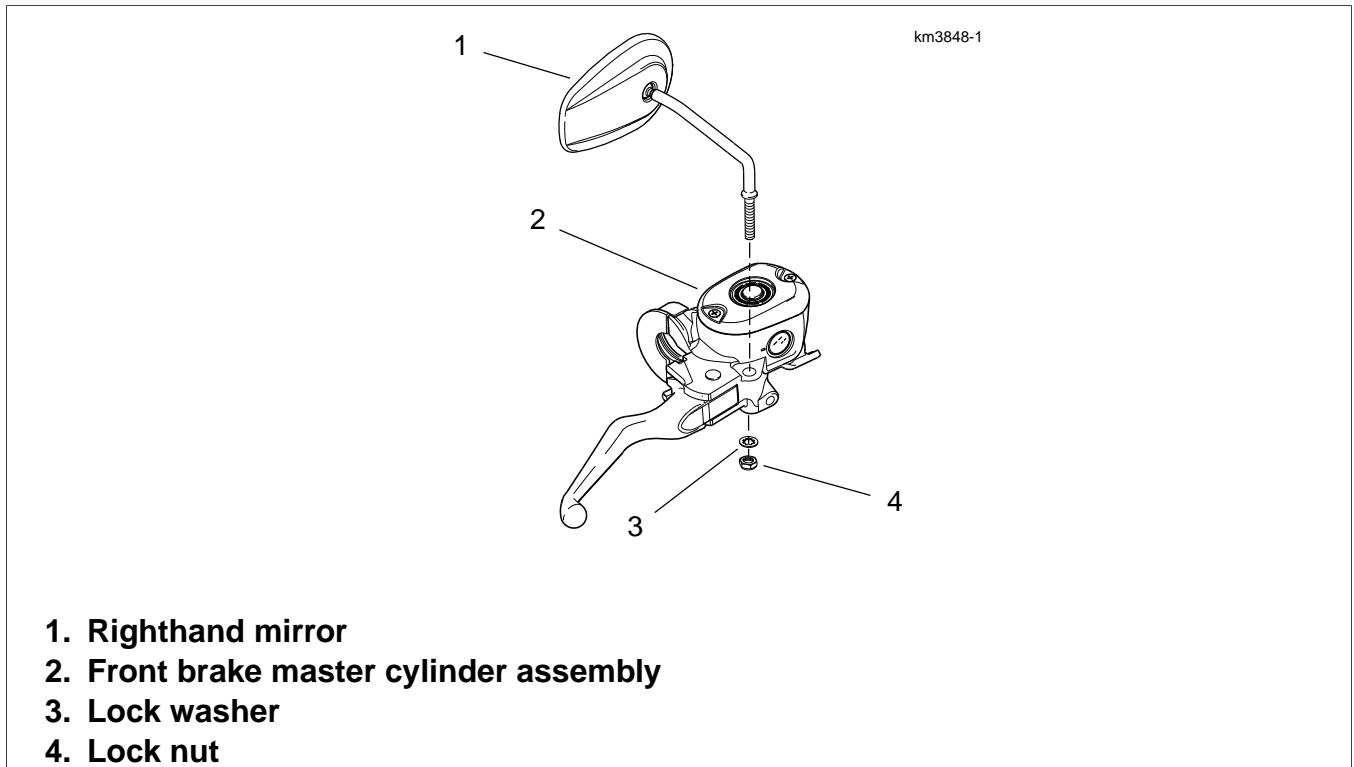
Recently, Harley-Davidson has changed the installation procedure for the mirrors on XL models. The protective cap, part number 8908, which was installed on the mirror stem threads is no longer required and has been eliminated. A new, taller locknut, (part number 7725) which provides additional thread engagement, eliminates the need for the protective cap.

Figure 1. XL Mirror Stem (protective cap removed)

Please update the 2009 Sportster Model PDI manual to reflect that NO protective cap is required. The "HEADLAMP & MIRROR" section of the 2009 Sportster Parts Catalog should also be corrected to reflect the running change.
