TT403: 2009 Sidecar Battery Tray Fitment

March 26, 2009

2009 Sidecar Battery Tray Fitment

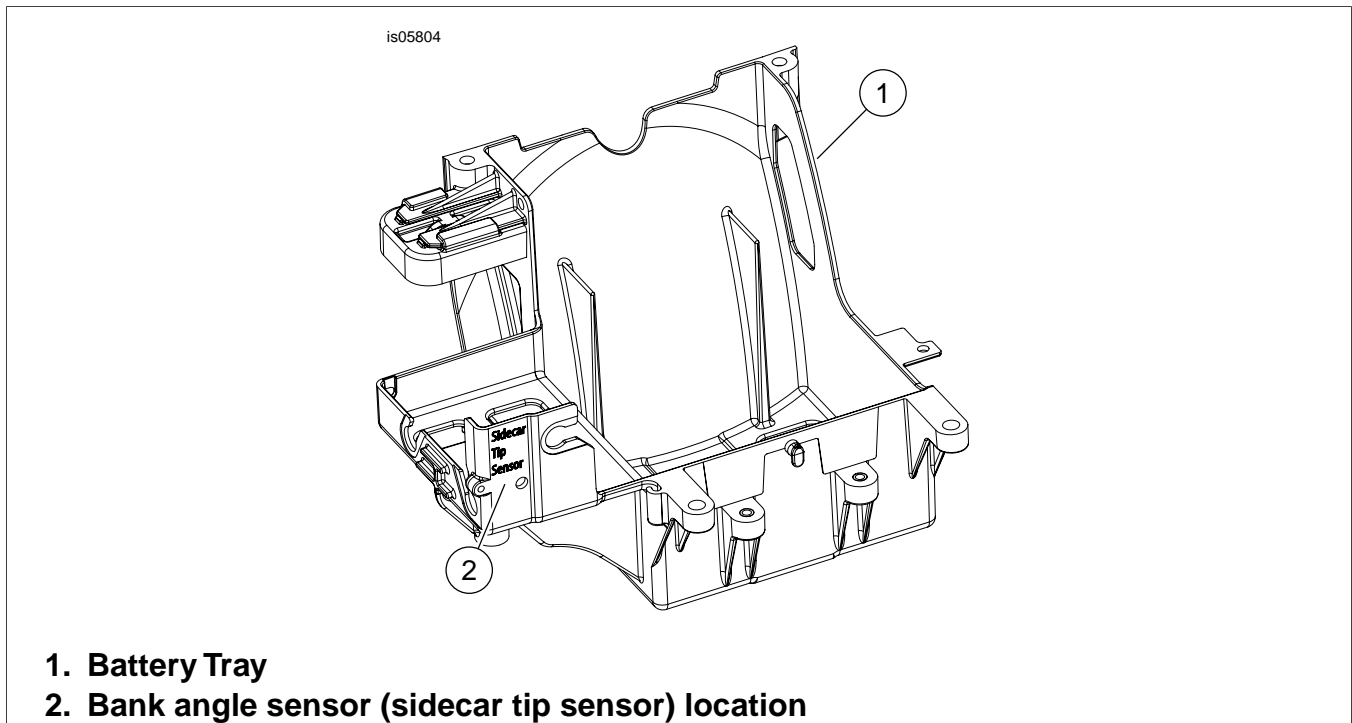
Figure 1. Battery Tray For Bank Angle Sensor

Early 2009 FL motorcycles that will have a sidecar installed require a new battery tray (part number 66281-09A or later revision) for proper bank angle sensor mounting.

The later battery tray can be identified by the words "sidecar tip sensor" in the location shown in Figure 1 below.

If the words "sidecar tip sensor" do not appear as shown in figure 1, the tray is an early version that must be changed before a sidecar installation may be completed.

As of March 2009, this battery tray will no longer be provided with each sidecar. Using the motorcycle's VIN provided with the sidecar order, we will determine if a new tray is needed by the assembly date. If one is required, a "no charge" part order will be automatically generated to ship a battery tray to the dealer that ordered the sidecar. The order will reference the sidecar order number.
