## Tri Glide Trunk Door Water Intrusion Diagnostics

TT411 – June 11, 2009 – Tri Glide Trunk Door Leak Diagnostics

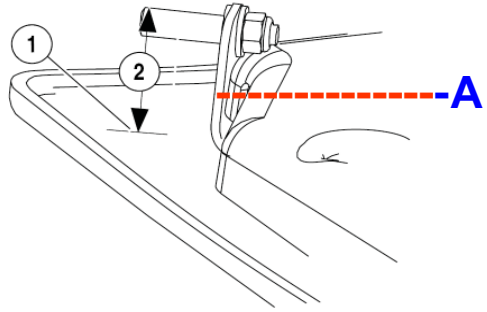
sm06539

- 1. Inner surface of door
- 2. Adjustment dimension
