# TT413: 2009 Touring Rear Fork Rusty Water Leakage

June 3, 2009

## 2009 Touring Rear Fork Rusty Water Leakage

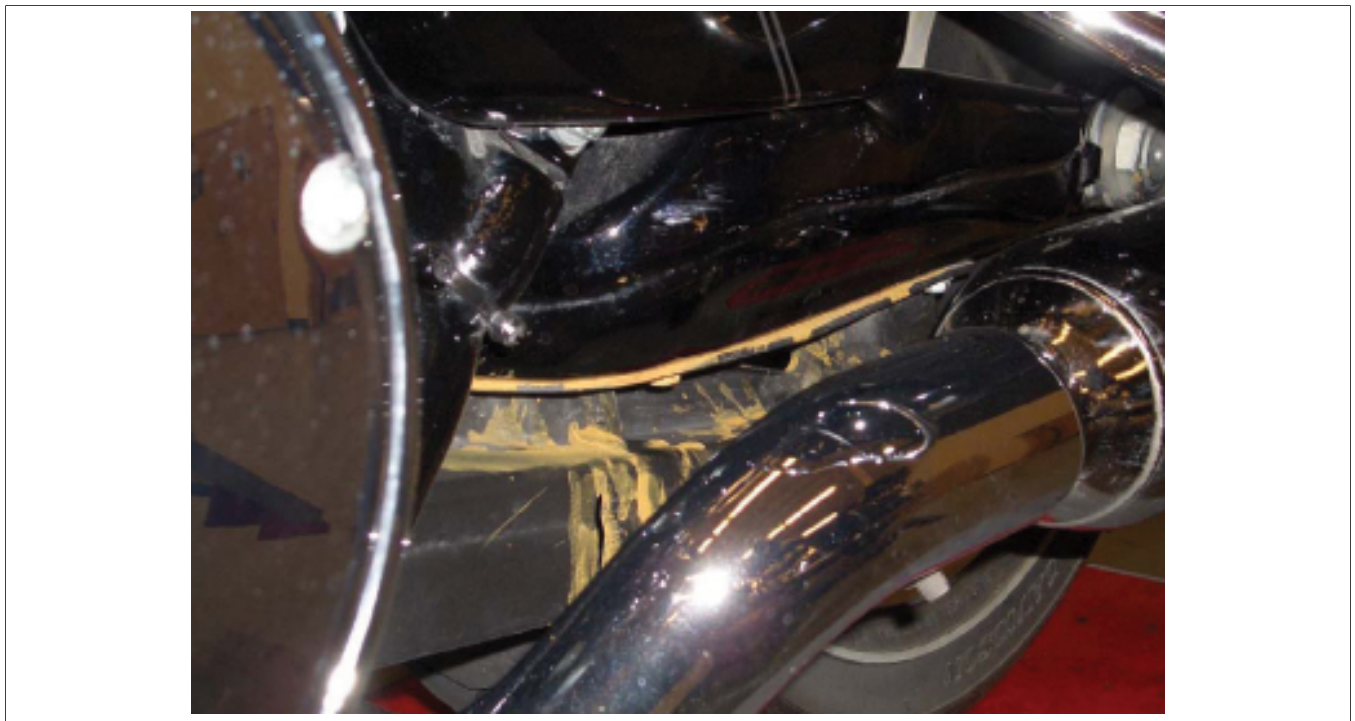
**Figure 1. Swingarm**

Some 2009 Touring models exhibit drainage of rusty water from the swingarm (where the debris deflector mounts), which has raised customer concern.

The potential water entry points are a forward facing drain hole (used in production) in the pivot shaft area, the two upper holes for the brake line retention clips, and the holes underneath the lower belt guard. On low mileage vehicles this may be residual after-wash from manufacturing's pre-paint procedure that did not boil out during the paint bake process, or it may be from external sources (puddles, washing, etc.) after the motorcycle was put into service. Dependant upon the amount of debris remaining inside the fork from the manufacturing process, and the fact the belt's debris deflector runs across the lower drain hole, it is possible for the water to build up and become contaminated. Add a few MPH to the equation along with the associated air flow and this stagnate water can slowly work its way out and onto the rear of the vehicle.

However, to ensure the condition does not continue we recommend opening up a clear escape path for the water to exit by:

1. Removing the debris deflector
2. Marking the location of the swingarm's drain hole, using some grease to find the drain hole (just forward of the center mounting screw)
3. Drilling a 0.250" hole in the plastic debris deflector (not the swing arm), directly in line with the swingarm's drain hole
4. Clean the vehicle, if necessary
5. Reinstall the modified debris deflector
