TT415: Sportster Rocker Cover Hardware Change

July 6, 2009

APPLIES TO	SYMPTOMS
2008 - 2009 Sportster Models	<ul style="list-style-type: none">• Part Availability, Installation or Fitment Updates• Literature Updates or Corrections

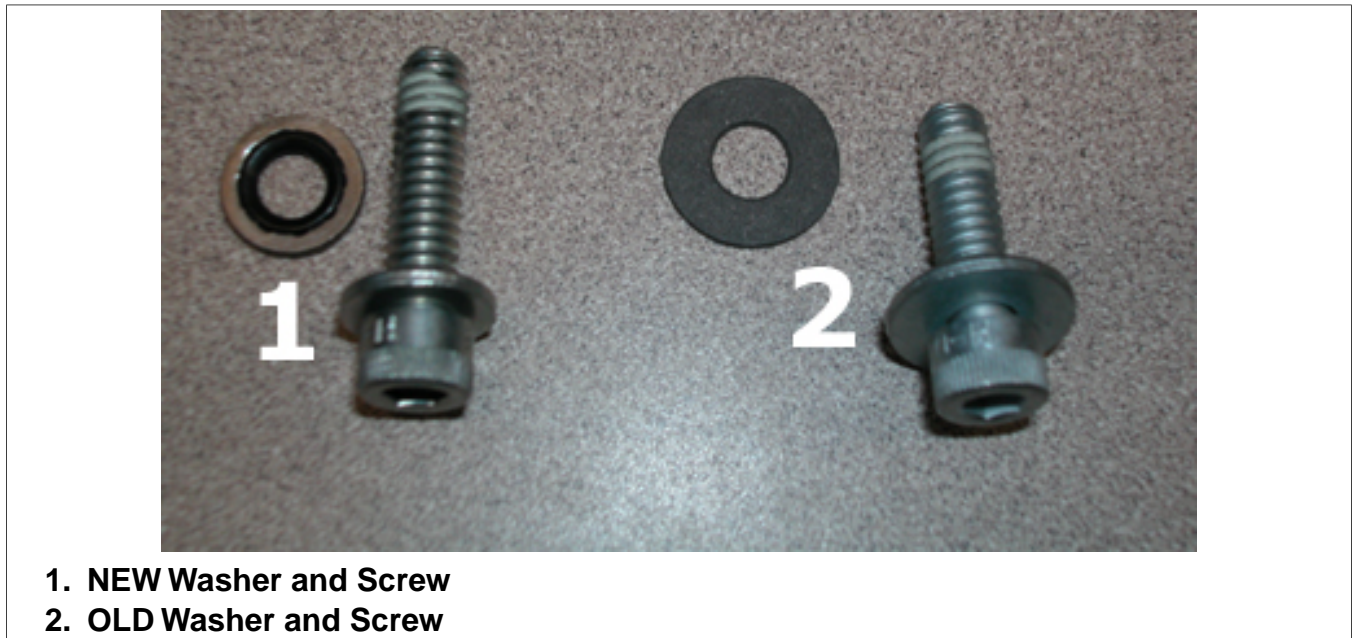
Figure 1. Washer and Screw

The change involves the fastener and washer for rocker cover shown in the image below. The washer has been improved for sealing, and the screw was changed to offer better thread engagement.

While these parts are listed correctly in the 2009 XL part catalog, they do retro-fit back to all 1986 and later XL models and 1984 and later Evolution engines.

Parts	New	Old
Washer	6589	63858-49
Screw	2486	882
