IH: Body Parts

FENDERS

1973-L1974 Rear Fender Reinforcement Bracket

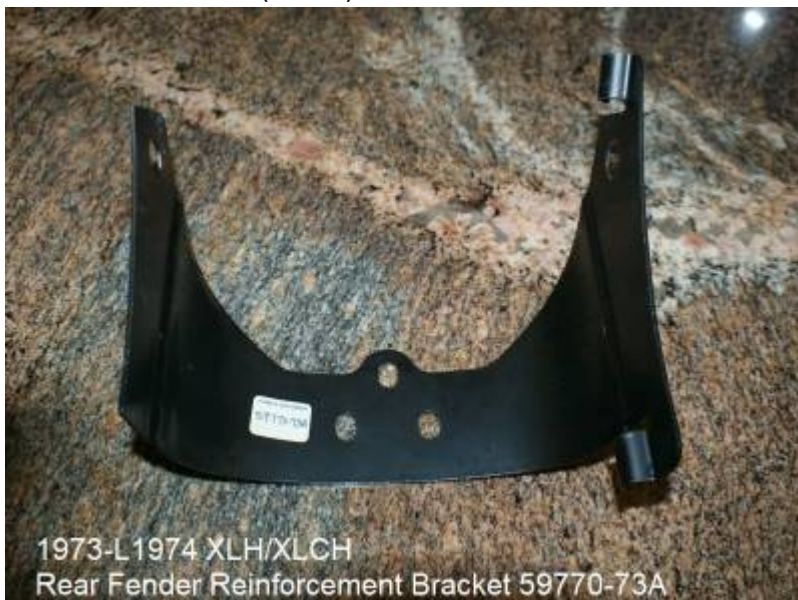
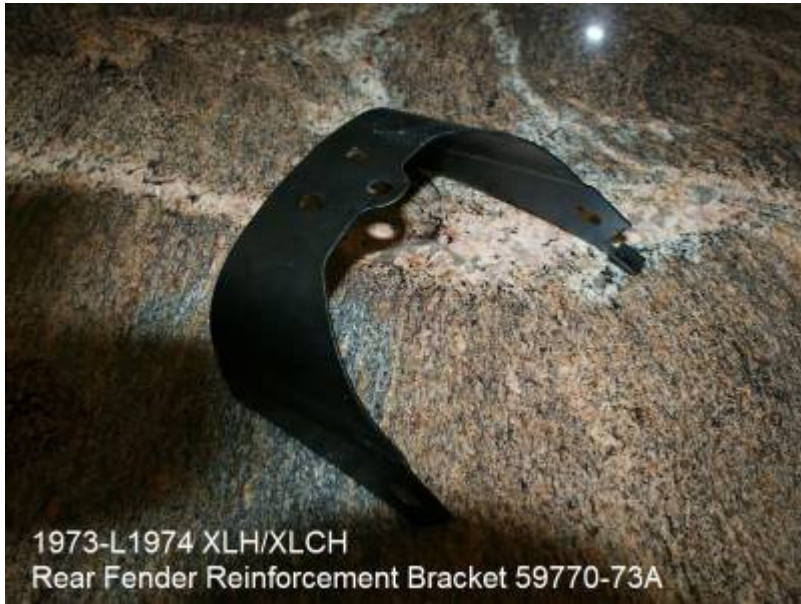
- Beginning with late production XL and XLCH models during March of 1974, a spot-welded reinforcement section has been added underneath the fender at the license plate bracket mounting holes. This was done to strengthen that area on the fender where the security system alarm is mounted to protect against cracking of the mounting holes in the fender. ¹⁾

Pics of the bracket (uncut):

- A bolt on version was made available for Early 1974 Sportster models as a replacement on models that had already left the factory before this upgrade was done. It was recommended that the dealer install the bolt on version on all 1973 and 1974 models that were equipped with the security system.

- The bracket (59770-73A) had to be modified at the dealership to fit Sportster models where the bracket (59714-74) for FX and FXE models were a bolt and go. The Sportster bracket was made with tabs on the ends that had to be cut off with a hacksaw to allow for the tail light wiring. ²⁾
