This article is an excerpt from Hot XL Magazine, Autumn 1997 Edition: ¹⁾

"Zippers Door", Installing One of These May Fix Your Alternator Problem

Story and photos by Stephanie Feld

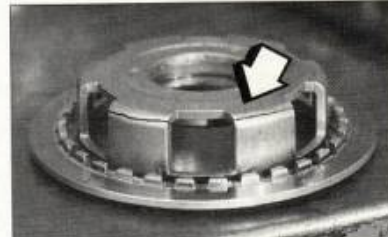
5 This is what happens if you over-tighten the spring compression tool. No wonder my clutch had been dragging! The last time I installed the clutch myself, I over-tightened the tool which broke the delicate aluminum casting of the pressure plate (see arrow).

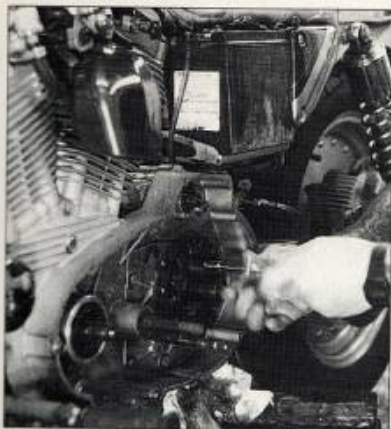
7 For once, the rotor and stator are still intact. Remove the stator from the old transmission access door.

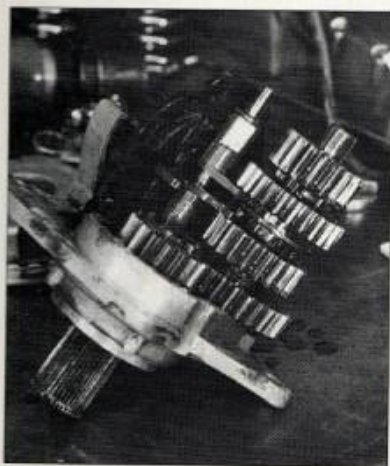
9 After inspecting the transmission, Rich decided that the countershaft third gear, which was missing a large chunk from one tooth, was overdue for replacement. We pulled a new Andrews gear from stock. That's the old pressure plate in the background.

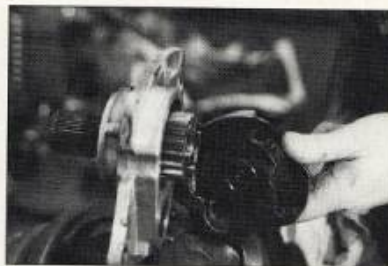
10 Inspect the shifter cam before removing it from the old door. The thrust surfaces are pretty burred up.

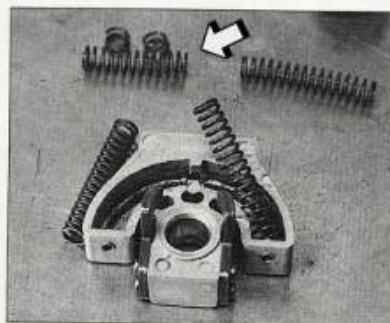
12 More broken stuff, this time a pawl carrier spring (see arrow). The new ones are sticking out of the shifter pawl. I can't believe this bike was still shifting gears!

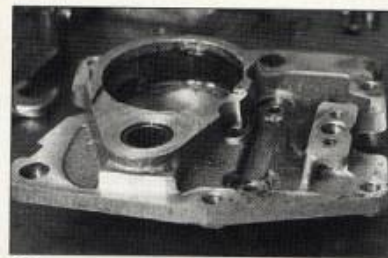
14 This stock H-D transmission door is a cast aluminum unit as are all Sportster OEM doors. However, there is no cast iron sleeve insert for the mainshaft bearing as in the earlier models. This allows the single-row bearing to work in the door and wear away aluminum. Result: the bearing becomes loose in the door.

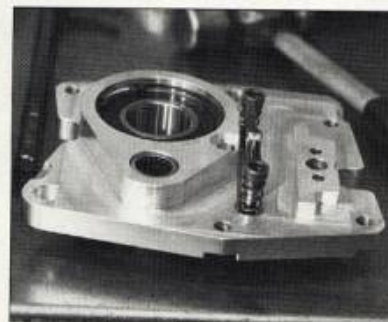
15 This is Zipper's billet aluminum door. Forged billet aluminum is much more resistant to wear than a cast aluminum one. This, combined with the larger surface area of the Zipper's double row bearing, prevents the wear common to the stock door.

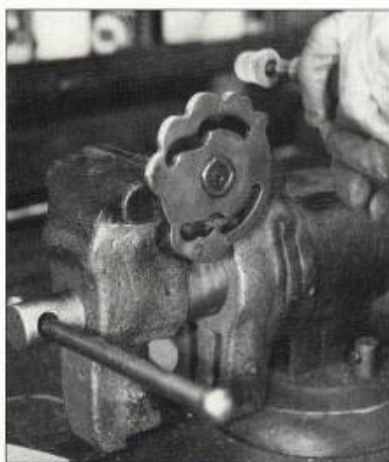
19 The shifter cam had more burrs than an overgrown cow pasture. Rich carefully cleans the sliding surfaces of the shifter cam where it engages the shifter cam follower so the Sportster will have smoother shifts.

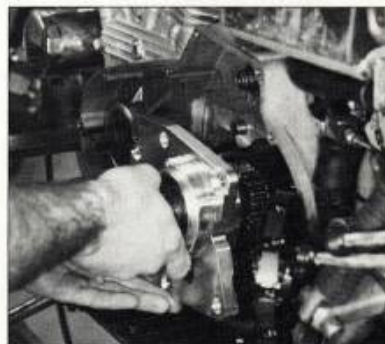
Back in 1985, somebody at the Harley-Davidson factory screwed up. The mainshaft on a four-speed Sportster transmission should have between .006" and .020" of end play when installed in the cases. Well, my Sportster's mainshaft end play was a whopping .137". In order to get it right, we needed a thrust washer — or combination of washers — between .117" and .131". Too bad the thrust washers made for the XL mainshaft only range from .0675" to .0965. No combination of those was going to help.

23 Rich installs the transmission and is checking the mainshaft's end play when disaster strikes yet again. The mainshaft has way too much end play and there are no mainshaft shims available to bring it within tolerance. So the crack team of problem solvers at Rolling Thunder went to work and soon came up with a solution. See the above Tech Tip sidebar for what they did.

Then the Rolling Thunder parts counter staff came to the rescue! They remembered that a "45" Flathead flywheel washer (#23972-21) was very close to what we needed. They pulled one from stock and at .062" it was nearly perfect when combined with a .0675" mainshaft washer. Rich carefully ground an additional .005" off the flywheel washer to make our final end play land right in the middle of the two extremes: .0125". My transmission is now better than new and still going strong.
