REF: Service Procedures 11C

What Causes the 1991-2003 Shifter Detent Plate to Lean

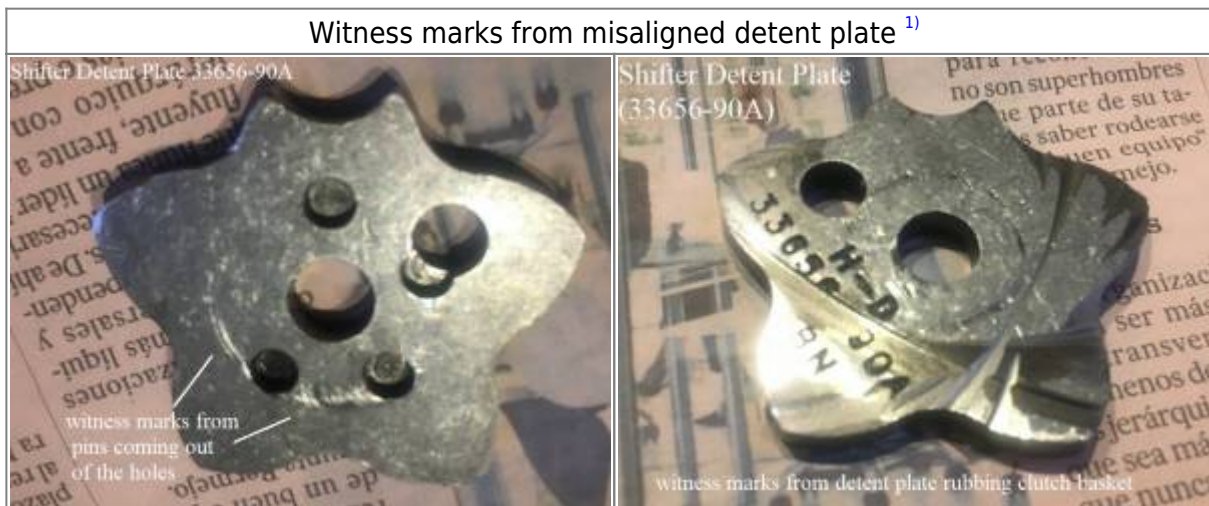
It's usually the shift drum pins walking out of their bore that leans the detent plate.

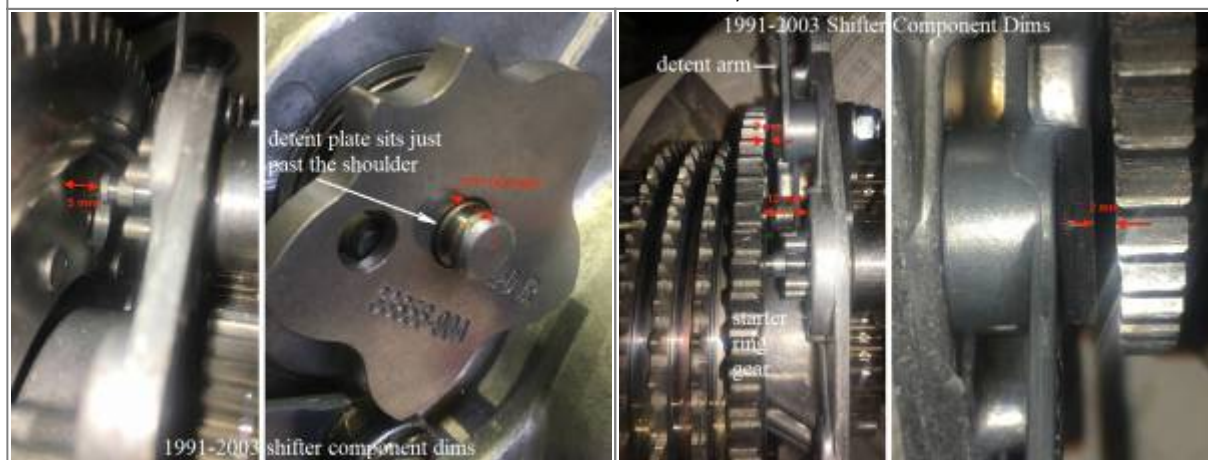
Dims taken from XLForum member, xLoneRiderx ^{2) 3)}

The detent plates' vertical position is established by the length of the pins on the end of the shift drum. They should all be “home” and protruding the same length out of the drum (installed height .326” - .334”).

However, since the space is so small between the plate and the clutch basket, a skewed detent plate can make contact.

The designed “slop”, adverse conditions and wear can easily make the detent plate “kiss” the back of the clutch basket.

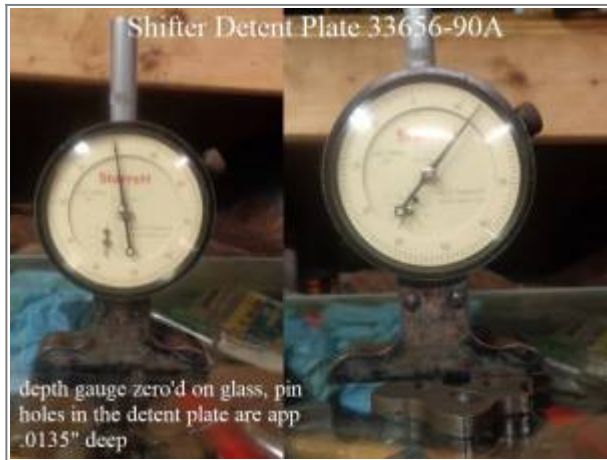
Detent plate pin hole depths ⁴⁾

This “angle” pushing the detent plate can scar up the holes in the back of it where the pins go in. The retainer clip allows the detent to move far enough off the pins to slap the holes when the plate returns.

You may have noticed marring around the those holes (which are not very deep to begin with).

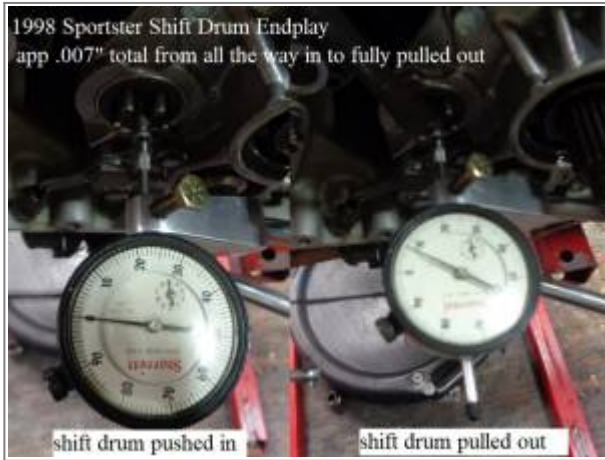
Shift drum end play ⁵⁾

With the drum itself able to shift axially (app .007"), the distance between the detent plate and the clutch basket will be variable within that range.

So a leaning plate may have a touch / not touch situation if the space falls within that end play.

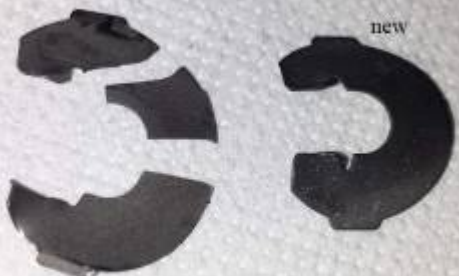
Shift drum pins walking out the drum have been responsible for breaking the flexible clip that holds the detent plate.

In this instance, the flex clip is being pushed backwards in circumference (like turning a sock inside out). And this will cause the clip to break sending it into the primary to chew and get chewed by tranny gears. The flex clip is made from spring steel and is meant to soften and return axial full body force (as in the detent plate pushing against it in a vertical position)

However, it is very brittle with forces trying to cup opposite ends and push them in reverse while holding the center still.

Broken detent plate retainer ring ⁶⁾	Retainer clip stresses ⁷⁾
<p>Shifter Detent Plate Retaining Ring (11019)</p>

<p>it's common to find these broken</p>	<p>1991-2003 shift drum pin(s) are subject to 'walking out' of the drum, leaning the detent plate and breaking the retainer clip. The retainer clip was designed to handle full shoulder side load. A pin walking out shifts the load on the retainer clip.</p>

If you measure the drum pins and they all protrude at different lengths, you can't just push them in. If you try to extract them, they are extremely hard to remove without heating them with a propane torch. The drum was specifically designed for that clip. In fact, it's difficult to find a replacement for it. And it is suggested to replace it every time you remove it.
