CAPACITOR DISCHARGE IGNITION SYSTEM / SX-175

HARLEY-DAVIDSON MOTOR CO., INC.

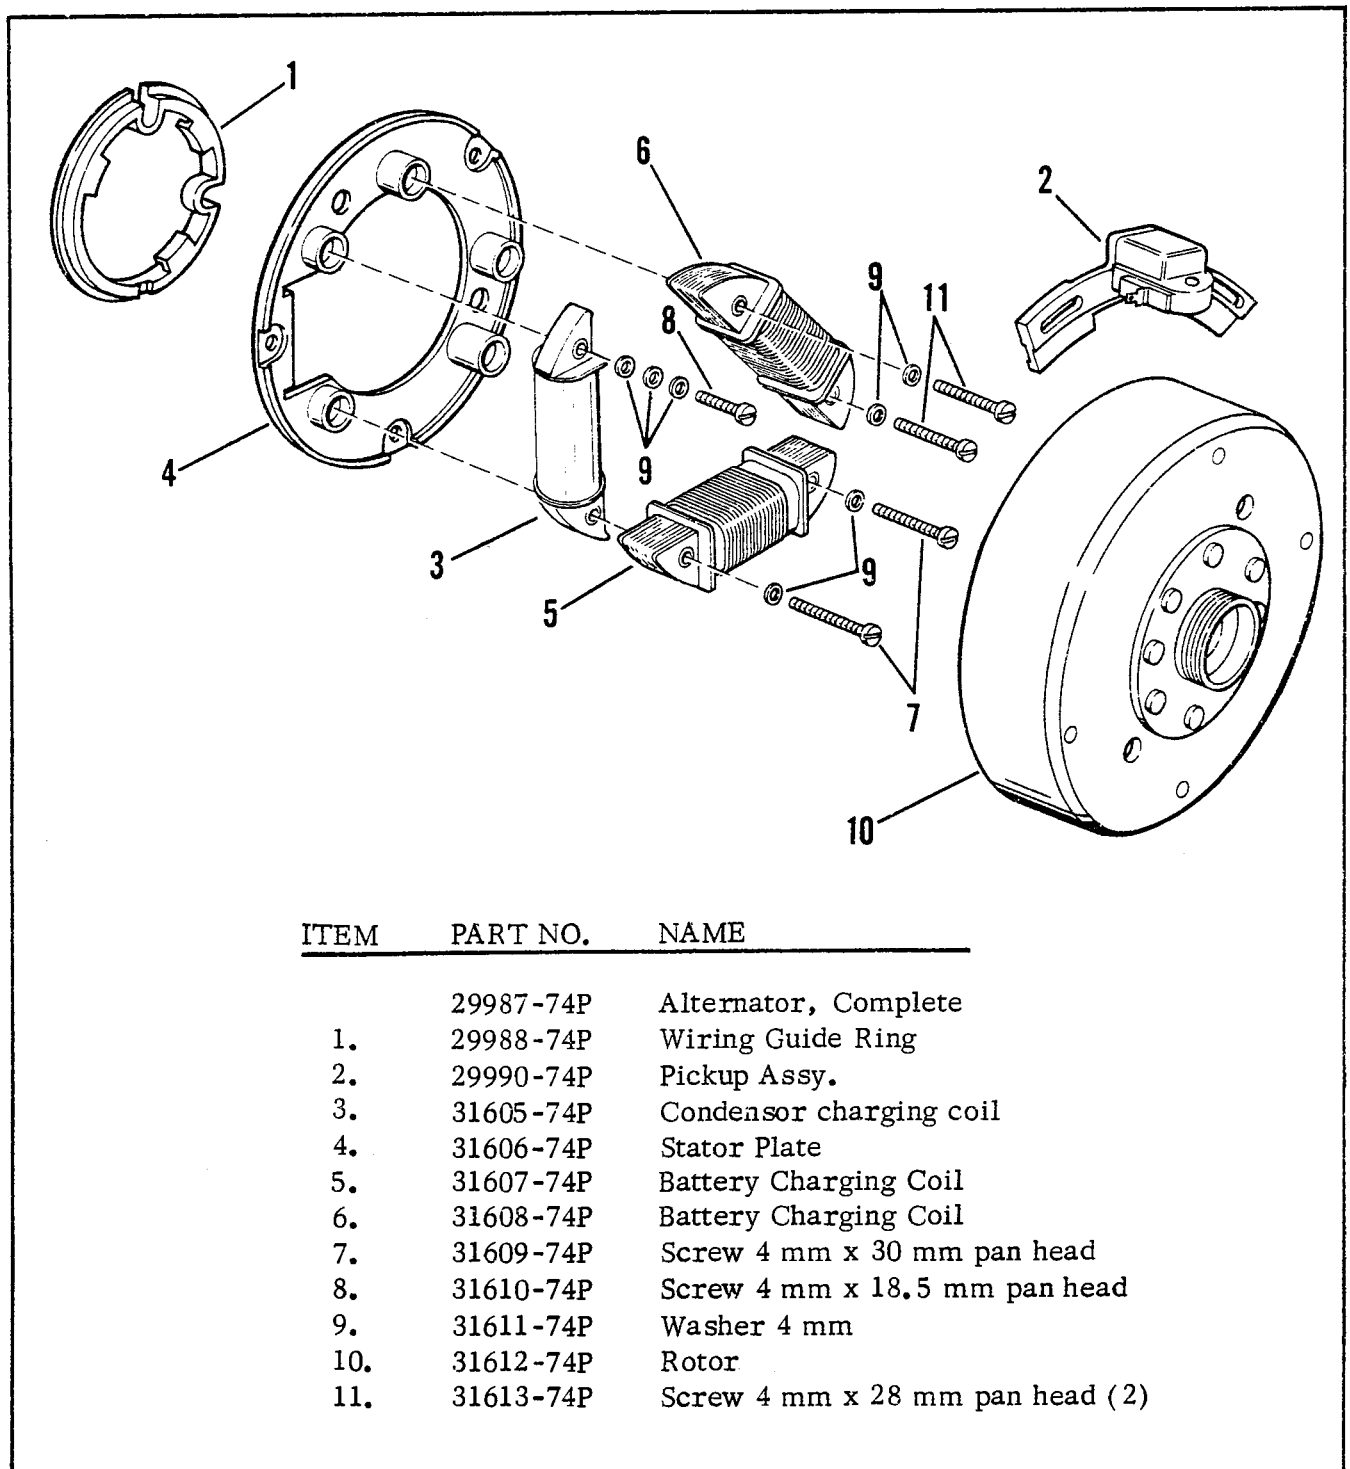
ALTERNATOR PARTS

An exploded view of the alternator with part numbers is shown for your information.

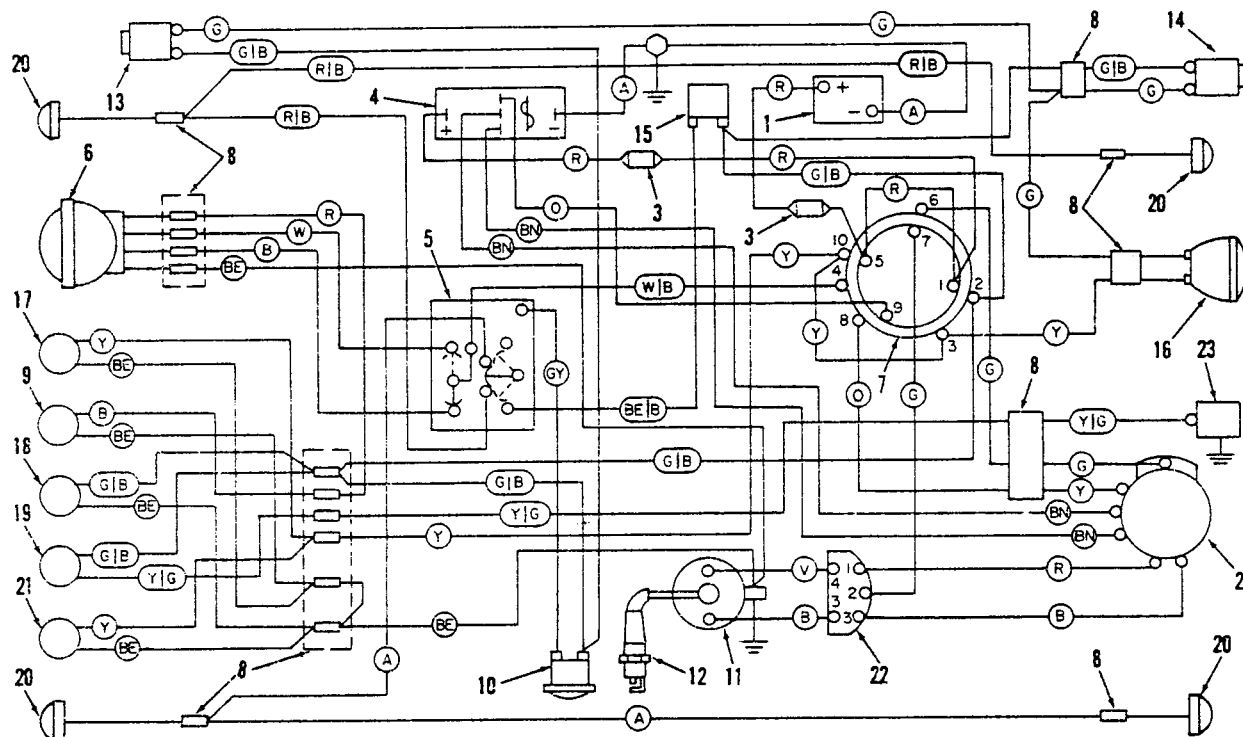
WIRING DIAGRAM AND KEY

6. Check for pinched wires behind stator plate, and insulation worn through from contact with crankshaft at this location. Also check all wire terminal connectors for correct wire location according to wiring diagram.

Note: A wiring guide ring was added for later 1974 models to correctly locate wiring away from the crankshaft. Installation of this part is recommended to update earlier 1974 models and prevent possible electrical faults.
