SERVICE BULLETIN

M-1099

February 15, 2000

1999 AND 2000 MODEL SERVICE INFORMATION

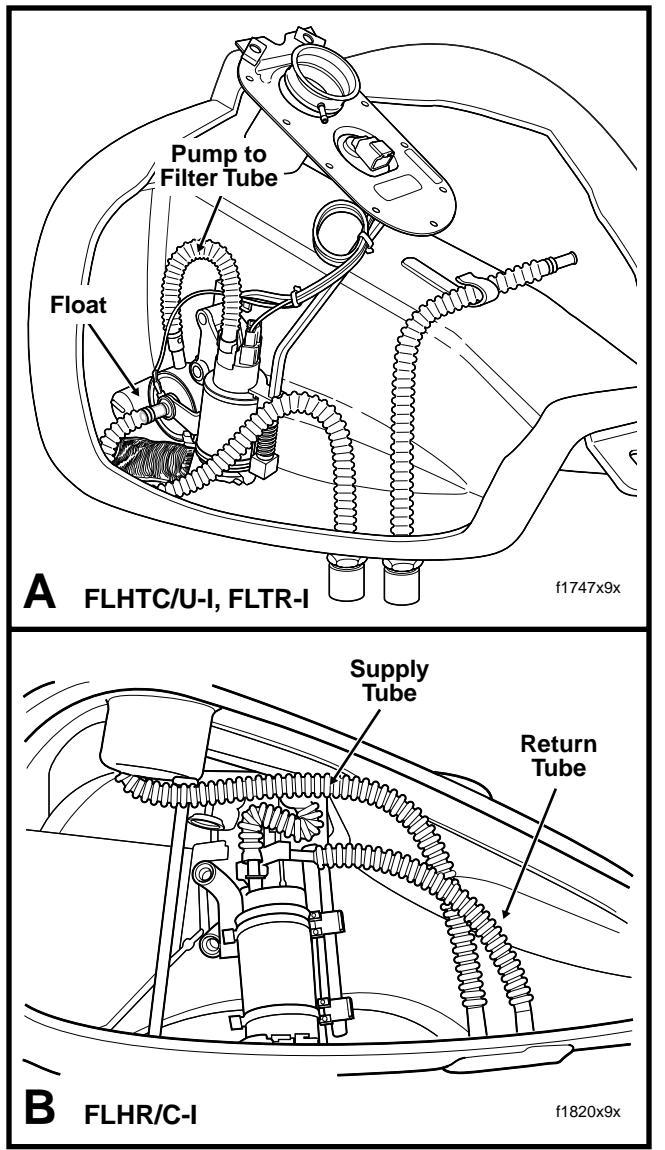
Figure 1. Check/Modify Routing of In-Tank Tubes

There have been some reports of an inaccurate fuel gauge on early 2000 model year EFI vehicles. In some cases, foreign material on the contact surfaces of the fuel level sender may be the cause. Before removing the in-tank fuel pump/filter canister/fuel level sender assembly, run through a tank of gas or two to exercise the float rod.

If the problem is not corrected, then the float rod may be contacting internal tubing. Proceed as follows:

- 1. Remove the console pod and canopy. See the 2000 FLT Models Service Manual, CONSOLE POD/CANOPY REMOVAL, page 9-100.
- 2. Raise float rod to determine if contact is made with pump-to-filter tube. See A of Figure 1. If contact is

made, remove hose clamp from filter inlet port and turn tube as necessary to coil or twist away from float rod. Install new hose clamp at filter inlet port. Verify that tube is not pinched or kinked.

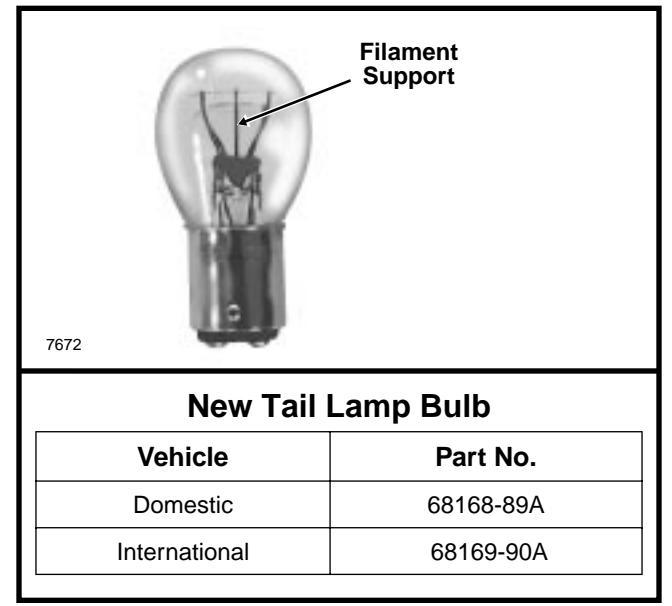
Figure 2. Use New Bulb for Improved Service Life

A new tail lamp bulb introduced on all 2000 model vehicles has a filament support that significantly increases the life of the bulb in high rpm or high vibration applications. See Figure 2. If hard use shortens the service life of the front <u>turn</u> <u>signal/running lamps</u>, the new bulb also can be installed at these locations for improved results.

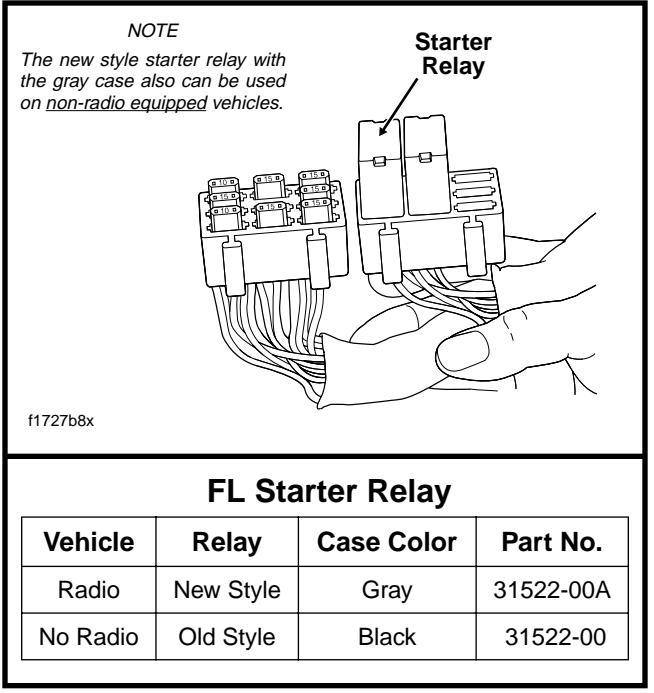
A new starter relay (P/N 31522-00) was introduced on all 2000 Dyna, Softail and FL model vehicles. Some 2000 FL model owners have since reported intermittent loss of radio while riding on rough pavement, and the new starter relay was found to be the cause. To correct the problem, an improved relay (P/N 31522-00A) with a gray case has been installed on <u>all</u> vehicles shipped from the York, Pennsylvania assembly plant after January 1, 2000. To avoid any problem,

all earlier 2000 FL model vehicles <u>with</u> <u>radios</u> should have the old style starter relay with the black case replaced with the new gray relay. [Complete a warranty claim using labor code 5832.] The old style relay can continue to be used on <u>non-radio equipped</u> vehicles. See the table in Figure 3.

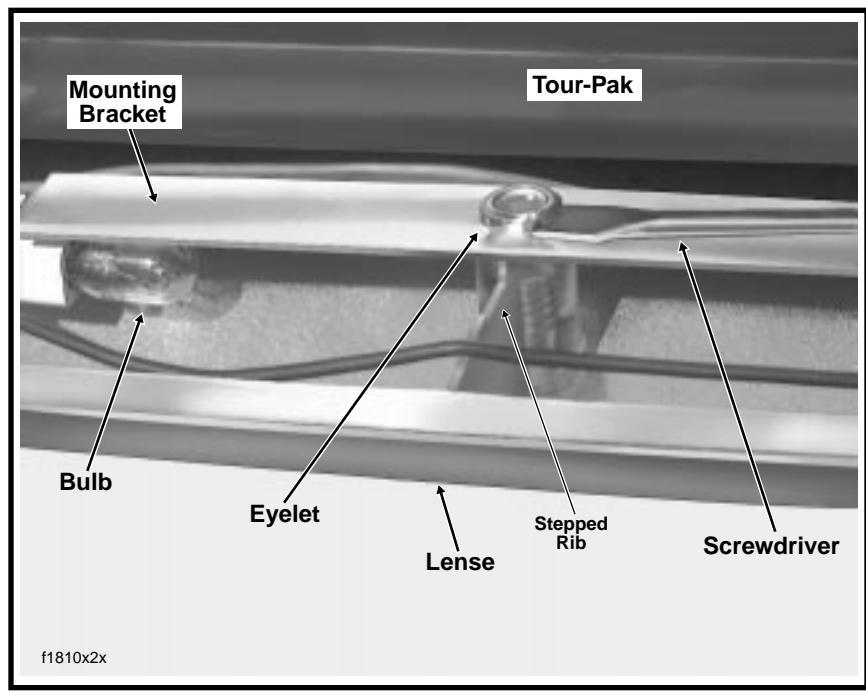
Figure 4. Remove Eyelets to Release Mounting Bracket From Lense

Since the space between the lense and mounting bracket is too narrow for bulb removal and installation, disassembly must be taken one step further than that described in the 2000 FLT Models Service Manual. Use this procedure for lense replacement also.

- Using the blade of an X-Acto knife or small screwdriver, gently pry up three eyelets on inboard side of mounting bracket. See Figure 4. Remove eyelets and then remove mounting bracket from lense. Discard eyelets if damaged.
- 3. Remove bulb from socket and discard. Install **new** bulb in socket.
- Align holes in mounting bracket with those in lense. Push three eyelets through mounting bracket holes into bosses of lense. Use **new** eyelets if damaged.
- Place lense assembly into position at side of Tour-Pak, but exercise caution to avoid pinching or kinking wires. Note that center rib on inboard side of lense has a stepped area for routing of the top wire. See Figure 4.
- 6. From inside Tour-Pak, install three T15 TORX screws.

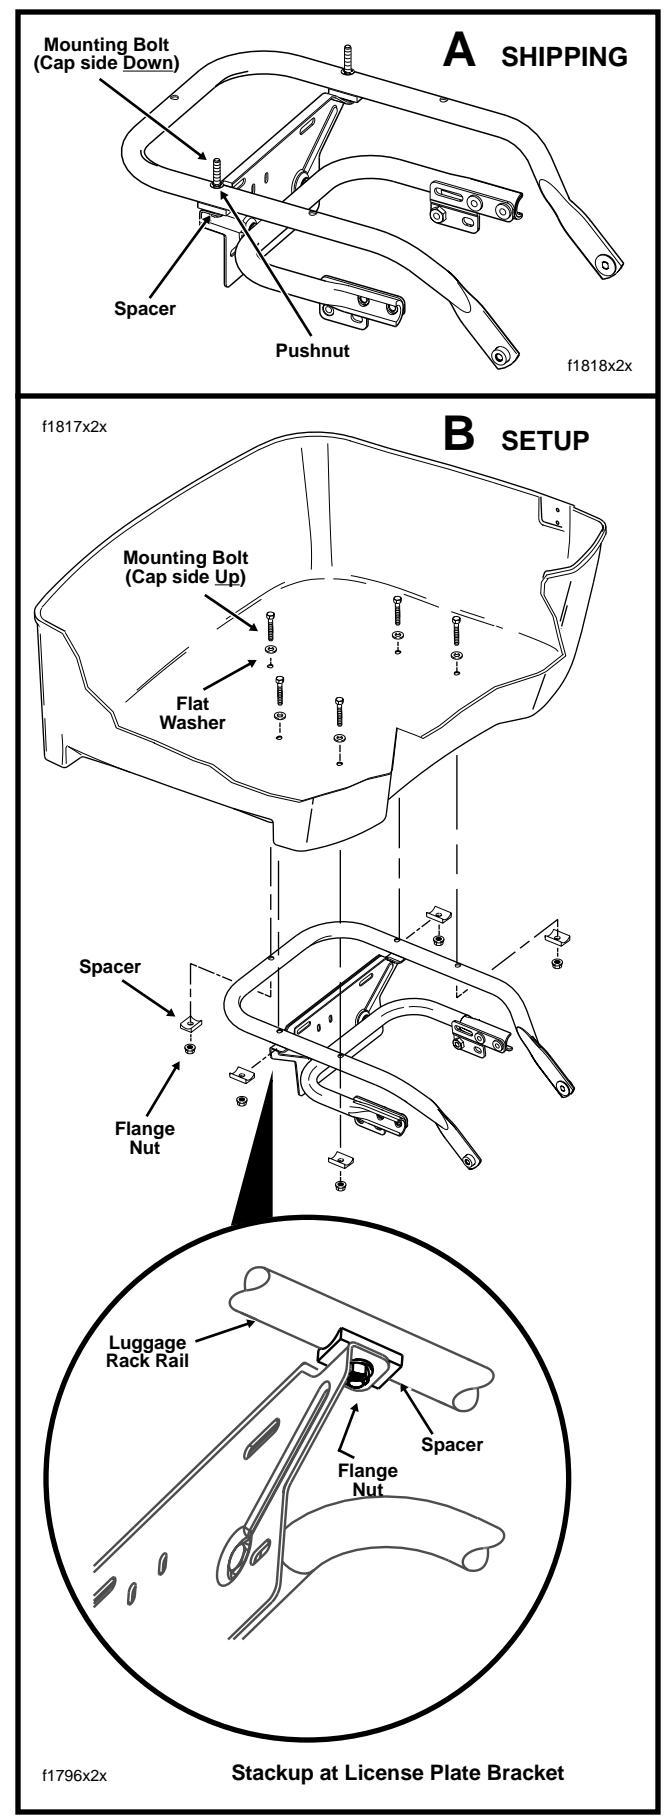
Figure 5. Install Tour-Pak Mounting Bolts

Some dealers are installing the late 2000 model year Tour-Pak mounting bolts upside down. In these cases, the ends of the bolts can tear the molded liner and scratch objects, such as helmets, stored inside the Tour-Pak.

When the vehicle is first shipped from the factory, the two rear Tour-Pak mounting bolts on the left and right side are installed upside down, and then held in place with pushnuts. See A of Figure 5. The Tour-Pak is placed over the bolts and secured using two flange nuts with oversized shipping washers. This configuration is only intended to faciliate crating and shipping of the vehicle.

After re-positioning the Tour-Pak, re-install the two mounting bolts from <u>inside</u> the Tour-Pak using the smaller flat washers and flange nuts provided. Three additional mounting bolts (along with associated hardware) are installed in the same manner. See B of Figure 5. The pushnuts and oversized shipping washers removed during setup are discarded.

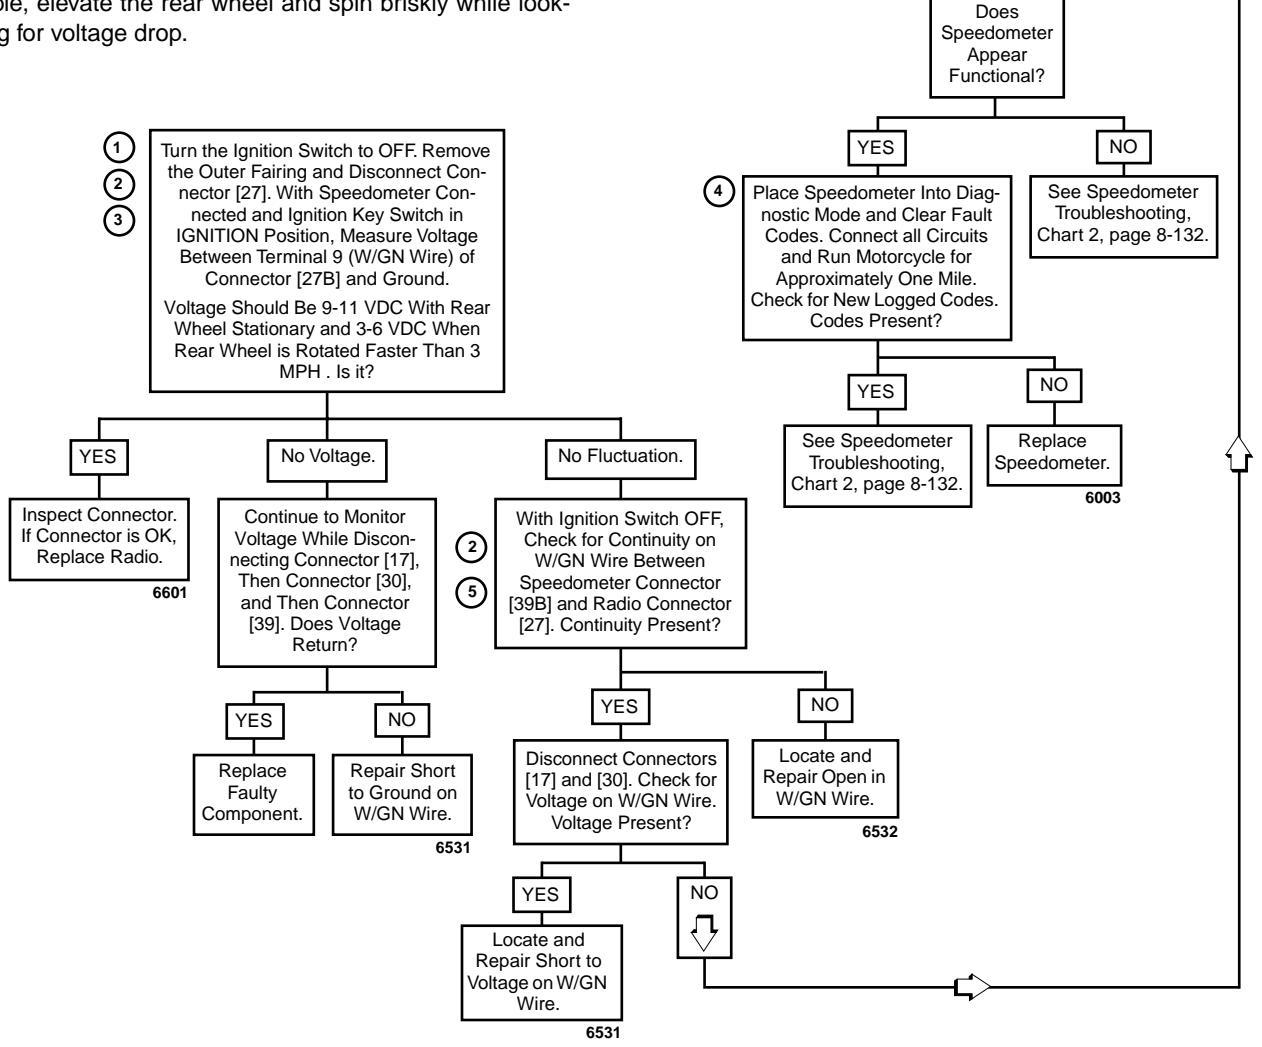
4. AUTOMATIC VOLUME CONTROL (AVC) INOPERATIVE HARDWARE DIAGNOSIS

The diagnostic flow chart under Automatic Volume Control (AVC) Inoperative, Hardware Diagnosis, on page 8-176 of the 2000 FLT Models Service Manual has several errors. For future reference, please copy the <u>corrected</u> flow chart on page 6 of this bulletin and insert it into the appropriate spot in your service manual.
