# **SERVICE BULLETIN**

#### M-1196

# **ADVANCED AUDIO SYSTEM SOFTWARE UPDATE V8.11.0**

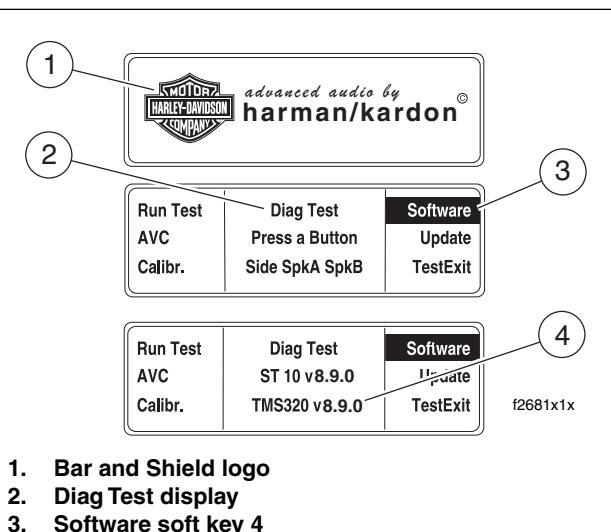
Figure 1. Identify Software Version Number

4. Software version number

- 1. Turn the ignition/headlamp key switch to OFF.
- Simultaneously press and hold any two soft keys (1, 2, 3, 4, 5, or 6).
- 3. Turn the ignition/headlamp key switch to ACCESS.
- 4. See Figure 1. Continue to hold the two soft keys while the Harley-Davidson Bar and Shield logo (1) is displayed. The display will cycle to Diag Test (2).
- 5. Press the Software or number **4** soft key (3) to display the software version number (4).
  - a. If the software version number is lower than v8.11.0, Update Receiver Software with the v8.11.0 update CD.
  - b. Receivers with v8.11.0 or higher will not need to be updated.

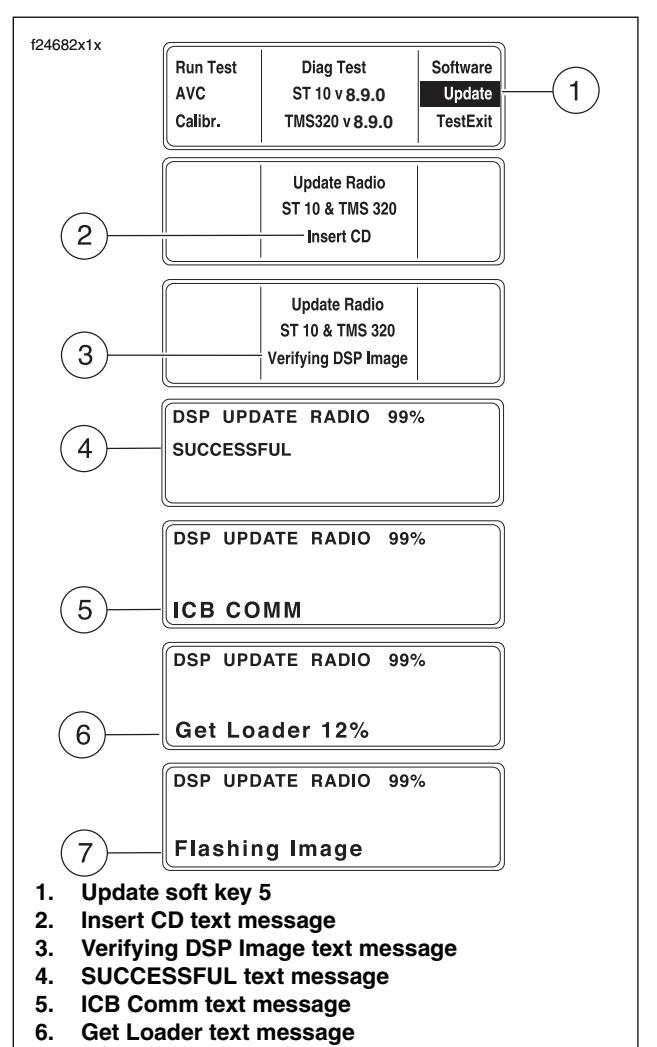
Figure 2. Update Receiver Software

Flashing Image text message

- Eject any current CD (open the CD cover and press the eject pushbutton). Leave the CD door open while the update CD is in the reader.
- See Figure 2. In the Diag Test display, press the Update (1) or number 5 soft key to open the Update Radio display.

- To update the radio, follow the text prompt, Insert CD (2), and insert the v8.11.0 update CD. The CD will automatically initiate the download. Updating the radio will take up to 7 minutes.

- a. The text message, Verifying DSP Image (3), is displayed as the percentage of download is updated.
  - b. An automatic power down and up, will proceed the text message, SUCCESSFUL (4).

- c. Sequentially, ICB COMM (5), Get Loader (6), and Flashing Image (7), text messages will be displayed as the percentage of download is updated.
  - d. The receiver will again automatically power down and up.

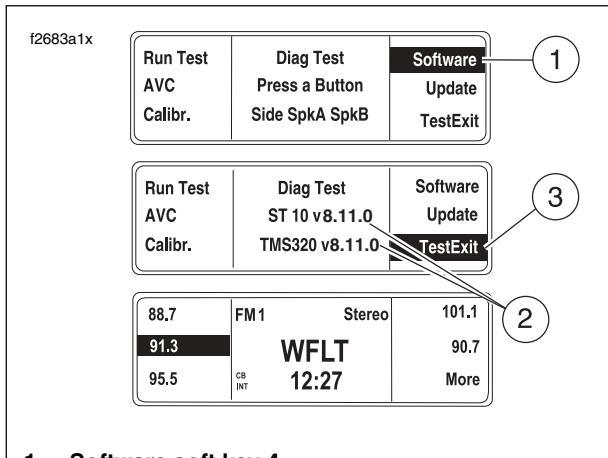
Figure 3. Confirm Update Version Number

- 1. Software soft key 4
- 2. Software version numbers
- 3. TestExit soft key 6

- 1. Turn the ignition/headlamp key switch to OFF.
- Simultaneously press and hold any two soft keys (1, 2, 3, 4, 5, or 6).
- 3. Turn the ignition/headlamp key switch to ACCESS.
- Continue to hold the two soft keys while the Harley-Davidson Bar and Shield logo is displayed. The display will cycle to Diag Test.
- 5. See Figure 3. Press the Software or number 4 soft key (1) to display the software version number (2).
- 6. Verify that both displayed software version numbers (2) are v8.11.0. If the version numbers are different from v8.11.0, start over with Update Receiver Software.
- 7. If both version numbers in the display are v8.11.0, press the TestExit (3) or number **6** soft key. The display will open to the current receiver mode.
