EVO: Oiling & Lubrication

Primary/Transmission Oiling

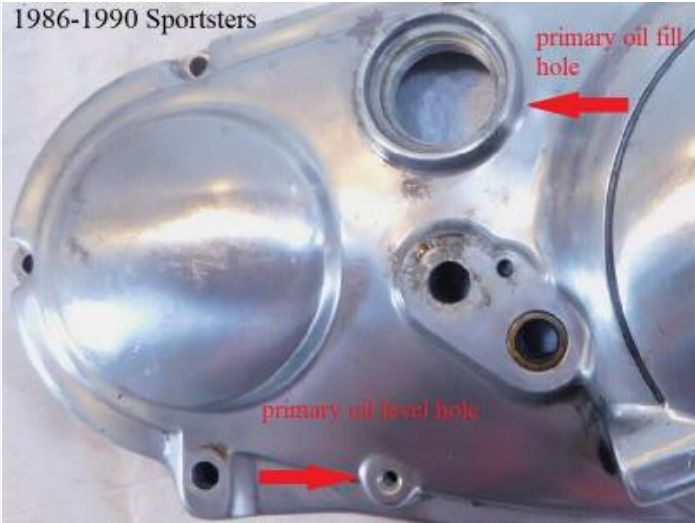
1986-1990 Sportster primary/transmission oil site level and fill holes ¹⁾	1986-1990 primary drain plug ²⁾
<p>1986-1990 Sportsters</p>

- **On the 1986-1990 models**, the oil level screw (stock is Philips-head) is located on the side of the primary cover, forward from the clutch cable mount and below the shifter lever. Oil should seep (not pour) from the hole, bike upright, with the oil level screw removed. If not, proper oil level is achieved by removing the primary chain inspection cover and slowly filling the primary with oil until it pours out the oil level hole. When it's just seeping from that hole, replace the oil level screw and the inspection cover. The Oil Drain Plug is located on the lower/rear of the left-side engine case.

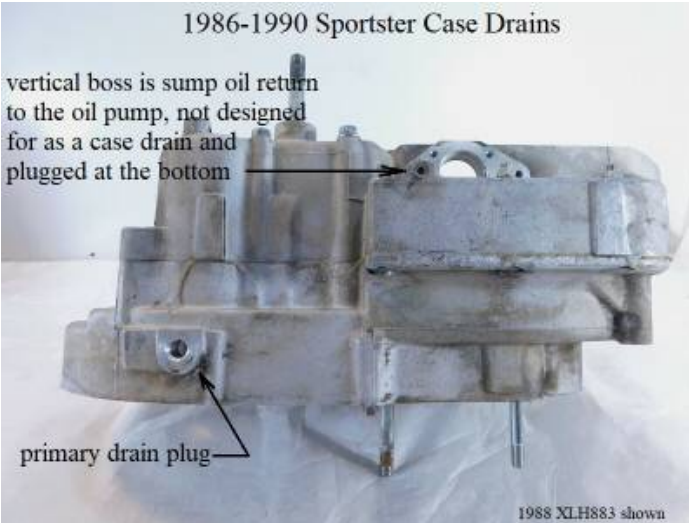
<p>1986-1990 Sportster Case Drains</p>

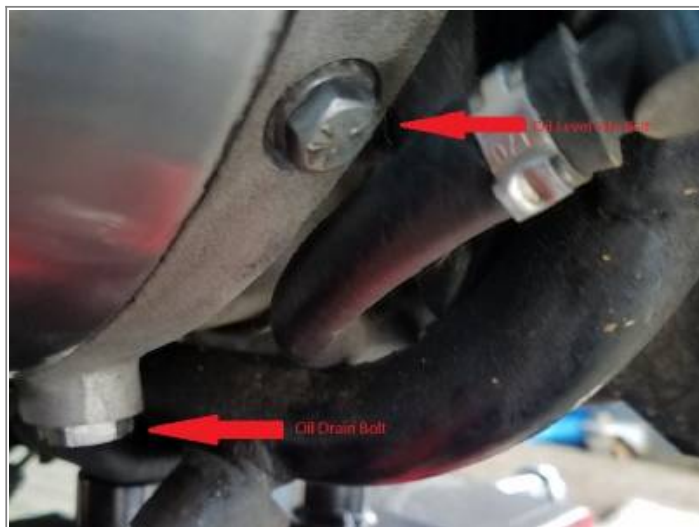
<p>1988 XLH883 shown</p>
1991-1993 Sportster primary/transmission oil drain & oil site level bolts ³⁾	1991-1993 Sportster primary/transmission oil fill hole ⁴⁾

- **On the 1991-1993 models**, the oil level bolt is located at the rear of left engine case, rearward of the oil drain plug. Oil should seep (not pour) from the hole with the oil level screw removed. If not, proper oil level is achieved by removing the primary chain inspection cover and slowly filling the primary with oil until it pours out the oil level hole. When it's just seeping from there, replace the screw and the inspection cover. The Oil Drain Plug is located on the lower/rear of the engine case.

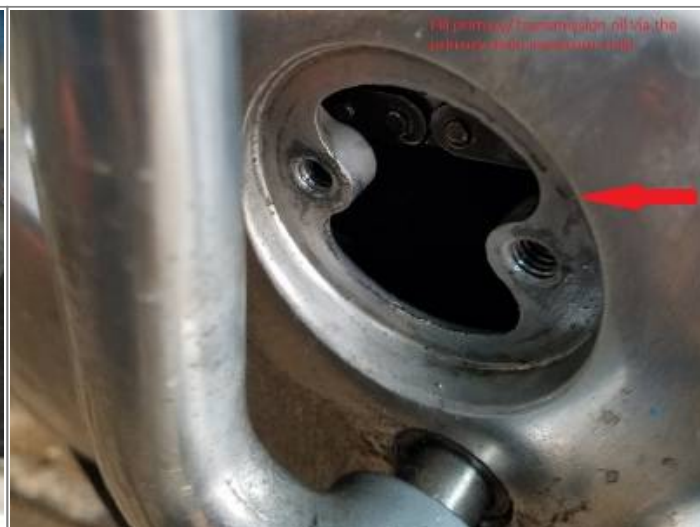
Primary / Transmission oil drain plug on 2001 Sportster ⁵⁾

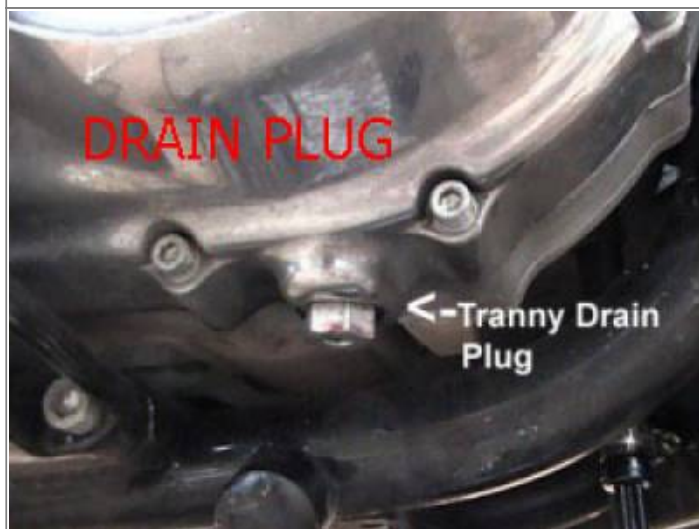
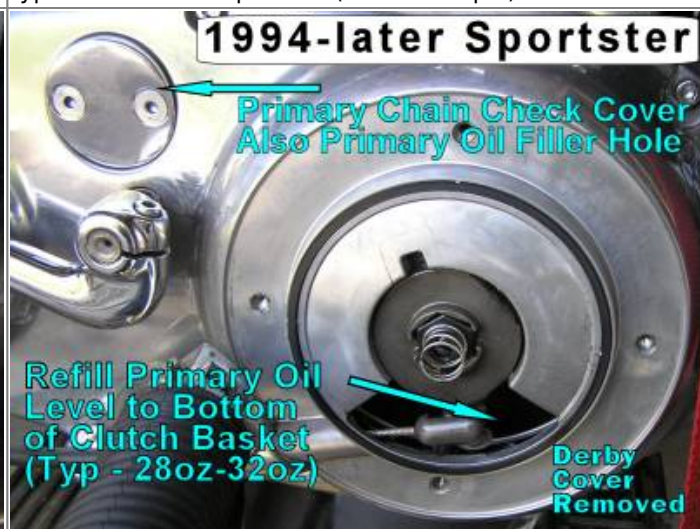
Primary / Transmission fill and check site for a typical 1994-later Sportster (1994 example) ⁶⁾

- Torque Specs:
 - Oil level screw (90-110 in/lbs)
 - Inspection cover screws: (40-60 in/lbs) or (4.5-6.8 Nm)
 - Drain plug (14-21 ft/lbs) or (19-28 Nm)
- **On the 1994-2003 models**, there is no oil level site hole and the clutch inspection cover (Derby Cover) is removed to check primary oil level. The proper level of oil, is when the oil level is just at

the bottom edge of the clutch diaphragm spring. The Oil Drain Plug is located on the lower/rear of the left-side engine case.

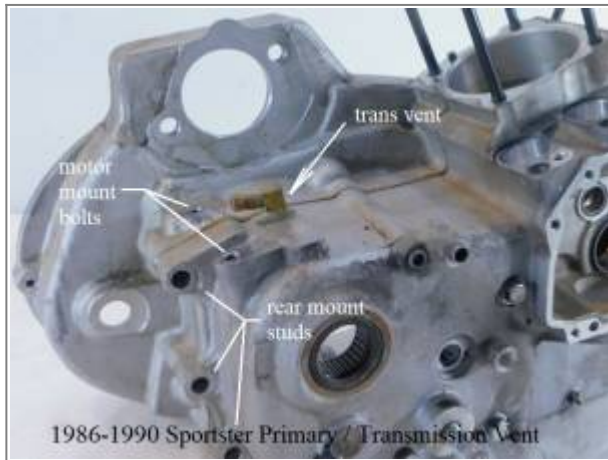
There is an illustration for 1990 models showing the trans vent coming up under the seat and looping down as in the 1991-1999 hose routing.

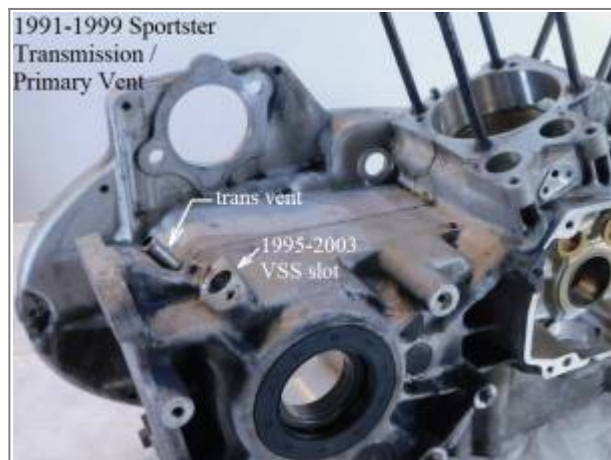
The fitting (63547-89) for the vent hose is a 3/8" tube pressed into the case with a hose bibb on the outside end.

1991-1999 Transmission Vent Fitting ⁸⁾

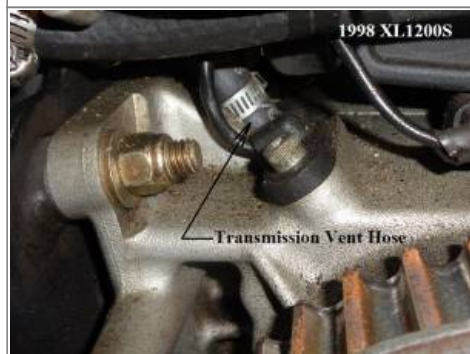
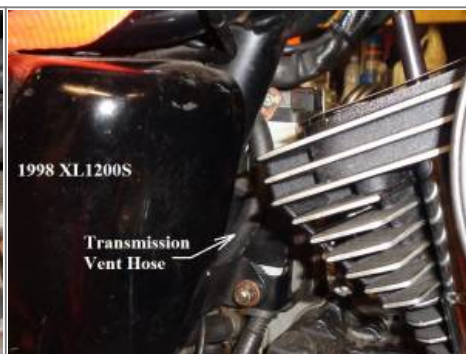
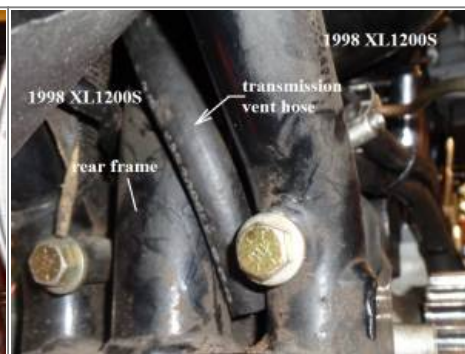
- The vent hose is raised up high under the seat, behind the battery box with a wide loop down toward the center of the seat downtubes.
Make sure that you manage a wide loop that will not eventually close the ID of the hose.
The hose is then left hanging low (tied off). Some run the hose end down behind the swingarm.
Some run the hose out past the center of the seat tubes, wedging it between the center rear tube and an adjacent L or R outside tube as in the pic below.

1998 transmission vent hose. ⁹⁾

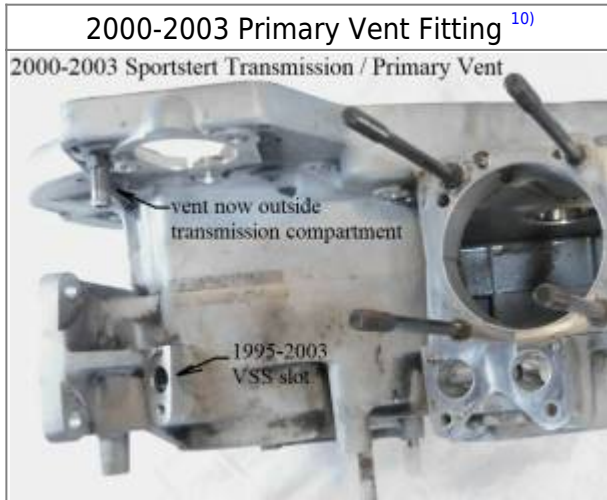
- Route the vent hose up, behind the front battery bracket keeping a long sweep below. Attach the hose to the inboard side of the oil tank with the original T-clip up and then run the hose outboard of the frame tube.
If desired, you can also run the hose down behind the swingarm or pinched between the rear seat post tubes as in 91-99 models above.
That would alleviate the need to tie the hose to the oil tank if your tank doesn't have those provisions.
You also tie the hose to the frame crossmember under the seat.

There was a service bulletin issued by the MoCo on 7-28-2000 detailing a change to the 2000 model vent routing at the factory.

The new routing eliminates sags (low points below the fitting at the crankcase) in the hose where oil may collect and be forced out later.

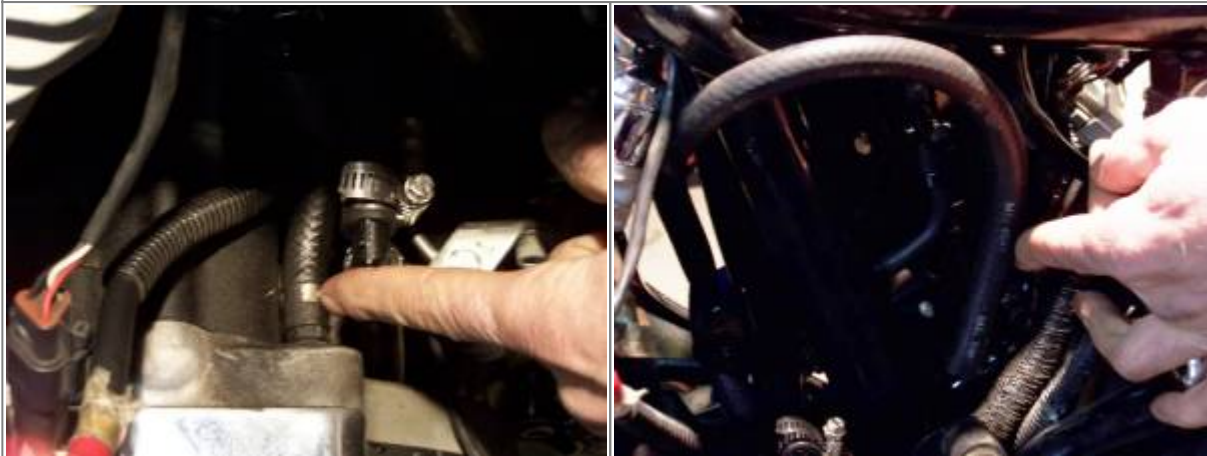
2000 transmission vent hose. ¹¹⁾

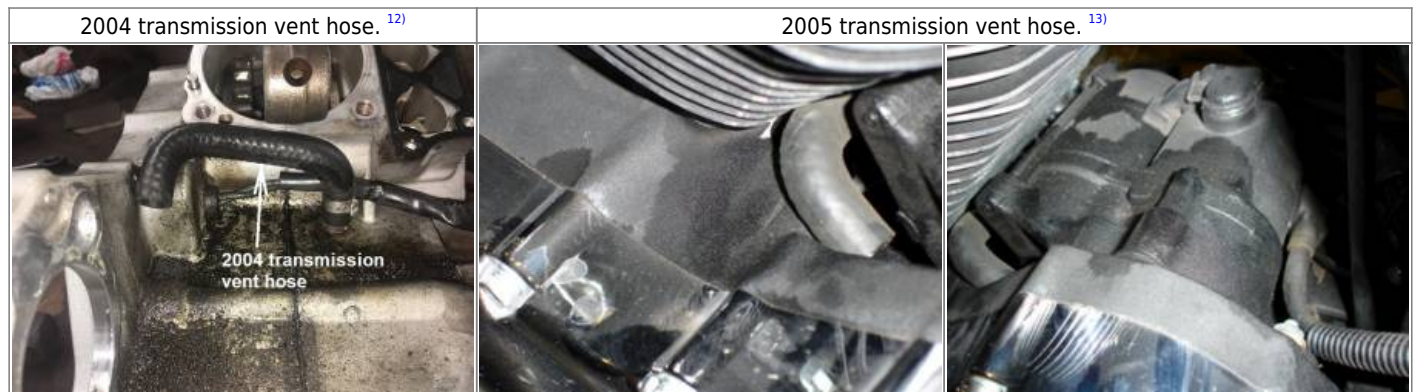
The hose end just peeks out the left side from behind the starter with a 90° bend on the end between the starter and back side of the primary case.

Looking at the first pic below, you can see it is also formed to run at an up angle from the fitting before it turns down at the ending bend of the hose.

The hose (63508-04) is short, preformed and is attached to the fitting with a hose clamp.
