REF: Engine Mechanicals - Sub-04G

Slack tube testing on a 1998 1250S model

This testing was done to see the changes in crankcase pressure using a homemade slack tube while changing some variables.

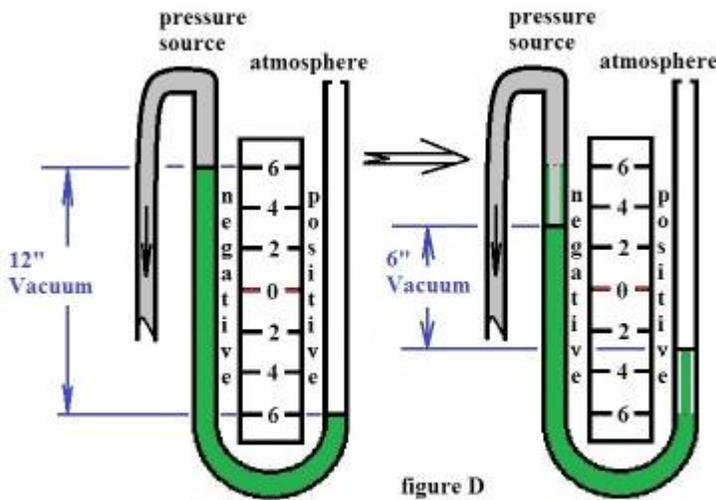
figure D

In the drawing below (left);

A rise in vacuum pressure of 6" of water (left leg) has a total of 12" in rise as the water has traveled in both legs.

Then, on the right;

An addition of 3" of positive pressure exerted (6" in actual height) on downstroke still yields a balance of

6" of total vacuum from the engine (showing 3" on left leg).

In this example, the total pressure in the crankcase is still negative but with not as much pressure as it was at the last upstroke.

12" of vacuum with 6" of positive added to it results in 6" of vacuum

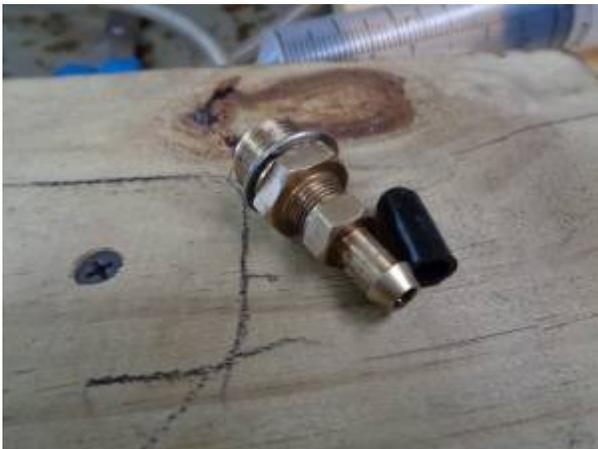
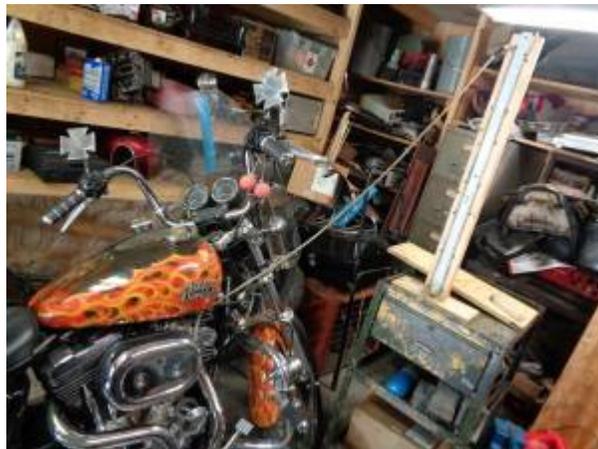
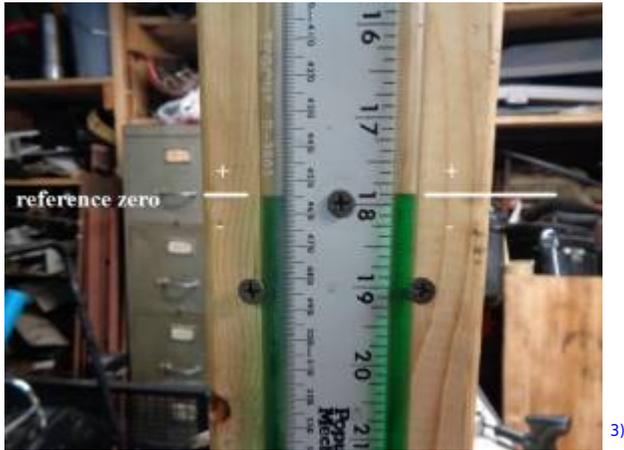
For this testing, a slack tube was made using an 1/8" hose barb fitting plugged into the timing plug hole with a length of 1/8" clear hose to the instrument.

All testing done with green coloring below was done with 36" ruler with reference zero at 18-1/8" on the ruler as shown below.

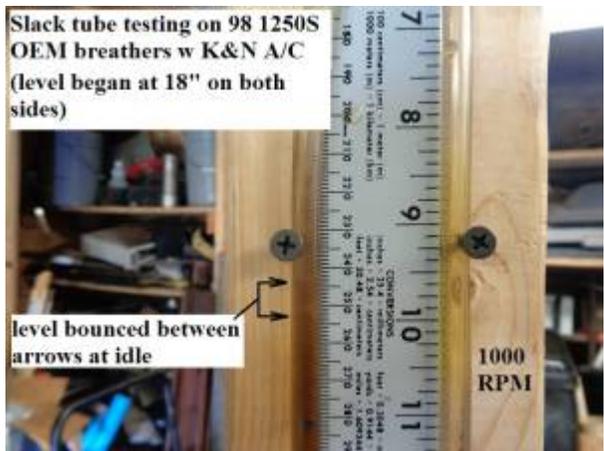
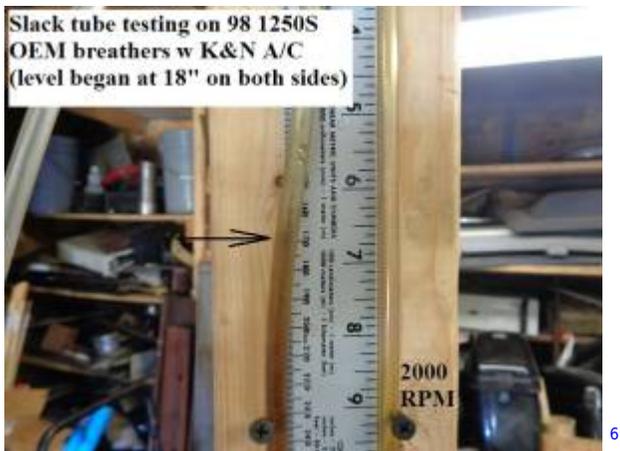
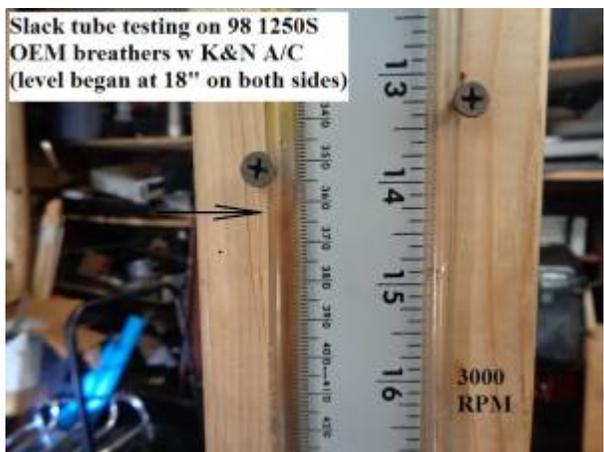
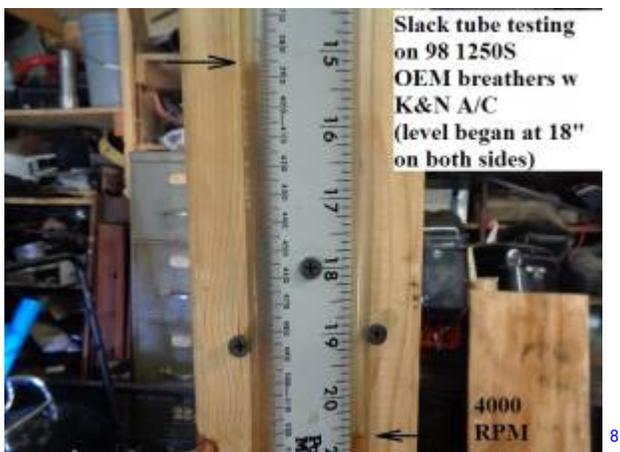
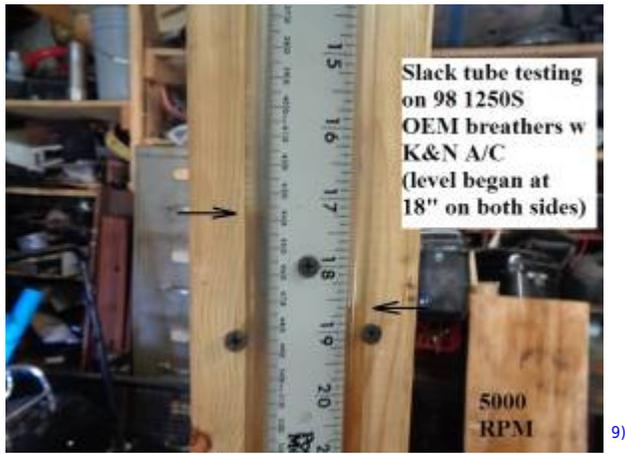
The level began at 18" on the ruler on both legs. There was about a 3/8" fluctuation at idle but was stable thru the rest of the testing.

Below are the results from 1000-5000 RPM.

As you can see, the coffee doesn't show up well in the pics which is why green food coloring in water was used in later testing.

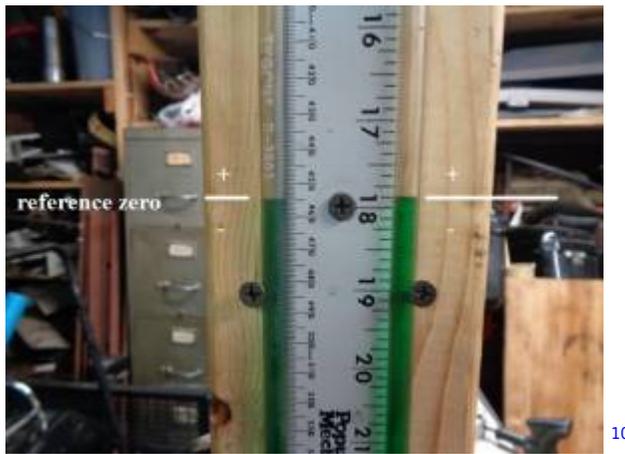
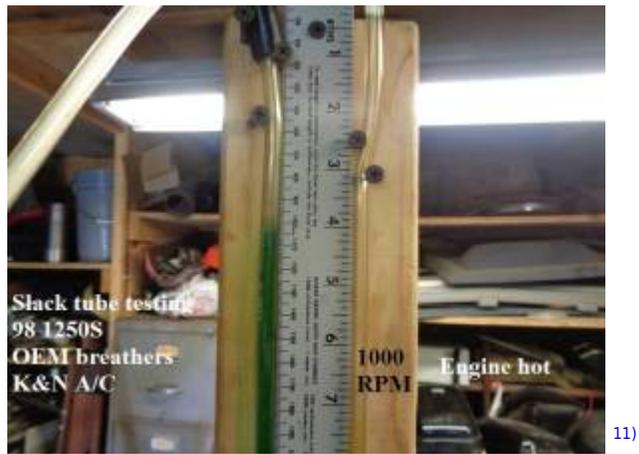
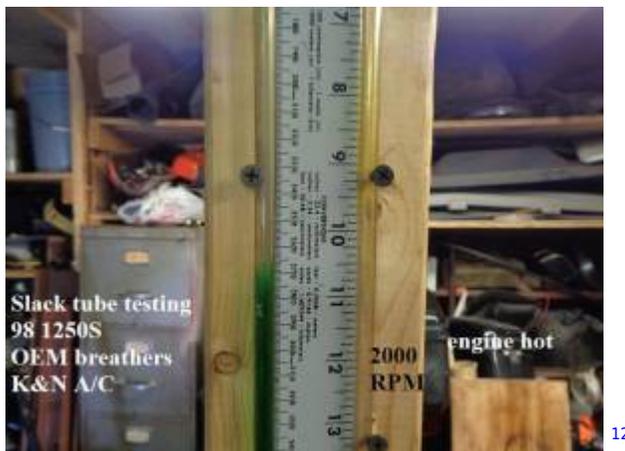
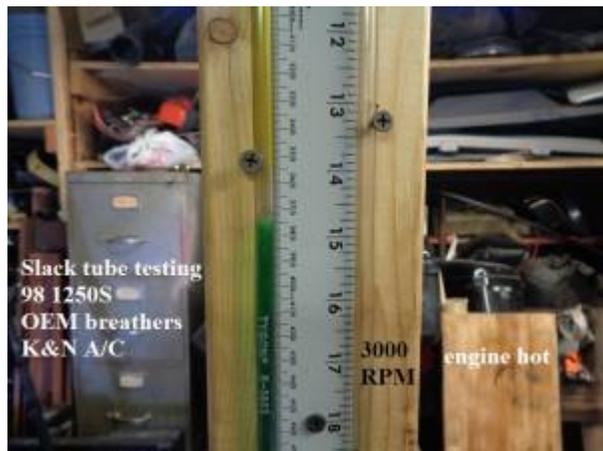
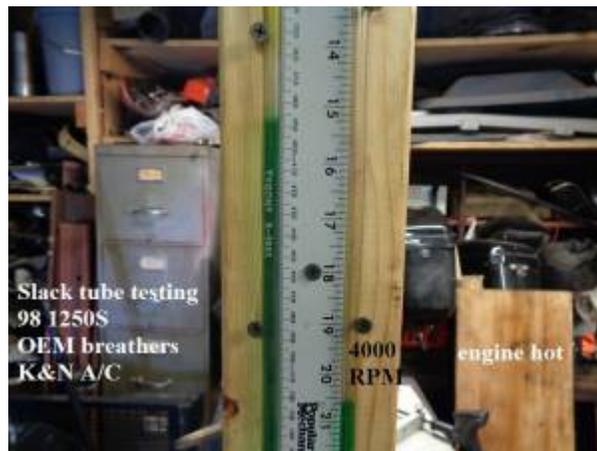
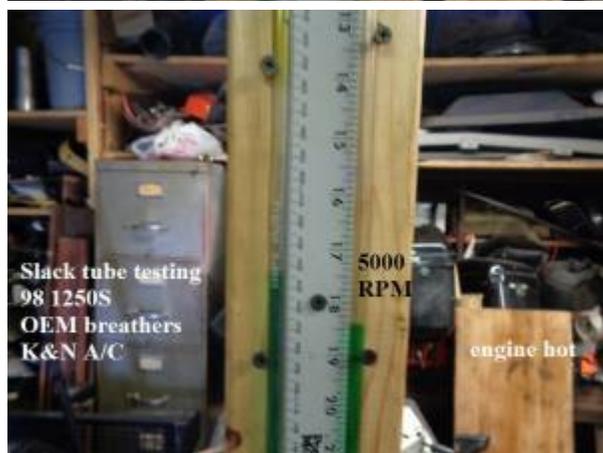
This is the first official test that was done with the engine up to temp. Green food coloring in tap water was used as the liquid media. The umbrella valves were in used state. The front umbrella had about 6 months use.

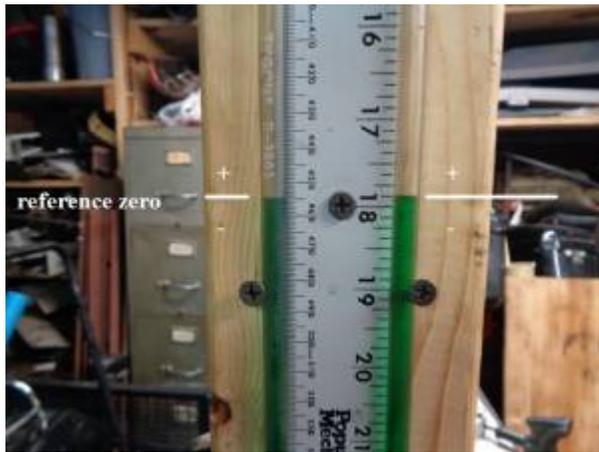
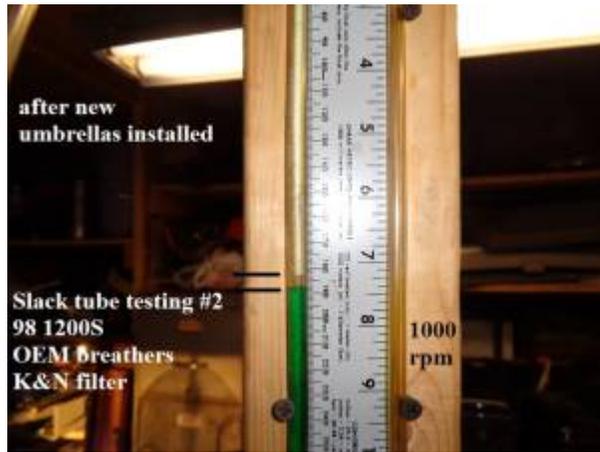
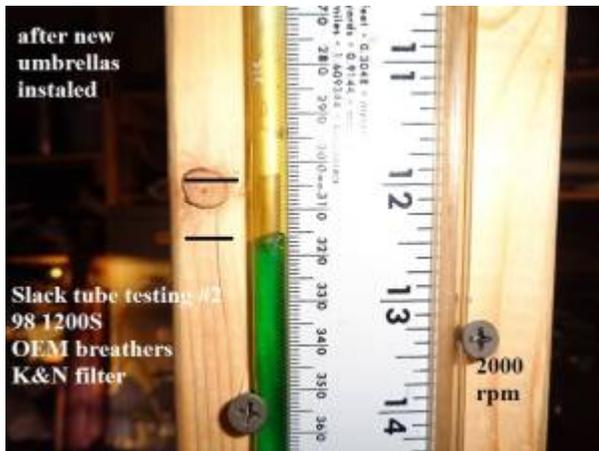
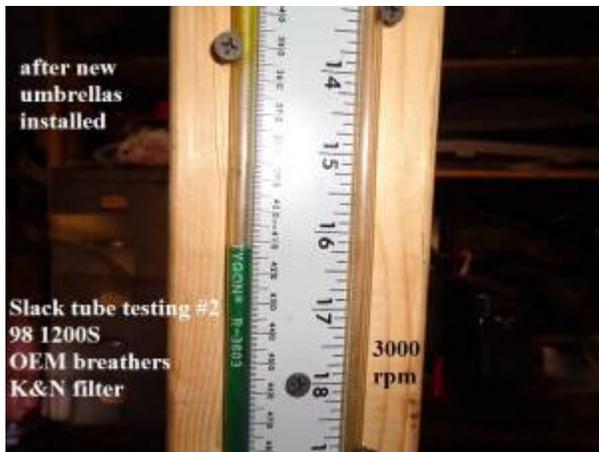
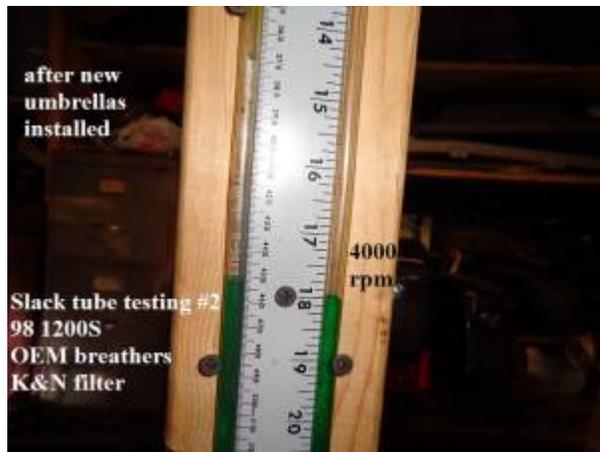
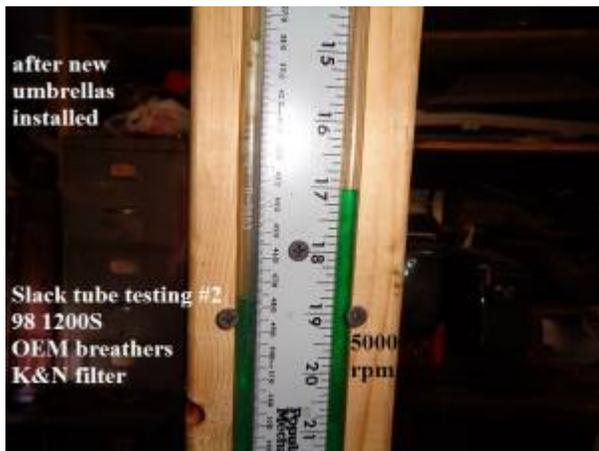
The results show about a 3-1/4" reduction in vacuum at idle in the left leg (6-1/2" of water column) with a new umbrella in each rocker box.

And the engine is now going to positive pressure around 4200 rpm.

At both 1000 and 2000 RPM, there was not a fast changing variance in the measurement (as was in the previous test mostly at idle).

The variant level is still about a 1/4" up and down but it rises and falls slower now.

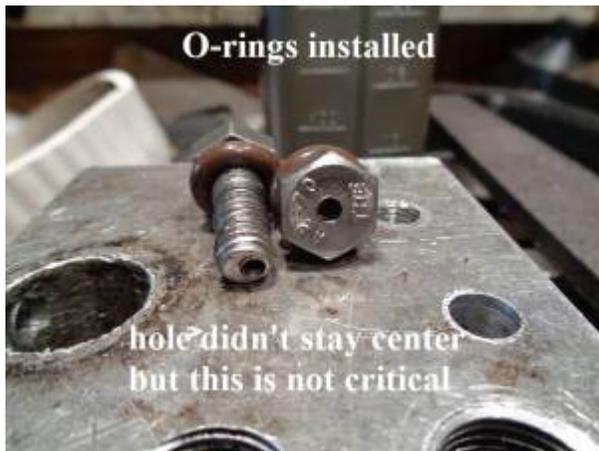
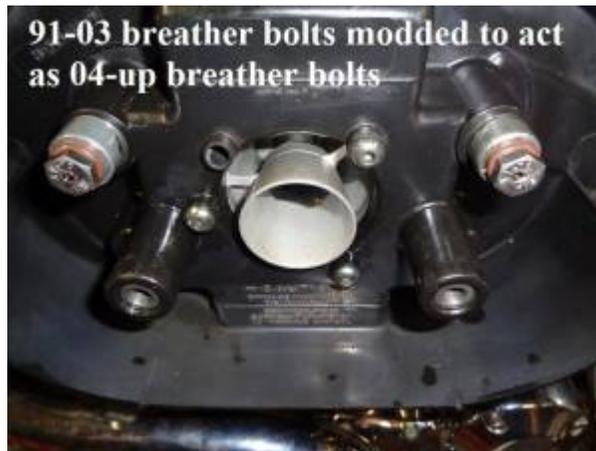
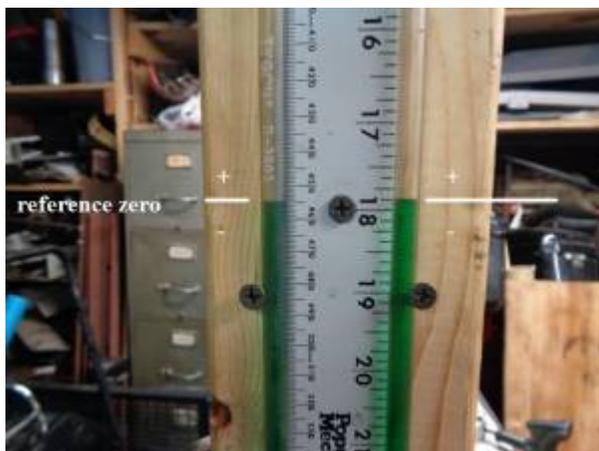
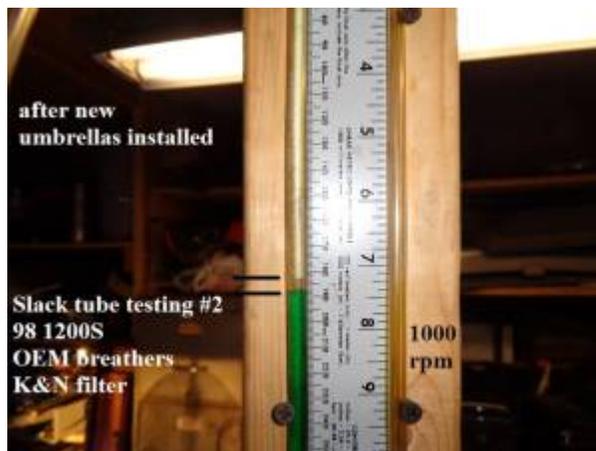
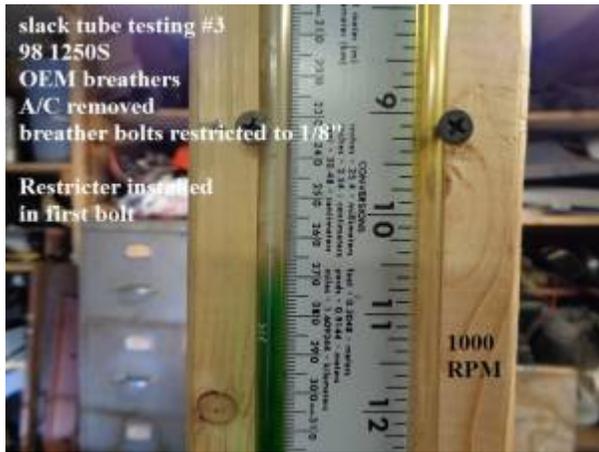
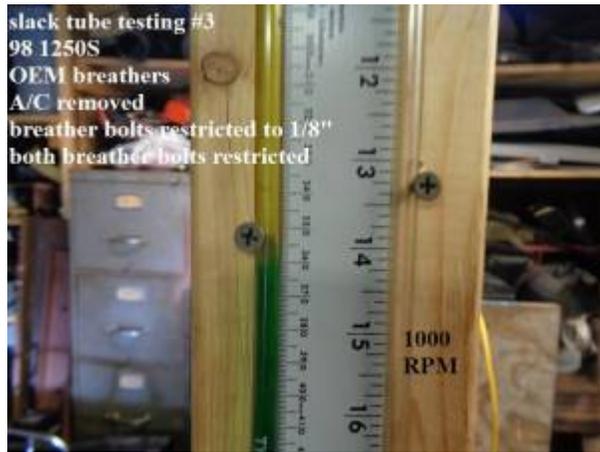
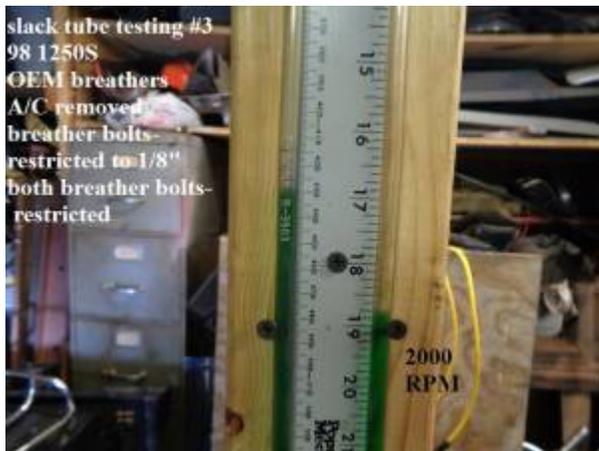
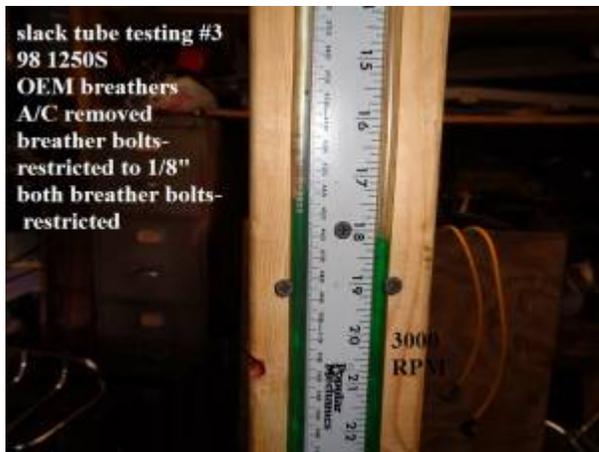
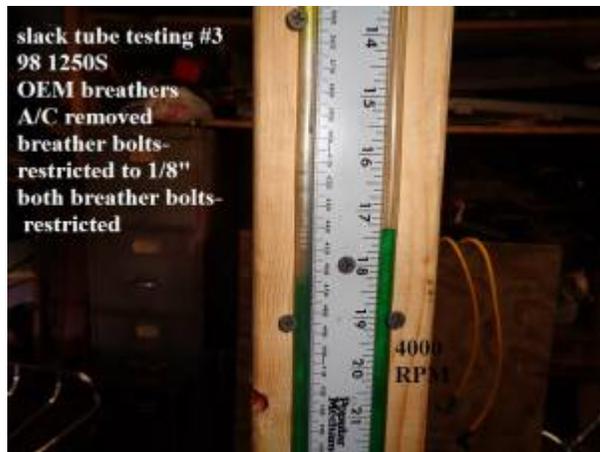
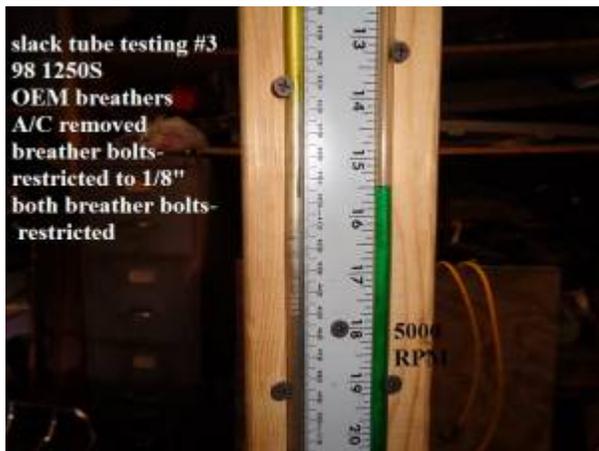
This was done to see what the affects were of the restricted breather bolts in 04-up engines. (to see if the restricted hole itself has an affect on pressure on the inside and if so how much)

The smaller bolt holes actually reduced vacuum and they also offered more control of crankcase pressure throughout the RPM range by creating lower pressure swings.

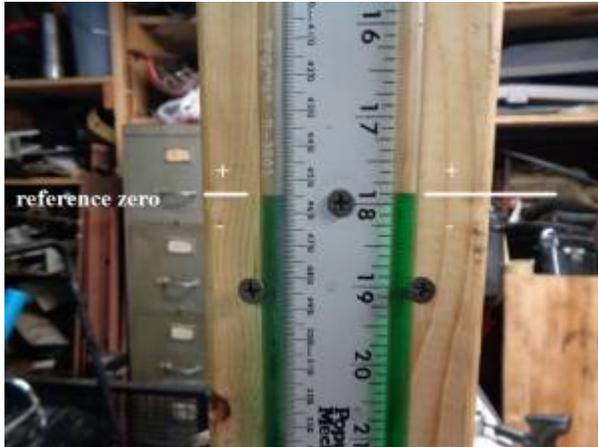
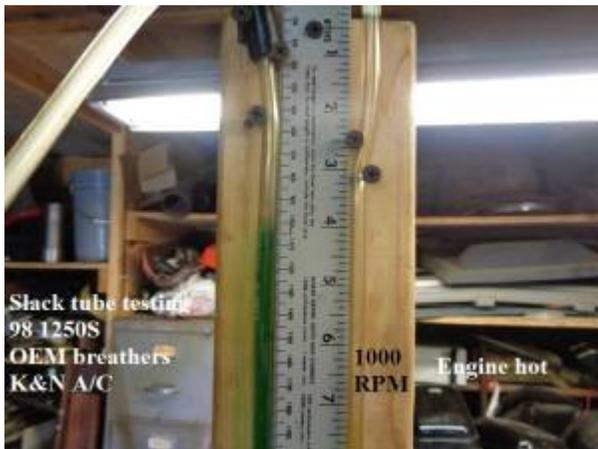
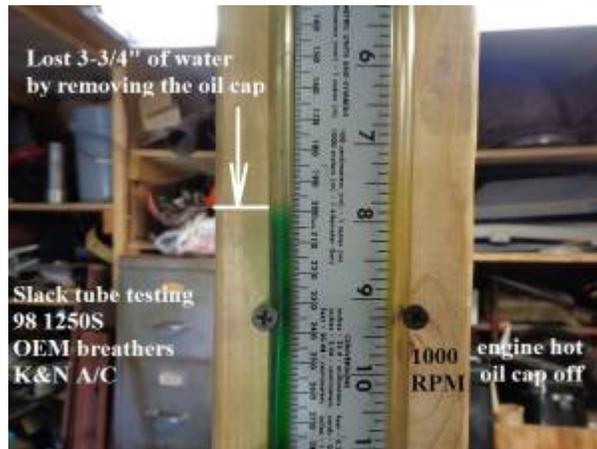
Before the new umbrellas, 3-3/4" (7-1/2" WC) of vacuum was lost while removing the oil cap and the engine died when removing the cap.

The idle changed with slight movements of the cap being closer to or farther away from the oil tank neck opening.

There was oil frothing in the oil tank with the cap off at idle. The frothing got less when the cap was 'slightly' off.

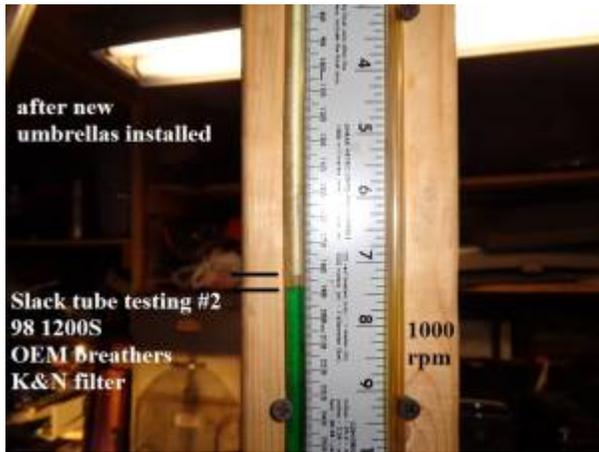
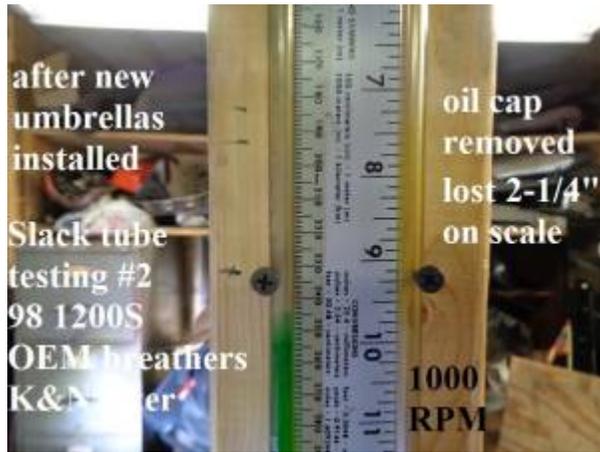
The overall vacuum decreased at idle with the new umbrellas.

When the oil cap was removed, only 2-1/4" (4-1/2" WC) was lost and there was only a slight pitch change in the engine with no noticeable amount on the tach.

No frothing in the oil tank now with the cap removed at idle. So it appears the problem was a stiff umbrella valve (rear).

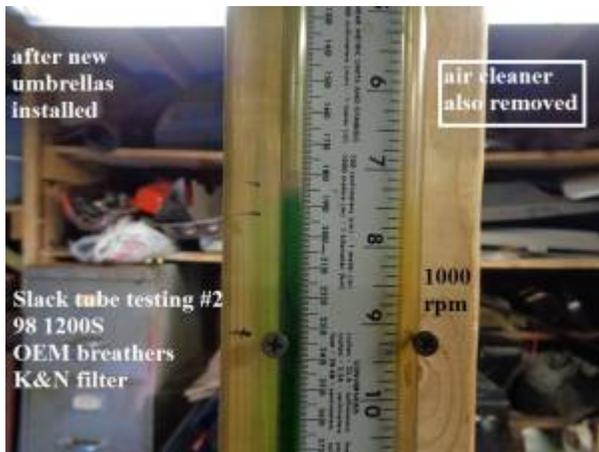
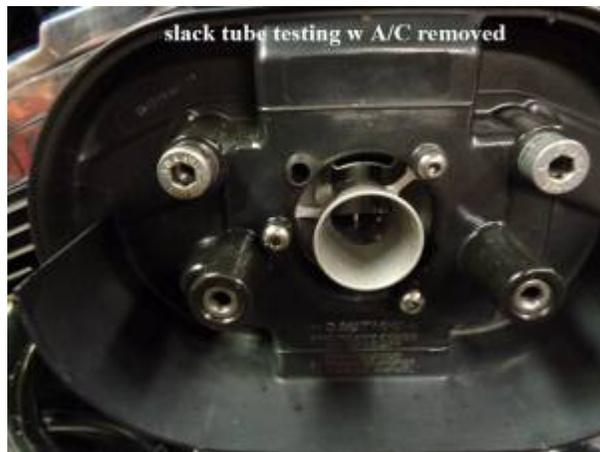
The A/C was removed to see if it had any impact on crankcase pressure testing. There was no noticeable difference with it off through the RPM range tested up to 5000. There was also no noticeable oil mist during this period. Condensation and light oil mist accumulation at the bolts was from original testing before replacing the umbrellas. But none of this was in the filter and no oil puking.
