REF: Service Procedures 11E

What Causes the 1991-2003 Shift Arm to Scrub the Starter Gear

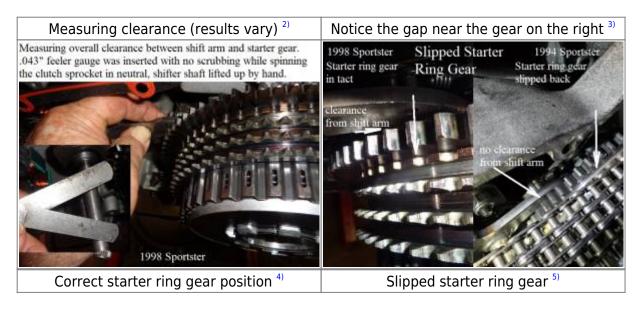
But there should be clearance between the shift arm and starter ring gear if you lift the shift shaft to the upper extreme.

A measurement was taken between the arm and gear with a feeler gauge at .043" (1.0922mm) without any scrubbing noticed (shaft lifted up by hand w/ cover off).

This dim is just a dirty one and results will vary. But the point of that measurement is there is that there will be some clearance between the two.

If the arm stays against the ring gear when the shaft is lifted, check the starter ring gear for breakage or slippage.

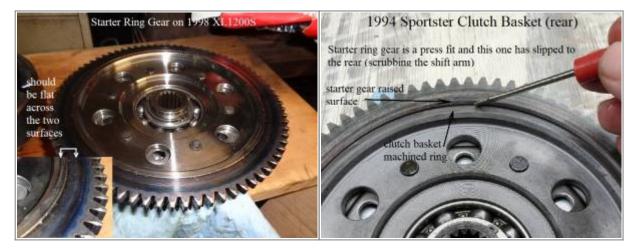
With deep scratches or the shift arm continuously rubs without stopping (permanent contact), check to see if the starter ring gear is backing away from the clutch basket.

The starter ring gear is pressed onto the rear of the clutch basket and has been known to slide rearward away from it.

This may never happen as it doesn't happen everyday, but always keep that in mind when it's found that the shift arm is constantly scrubbing the ring gear.
