No. M-751

SAFETY DEFECT CODE 041

REAR BRAKE PEDAL STOP BOLT JAMNUT / 1979 XLH, XLS

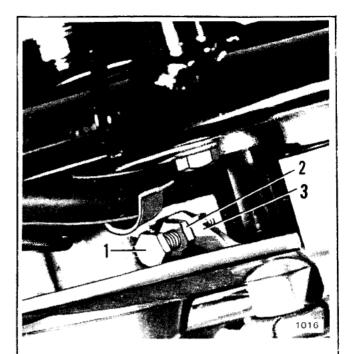
The brake pedal stop bolt is located underneath the right side of the engine just below the rear brake pedal as shown in the illustration.

REAR BRAKE PEDAL ADJUSTMENT (Behind Sprocket Cover Below Engine)

- 1. Stop Bolt
- 2. Jamnut
- 3. Pedal Shaft Lever

Check jamnut (2) for tightness and check brake linkage for proper adjustment as follows:

Work rear brake pedal by hand to determine free play (movement before plunger contacts piston in master cylinder). Free play, of plunger should be approximately 1/16 inch to be sure rear brake cylinder hydraulic pressure is relieved when brake pedal is released.

To adjust free play, loosen jamnut (2) and turn stop bolt (1) inward (clockwise) to decrease free play, or outward (counterclockwise) to increase free play. When 1/16 free play is obtained, tighten jamnut (2) against shaft lever (3) while holding stop bolt (1) in position. Recheck free play.

If the jamnut is loose, the stop bolt could unscrew from the shaft arm and allow the bolt head to contact the lower inside edge of the sprocket cover, possibly locking the rear brake in the applied position or preventing the rear brake from being applied. If either of these conditions occur while using your rear brake, you could lose vehicle control and possibly crash, causing personal injury.
