SERVICE BULLETIN

M-991

MARCH 30, 1990

1340 CLUTCH INFORMATION FOR 1990 MODELS

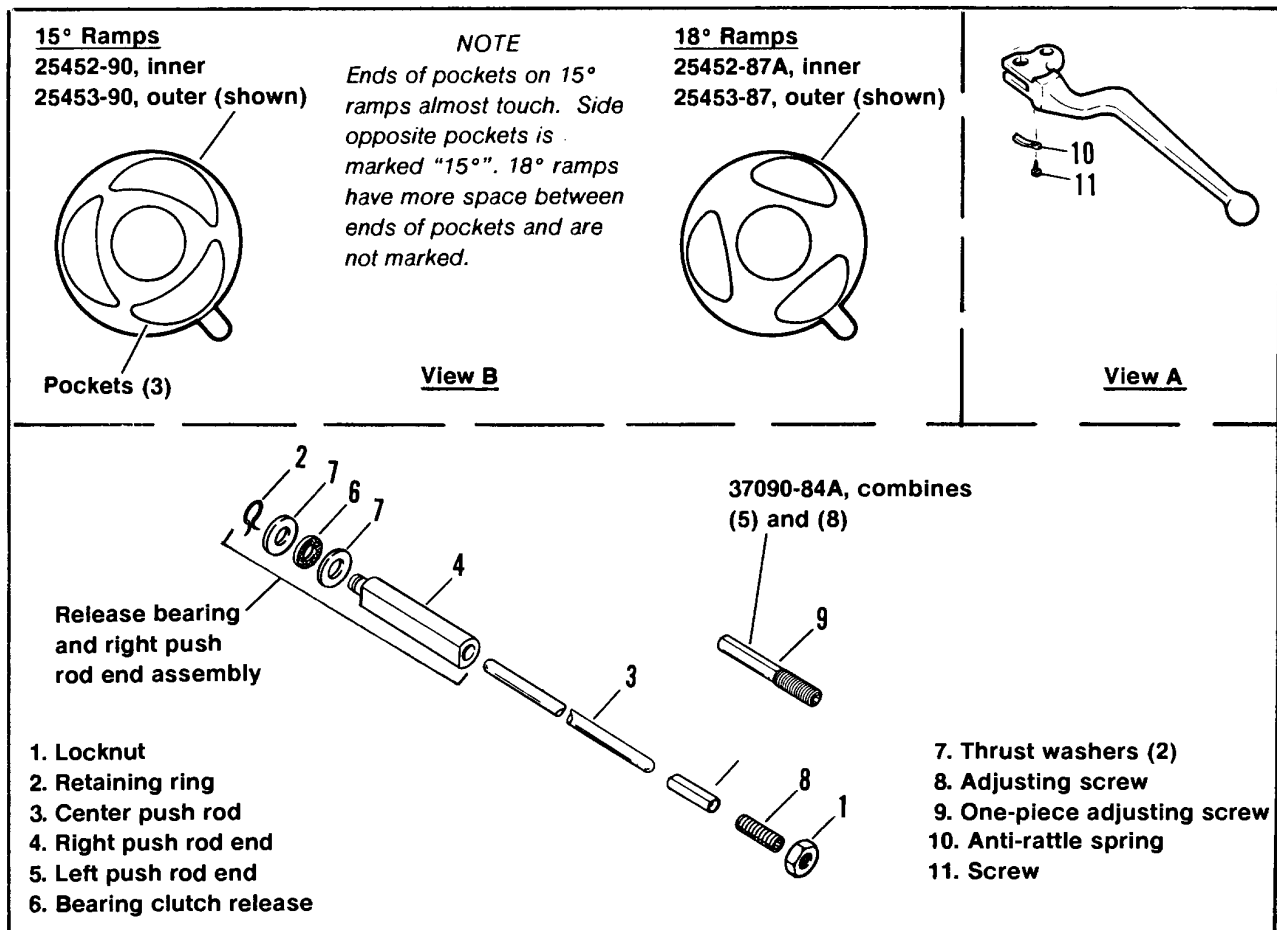
Figure 1. Clutch Release Components

See Figure 1. The left push rod end, Part No. 37090-84 and adjusting screw, Part No. 37357-84 have been replaced by a single item Part No. 37090-84A. This change reduces the possibility of clutch drag by decreasing any tendency for the clutch pressure plate to tip. This change was made to production vehicles in December, 1989.

See Figure 1, View B. Beginning **March 28, 1990**, **transmission number 90087042**, clutch release ramps, Part No. 25452-87A (inner) and 25453-87 (outer) will be used in production. These ramps will provide more movement (lift) to the push rod to further reduce the possibility of clutch drag. This change will slightly increase clutch lever effort.

See Figure 1, View A. During the installation of the one-piece adjusting screw and earlier release ramps, remove the anti-rattle spring (10) and its' retaining screw (11). The spring may affect free-play in the clutch lever and could cause the clutch throw-out bearing to be slightly loaded. That loading could cause premature failure of the throw-out bearing.

3. See Figure 1. With a magnet, remove the left push rod end (1).
4. Install new one-piece adjusting screw into release plate and install locknut (2) on adjusting screw. **DO NOT ADJUST PUSH ROD NOW**, adjust after release ramps have been installed.

1. Refer to pages 7-30 and 7-31 in the 1985 TO 1990 FX/SOFTAIL MODELS Service Manual, Part No. 99482-90 for instruction on removing release ramps and installing the earlier ramps. See Figure 1, View B for identification of release ramps.
2. See Figure 1. After transmission side cover has been removed, remove the clutch release bearing and push rod assembly and center push rod (3). Install a new release bearing if excessive wear or overheating of bearing is evident. Also inspect the center push rod (3) for wear or damage. Install new push rod parts if required.

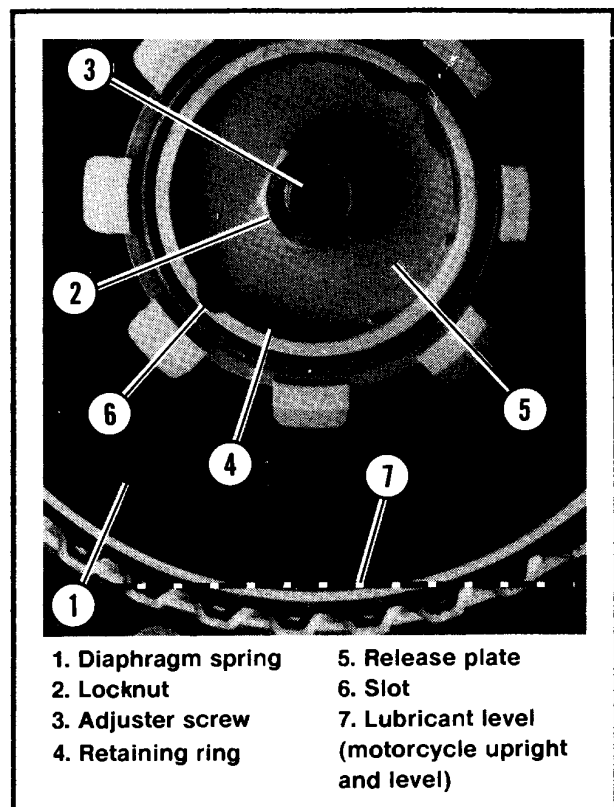
Figure 2. Push Rod Adjustment

1. Loosen clutch cable and remove the clutch inspection cover.
2. See Figure 2. Loosen locknut (2) and unthread adjuster screw (3) from release plate (5).

3. See Figure 2. After transmission side cover has been installed, fill the transmission with lubricant to the full mark on dipstick with dipstick resting in place (not threaded into side cover). Adjust clutch push rod by lightly bottoming adjuster screw (3) and then backing screw out 1/2 - 3/4 turn. Hold screw with allen wrench and tighten locknut (2) to 6-10 ft-lbs torque.

Adjust clutch cable free play at the clutch lever to 1/8-3/16 in. The same free play specification was used on 1989 models.
