SERVICE BULLETIN

M-1040

NEW CRUISE SET/RESUME AND CB PUSH-TO-TALK (PTT) SWITCHES

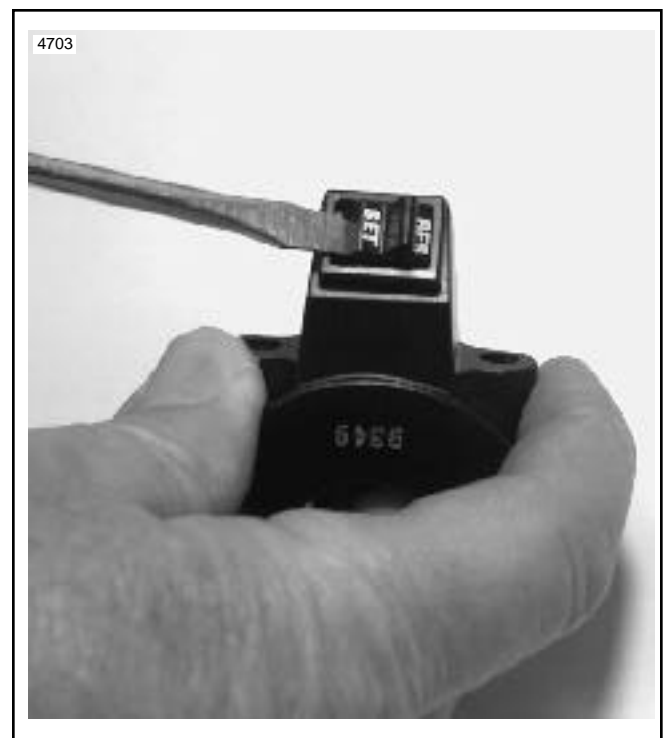
Figure 1. Removing Switch Actuator (Button)

1. Remove the handlebar clamp and SET/RESUME switch following Service Manual procedures.
2. See Figure 1 and 2. Gently pry upward on the actuator (1) with a screwdriver to disengage the actuator pins from the holes in the switch tabs (2).
3. Gently pry the speednut (3) from the switch (4).

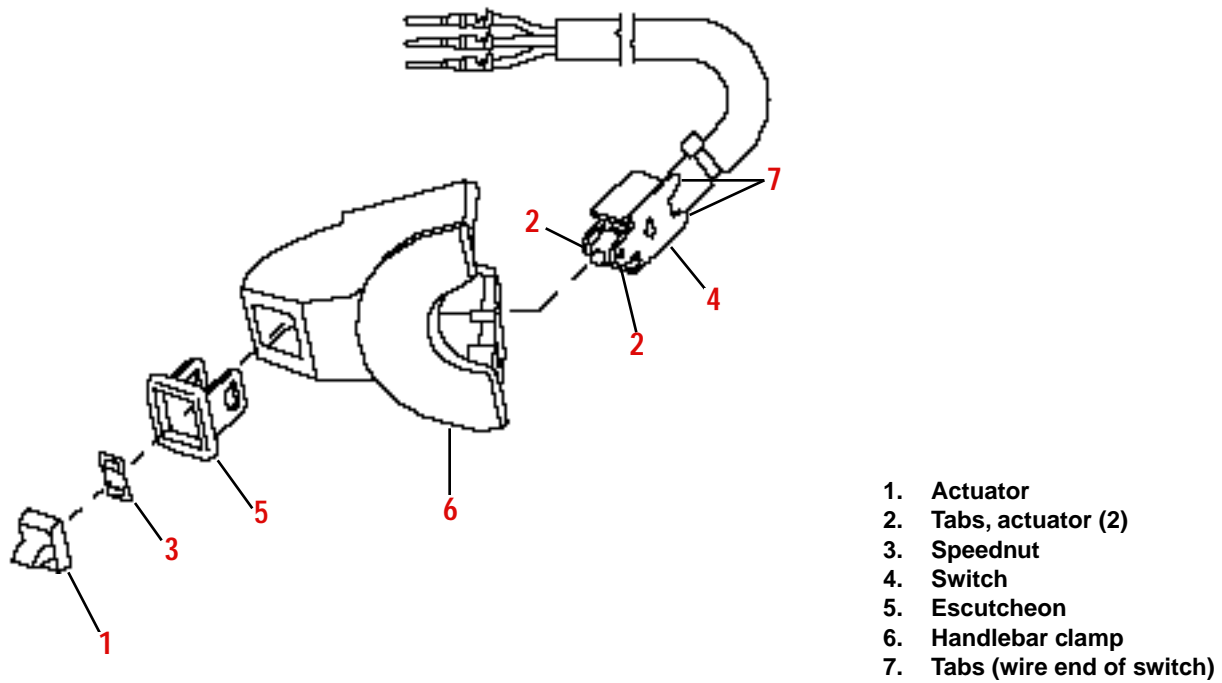
Figure 2. Cruise Control SET/RESUME Switch Assembly

1. See Figure 2. Insert the escutcheon (5) into the handlebar clamp (6).
2. Insert switch (4) with side having two tabs (7) positioned as shown in Figure 2.
3. Press switch into escutcheon (5) until it latches into position.
4. Install speednut (3), place actuator (1) on switch rod and press until actuator pins enter holes in switch tabs (2).

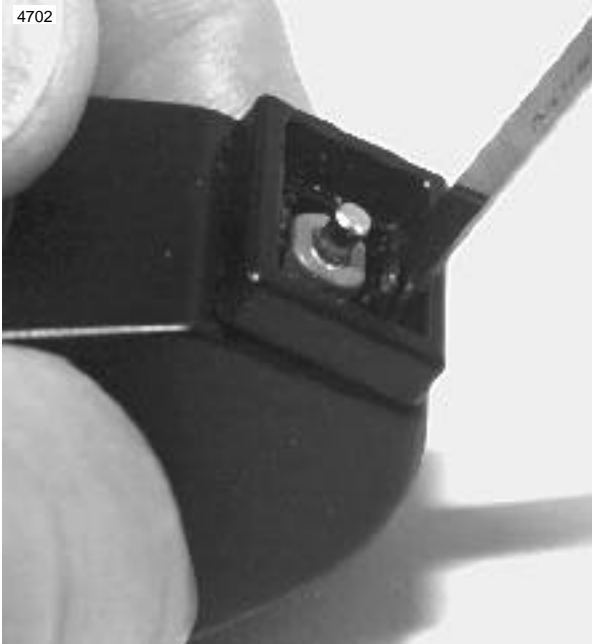
Figure 3. Releasing Left Latch With Steel Rule

4. See Figure 3. Unlatch the left latch, as viewed from front of switch, on the escutcheon (5) by inserting a steel rule or a thin (0.020 in. thick) metal strip (1/4 in. wide X 3 in. long) between the left switch tab and inner wall of the escutcheon (5).
5. See Figure 4. Lift right latch of escutcheon with a small screwdriver inserted from rear of handlebar clamp.
6. Switch (4) may be removed from rear of handlebar clamp and escutcheon (5) from front.

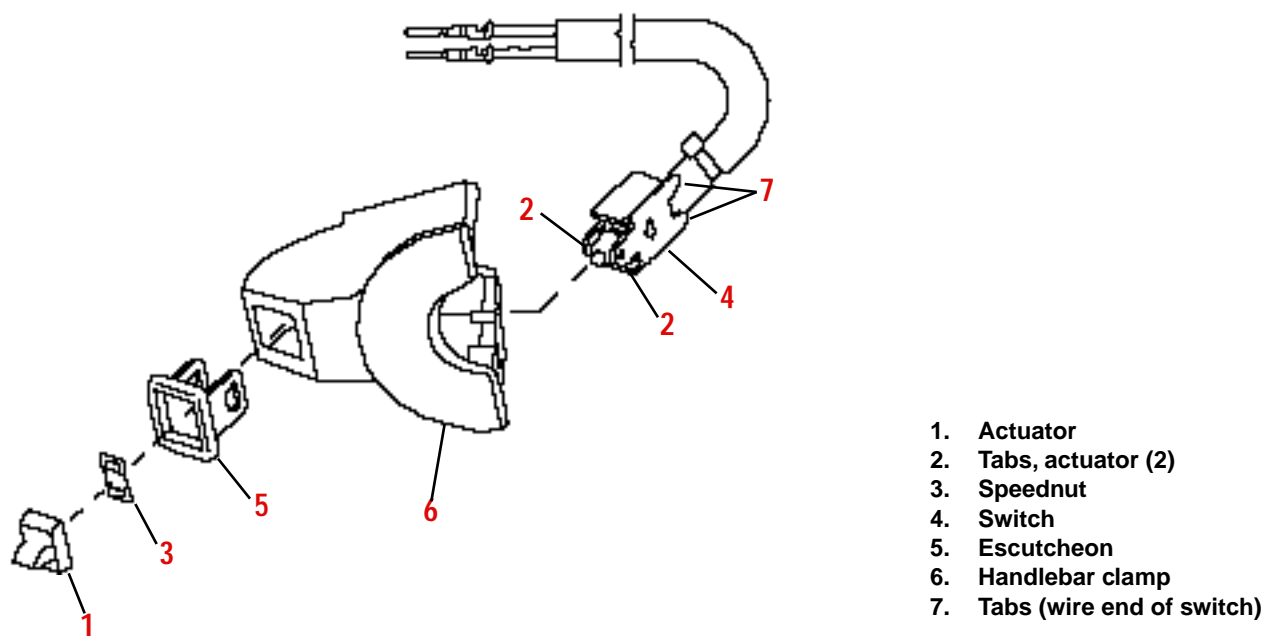
Figure 5. CB Push-To-Talk (PTT) Switch Assembly

See Figure 5. On late 1994 models the PTT switch was changed to a sealed configuration. The new switch and harness is being made available in kit form under Part No. 77100-89B. Follow the REMOVAL/INSTALLATION given previously for the SET/RESUME switch to service the PTT switch. Detailed instructions for PTT switch will be covered in Instruction Sheet 77100-89B.

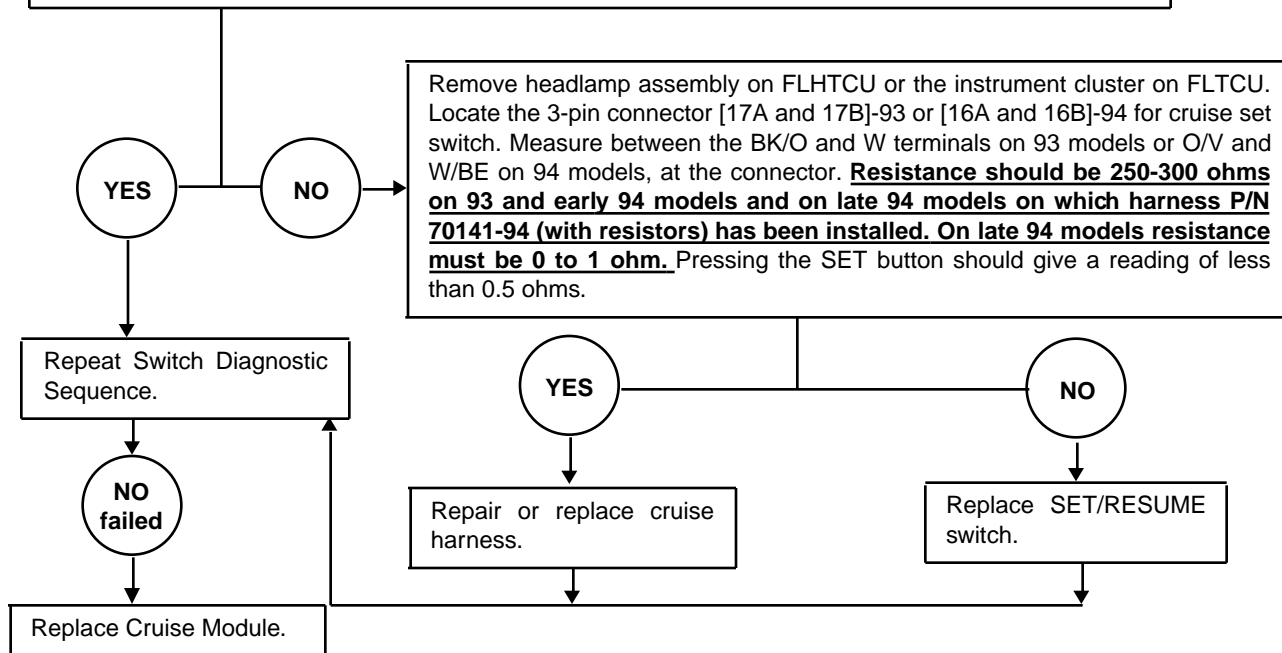
CHART B CRUISE TROUBLESHOOTING

RESUME SWITCH

Check continuity between the BK/O (93) or O/V (94) terminal (F) and the W (93) or W/BE (94) terminal (C). **Resistance should be between 250-300 ohms on 93 and early 94 models and on late 94 models on which harness P/N 70141-94 (with resistors) has been installed. On late 94 models resistance must be 0 to 1 ohm.** Pressing the SET button should give a reading of less than 0.5 ohms.
