SERVICE BULLETIN

M-1087

Noncompliance Recall Code 097

1997 AND 1999 MT 500 LABELS

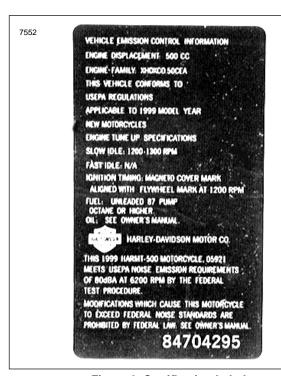
Figure 3. Certification Label

Harley-Davidson has determined that certain 1997 and 1999 MT 500 model motorcycles fail to conform to the Federal Motor Vehicle Safety Standard (FMVSS).

More specifically, the certification label as required by FMVSS 571.120 section 5.3 was omitted from the motorcycle, the brake fluid reservoirs are not labeled in conformance with FMVSS 571.122 section 5.1.2.2, the choke lever is not labeled in conformance with FMVSS 5.2.3 and the Owners manual does not contain the proper owner notification as specified in 49CFR 575.6, including the information giving the consumer the National Highway Traffic Safety Administration's name, address and phone number.

- See Figure 4. Clean the certification label already in place and the area surrounding it.
- See Figure 3. Remove adhesive backing from new label.
 Affix new label in the position shown in Figure 4.

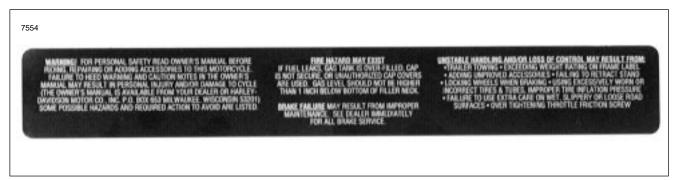
Figure 14. Safety Precautions Label

Three other labels are included in this recall; the EPA Certification, Oil Tank Fill and Safety Precautions labels. Although the Oil Tank Fill and Safety Precautions labels are not mandated, Harley-Davidson considers them important and they are to be affixed to the vehicle.

- 1. See Figure 15. Clean the area of the gas tank where the label is to be placed.
- 2. See Figure 14. Remove adhesive backing from new label. Affix new label in the position shown in Figure 15.
