## SAFETY RECALL 0806 – M2 CYCLONE FRONT BRAKE LINE WIRE GUIDE

Buell Motorcycle Company has decided that a defect which relates to motor vehicle safety exists in certain 1997 Buell M2 Cyclone model motorcycles.

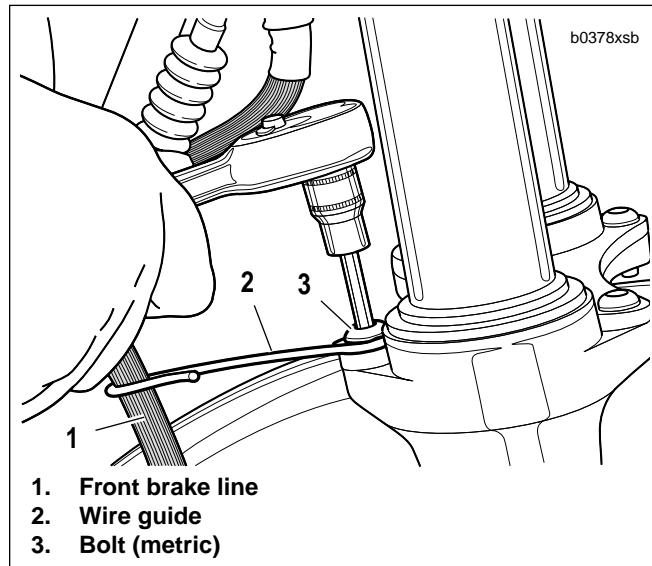
Figure 1. Removing Wire Guide

Buell has learned that the front brake line guide could cause the front brake line hose to kink during front brake operation. This could impede return brake fluid flow and prohibit the immediate release of the front brake caliper pistons. This could occur without prior warning. Rear brake performance is not affected.

- See Figure 1. If vehicle has a wire guide (2) installed around the front brake line (1), remove bolt (3) (metric).
- Remove end of wire guide from brake line. Cut wire guide into two pieces and discard.
- Apply two drops of LOCTITE THREADLOCKER 242 (blue) to threads of bolt (3) (metric). Install bolt and tighten to 10-12 ft-lbs (13.6-16.3 Nm).
