2009 BUELL 1125CR REAR CAM CHAIN TENSIONER RECALL

Buell Distribution Company, LLC. has determined that a defect relating to motor vehicle safety exists on certain 2009 model year 1125CR model motorcycles built April 11, 2008 through September 11, 2008.

These model motorcycles built during the above date range may experience a premature failure of the rear cylinder cam chain tension guide, part number F0020.1AM. This can cause plastic debris to block the oil pump screen, possibly leading to oil starvation and engine seizure. This condition may allow the engine to seize, resulting in rear wheel lock-up. This could result in a crash, which could cause injury or death to the rider.

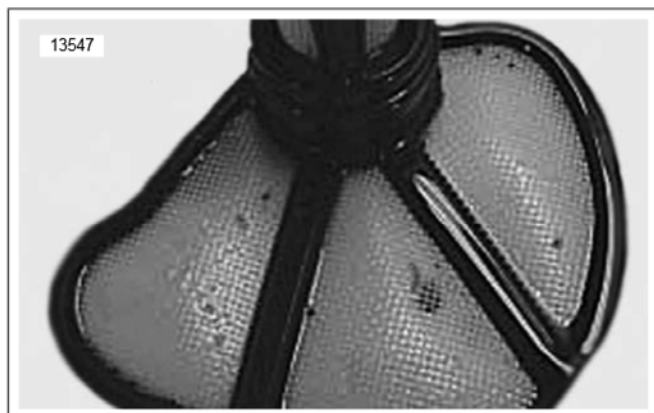
Small particles of metal and plastic abrasion are the result of normal operation and are acceptable.

Figure 1. Oil Strainer: Acceptable Small Particles

See Figure 1. and Figure 2. If black-plastic debris is **not** present, install the strainer and the recall kit. See Install the Oil Strainer, Remove the Rear Cam Chain Tensioner and Install the Safety Recall Code 0836 Kit (Part No. 94699Y).

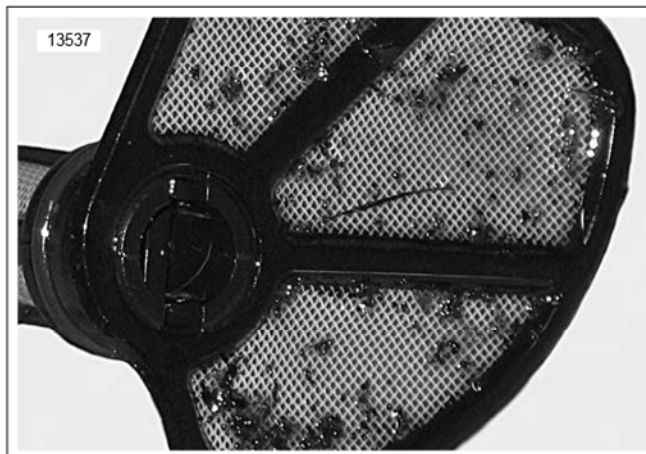
Figure 3. Oil Strainer: Excessive Black-Plastic Debris

See Figure 3. and Figure 4. If excessive black-plastic debris is present, call Tech Service.

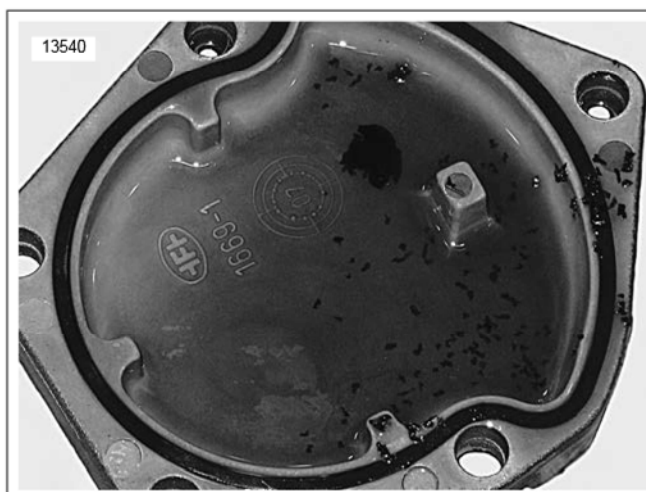
Figure 4. Strainer Cover: Excessive Black-Plastic Debris

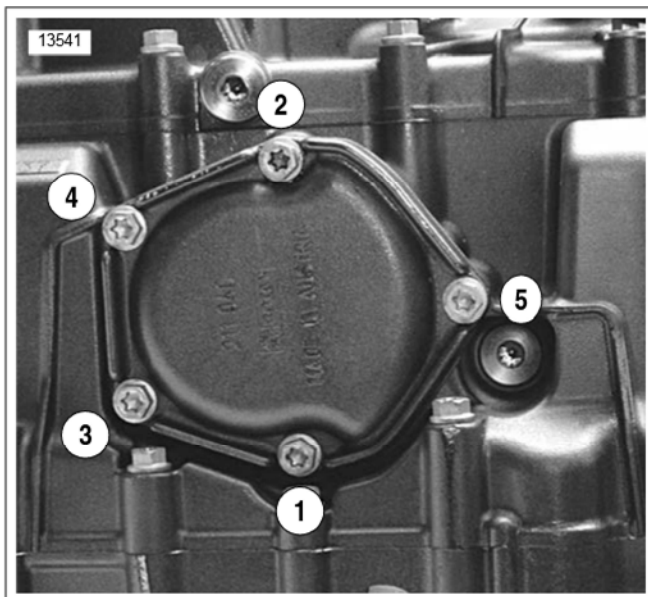
Figure 5. Oil Strainer Cover Torque Sequence

1. Install the strainer:
 - a. Install a **new** O-ring on the strainer and apply engine oil.
 - b. Push the strainer into the engine cavity.
 - c. Install a **new** cover rubber ring.
 - d. Install cover and fasteners.
 - e. See Figure 5. Tighten in sequence to 11 Nm (97 in-lbs).
2. Install the muffler. See the service manual.
3. Install the recall kit. See Remove the Rear Cam Chain Tensioner and Install the Safety Recall Code 0836 Kit (Part No. 94699Y).
4. Test ride and check the oil level.
5. File a warranty claim for parts and labor for 0.7 hour inspection of strainer. Please reference Service Bulletin B-084A.

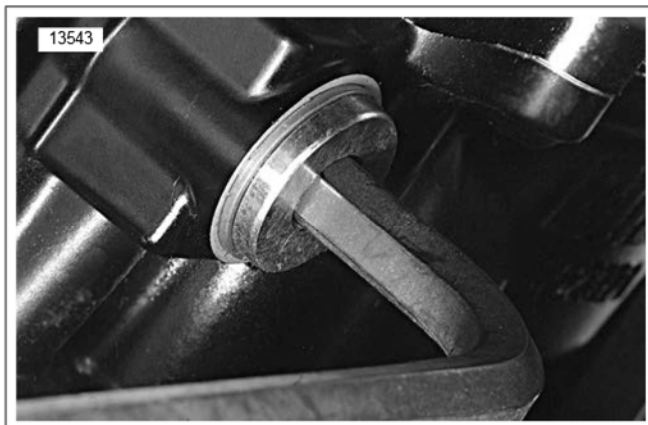
Figure 6. Remove the Tensioner Plug

See Figure 6. Avoid stripping the plug hex. Bottom the hex key in the plug and firmly support the key.

2. Remove the tensioner plug.
3. See Figure 7. Remove the rear cam chain tensioner.

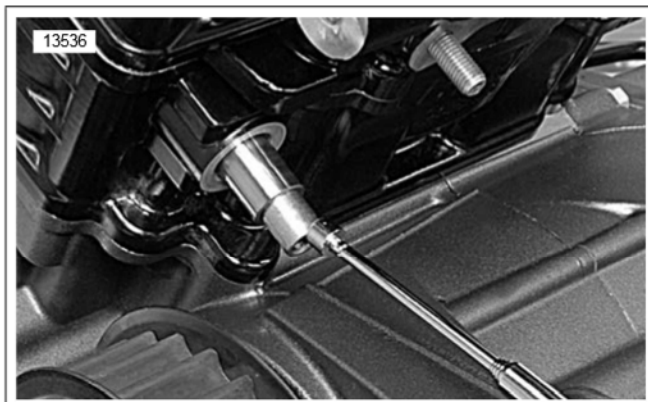
Figure 7. Remove the Chain Tensioner

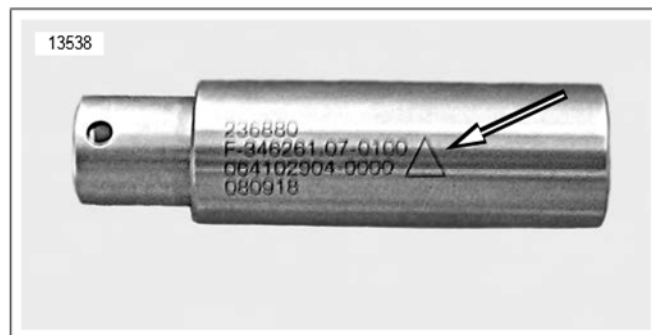
Figure 8. Triangle Marking on Cam Chain Tensioner

See Figure 8. The **new** cam chain tensioner is marked with a triangle.

1. With the small diameter towards the outside, insert the **new** chain tensioner.
2. See Figure 9. Measure from the tensioner to the plug sealing surface. Refer to Table 2. for **approximate** tensioner depth specification for ease of tensioner plug installation.

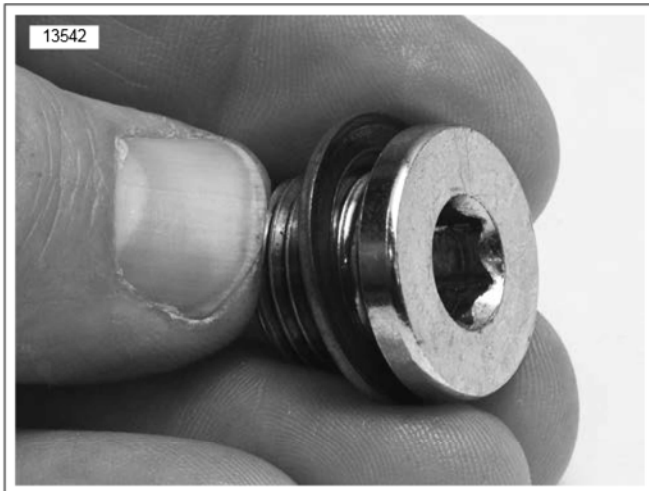
Figure 10. Tensioner Plug with Sealing Ring

3. If the tensioner protrudes beyond specification:
 - a. Raise the rear wheel.
 - b. Shift transmission into 6th gear.
 - c. Press the tensioner into the cylinder and rotate the engine with the tire (forwards or backwards) until the tensioner depth is at specification.
4. When tensioner depth is at specification:
 - a. See Figure 10. Fit only one sealing ring to the plug (provided in kit 94699Y).
 - b. Thread the plug in over the tensioner.
 - c. Bottom the hex key and tighten the plug to 30 Nm (22 ft-lbs).
5. Install the sprocket cover and tighten fastener to 13.0-14.5 Nm (115-128 in-lbs).
