Leather/Vinyl Products Repair Information:

This Tech Tip is to remind dealership personnel of service kits that are available for seat and saddlebag repairs. Also included are some reminders on frequently overlooked field fixes for seat/saddlebag repairs.

Seat and Saddlebag Service Kits

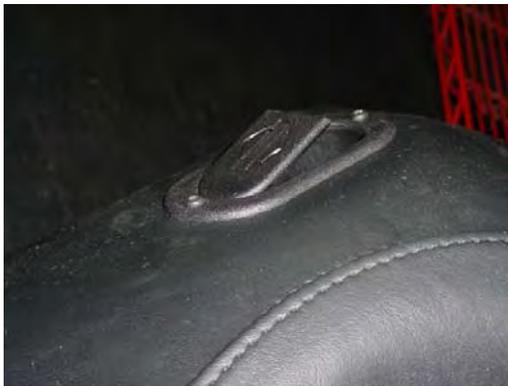
Figure 1

1. Broken release handle housing—replacement housings are available (see Service Kits listed in above table.)
2. Backrest pad won't stay locked in desired position because the release cable came out of its anchor point on the back of the release handle. (Figure 1)
 - a. Remove the two screws and pull handle out until it clears the seat (see Figure 2. The handle will still be attached to the cable and will not come out fully.).
 - b. Rotate the handle 180 degrees to expose the cable and handle slot.
 - c. Pull slightly on the handle assembly while pushing the backrest to its rearward position—this will add a little slack to the assembly.
 - d. Re-install the cable back into the handle slot. (see Figure 3)
 - e. Rotate and install the handle assembly into its original position. Test the handle for proper installation.

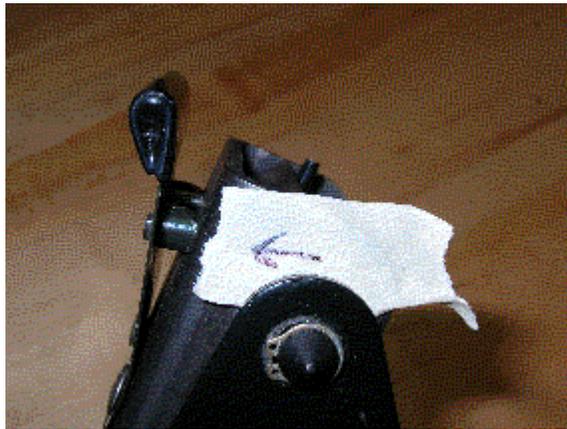
Bent Flat Spring

The flat pivot spring that locks backrest pad into mechanism gets bent and won't secure the backrest pad (see below). There is a repair part for FL Adjustable Backrest kit (53047-01--see Service Kits listing).

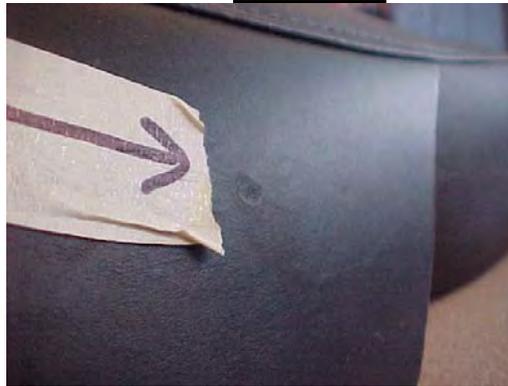
BUG BITE

The purpose of this Tech Tip is to serve as a reminder on some seat/saddlebag characteristics that would not be considered warrantable. Leather is porous and organic, and each leather product will settle into its own distinct appearance with use. Most leather products will carry unique markings (scars/bug bites, wrinkles, lines, and creases). These products will mature into their own custom style from exposure to sun, rain, age, and usage.

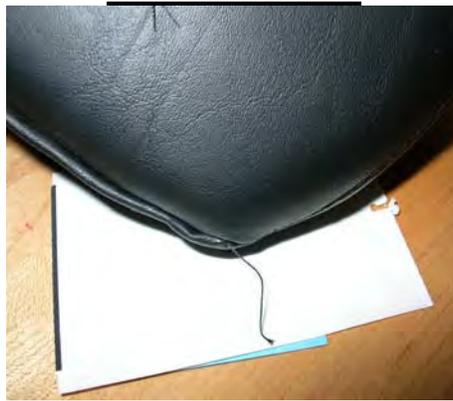
BACK-TACKING

This is called “back-tacking”. When vinyl or leather is being sewn together, it sometimes becomes necessary to start and stop a stitch (i.e., running out of thread on a sewing machine). At the point where one stitch ends and another begins, the threads are knotted and a loose “tail” end of thread results. This loose end is tucked under the original stitching, but sometimes it comes loose and sticks up—having the appearance of a broken stitch (see following picture). This thread end may be cut off—it will not compromise the integrity of the stitching.

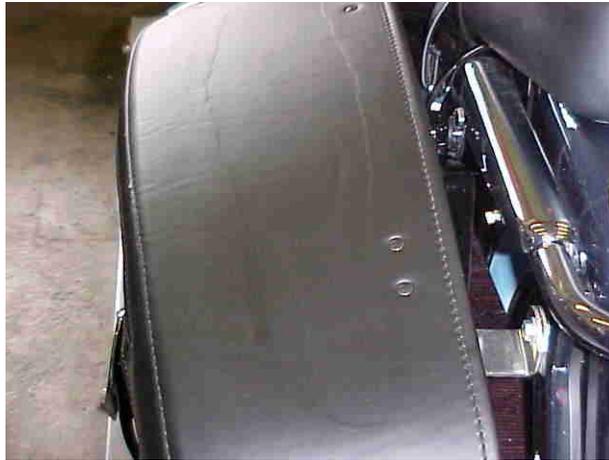
WATER MARK

Because leather is porous, it might (if subjected to prolonged exposure to moisture) develop a “veining” or other similar pattern in the leather. These are referred to as water marks, and are a naturally occurring characteristic of leather. This condition would not be considered warrantable. To help minimize the risk of water marks, the customer should occasionally treat leather surfaces with leather dressing.

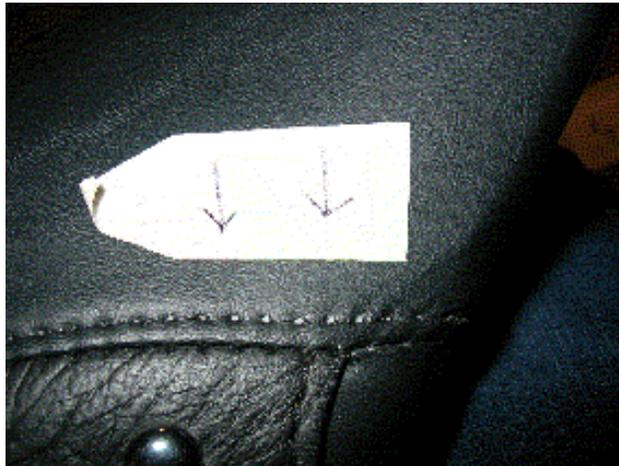
NEEDLE HOLES—WHITE SPOTS

The black vinyl used in making seats is relatively thin and has a white backing material. As seat vinyl is subjected to use, it stretches at the edges—along the seams. This stress will cause the vinyl coating to peel back slightly from the stitching, possibly allowing the white backing to be visible. Even though these white spots may be visible, the integrity of the part is not compromised. If desired, you may color the white spots in with a black marker to make the seat more cosmetically appealing.

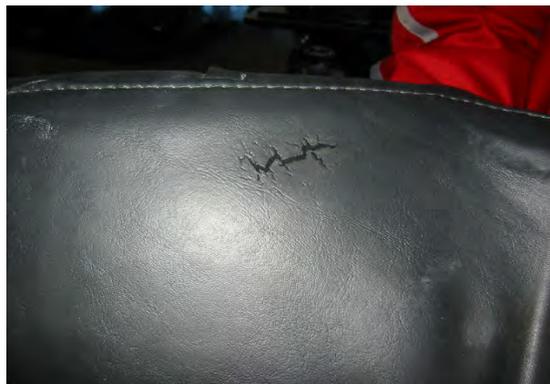
VINYL MELT

Vinyl covered products may be damaged by exposure to extremely high temperatures. Although vinyl will not physically burn, the vinyl itself may appear to “melt”. Most heat related damage occurs by:

1. Leaning the seat against hot exhaust pipes or engine parts after removal
2. Exposure to a concentrated light source (like the reflection of the edge of a mirror or a chrome piece on the motorcycle).

Although vinyl melting due to reflected light would not be considered a defect in the material itself, Harley-Davidson will warranty one such damaged part per vehicle.

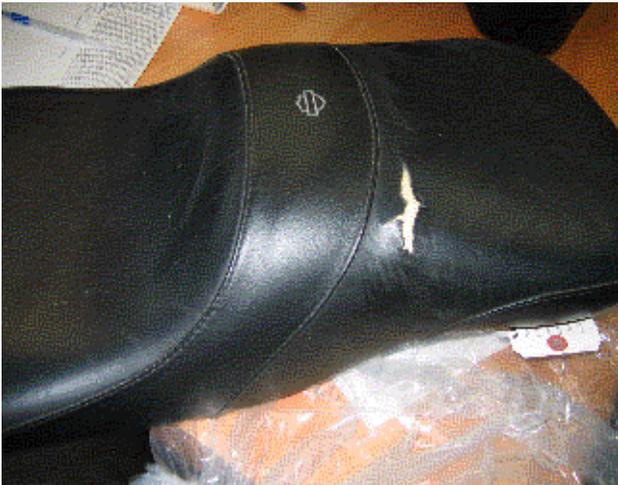
DRIED OUT LEATHER—LACK OF MAINTENANCE

Included with the purchase of most leather seats and saddlebags are small containers of leather dressing--it is important that the customer be instructed to use it occasionally on saddlebags, seats, or other leather accessories. Leather that is not protected with leather dressing may eventually dry out and crack (see below), or stretch to the point where it will tear out stitching

It is important that leather products be cleaned properly (*avoid detergents, soaps, and aerosol spray cleaners designed for “total cycle cleaning”—saddle soap is recommended*). Proper leather care is covered in the Owner’s Manual.
