TT263 – August 31, 2006

## **New Saddlebag Repair Kits and FLHRS Latch Adjustment**

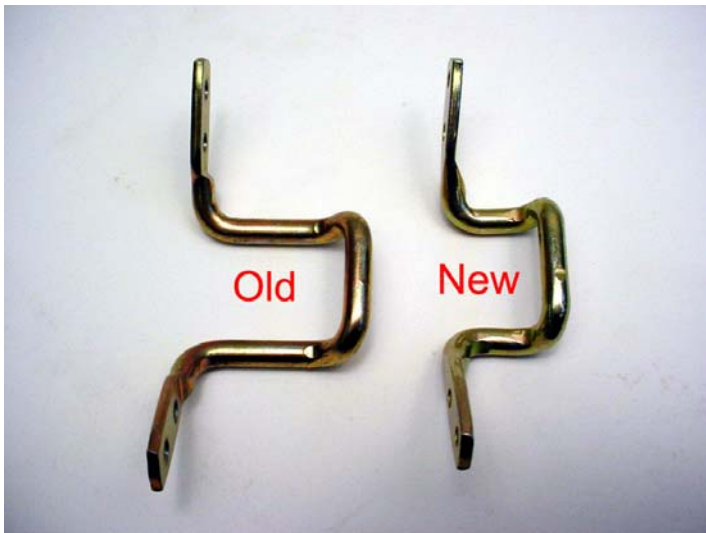
Harley-Davidson has developed a new repair kit (PN 52154-07) for FLSTN P&A saddlebags (PN 53015-05). Depending on use, the lids on these saddlebags might over time develop a 'gap' between the sealing surfaces on the inboard side of the bag and the lids. The new repair kit contains a shorter wire form hasp and fasteners, which will pull the latch assembly closer to the rear of the bag thereby creating a better lid seal. Please see P & A Service Bulletin # P-63 for more details. (NOTE: the saddlebag will require a little more effort to open and close the lid with this new fastener.)
