TT462: TEAR-AWAY CABLE STRAP

2017-11-15

APPLIES TO	SYMPTOMS
Softail and Touring	<ul style="list-style-type: none">• PDI (Predelivery inspection)

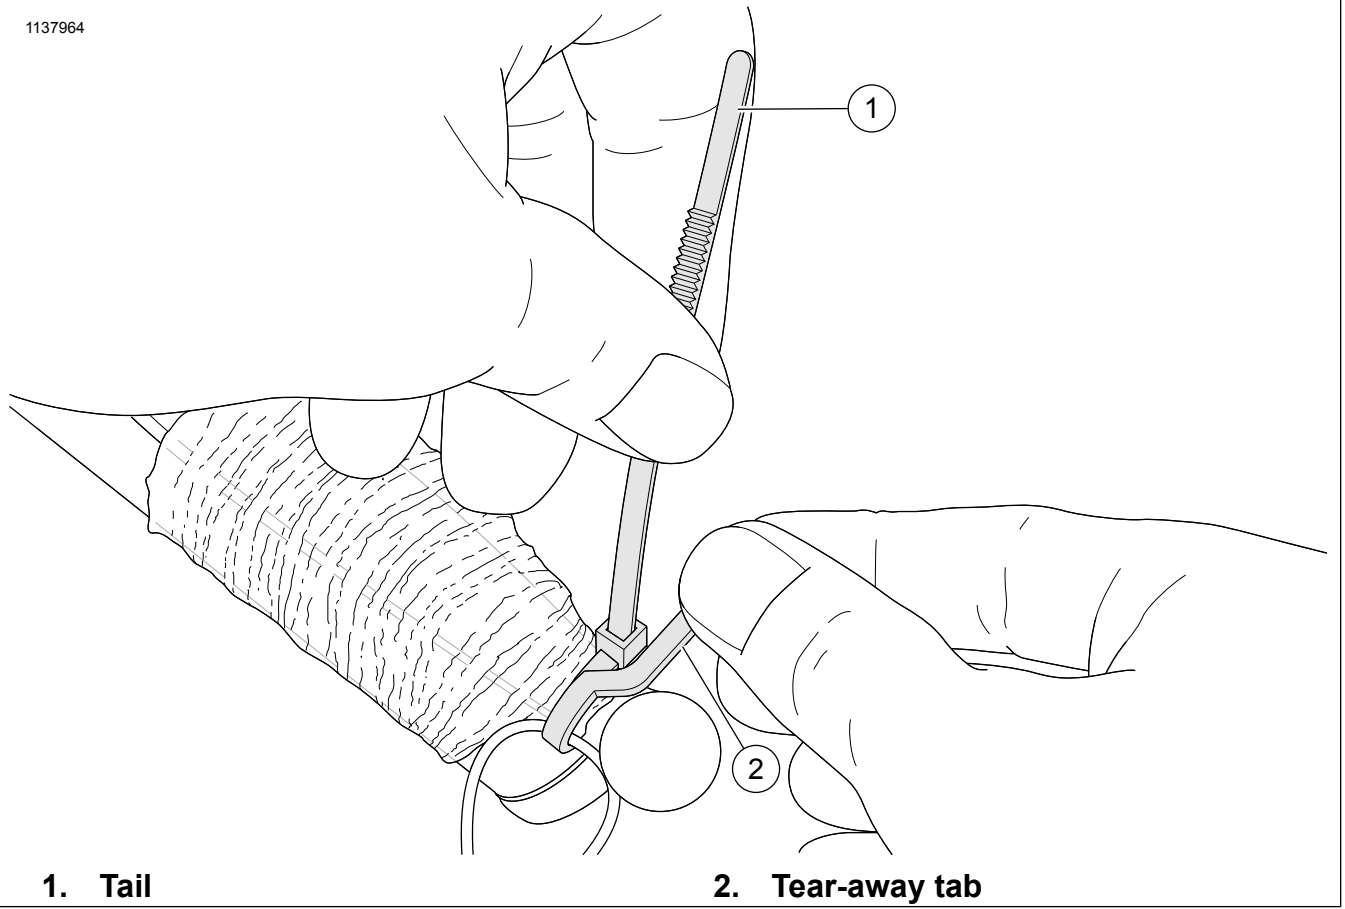
Figure 1. Tear-Away Cable Strap

Damage has occurred on some hand grips or brake levers when using side cutters to cut the cable strap that holds the keys in place.

1. Tail

2. Tear-away tab

1. Refer to Figure 1. Remove tear-away cable strap.
 - a. Grasp tail (1) of cable strap with one hand.
 - b. Grasp tear-away tab (2) with other hand.
 - c. Pull tab to release. Refer to Section Video.
