Notable Separator Plate Design Change / Flaw Between the BUELL (03-06) & (07 & up) Style Oil Pumps

Article by EircZ of the XLFORUM®:

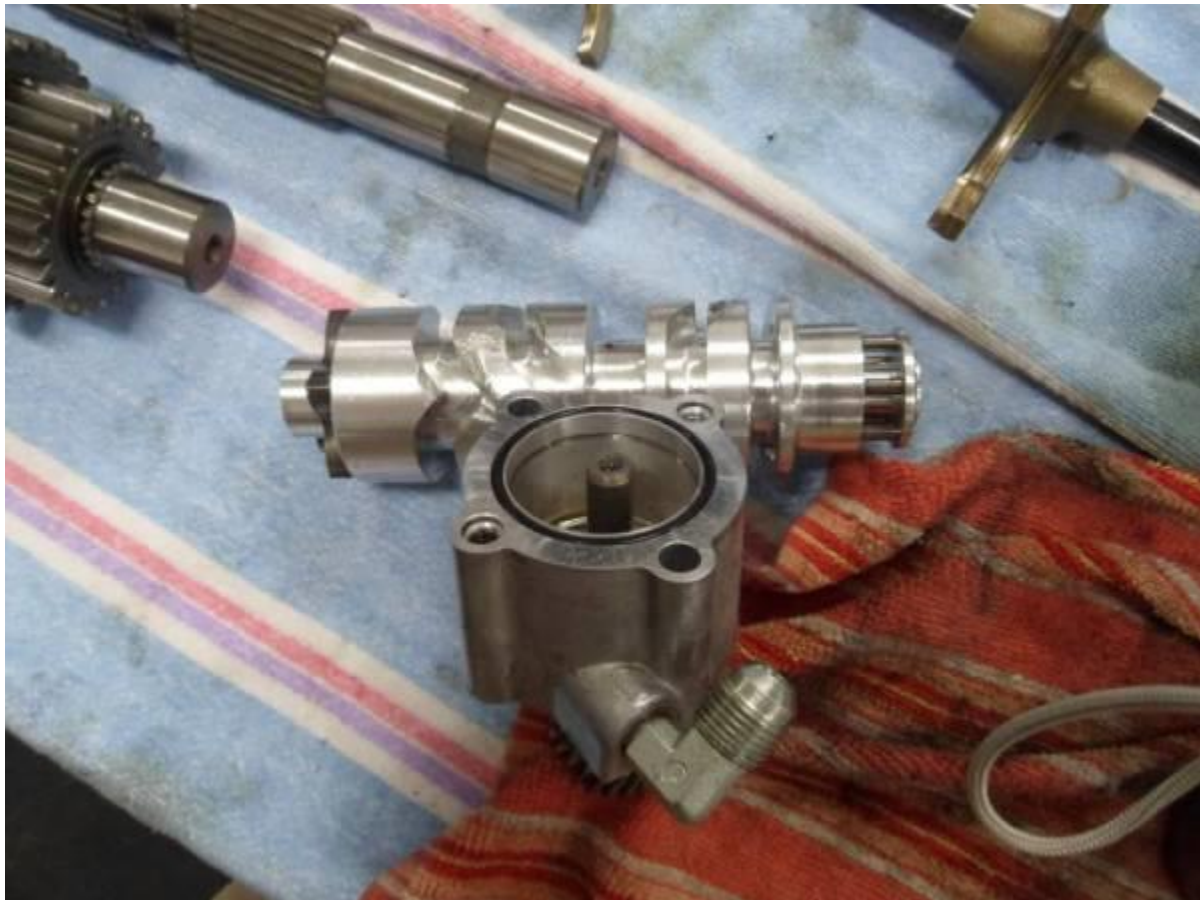
- The washer that separates the feed from the scavenge gerotors on 2007 style Buell oil pumps can freely rotate and wear against the inside bore of the pump. The pump bore is not grooved but can be worn in from the washer spinning during use. It does slowly introduce aluminum into the oil supply and return but very slowly and the oil filter should take care of any problematic debris. Also, the piston jets do not have a check valve. They are free flowing.
- On the 2005 pump, the OD of the scavenge gerotor is smaller than the feed gerotor.
- The OD is the same on the feed and scavenge gerotors on the 2007 pump. ¹

2007 Buell XB oil pump (# 26357-02B) with a groove that was worn into the bore after ~7k miles of use ²

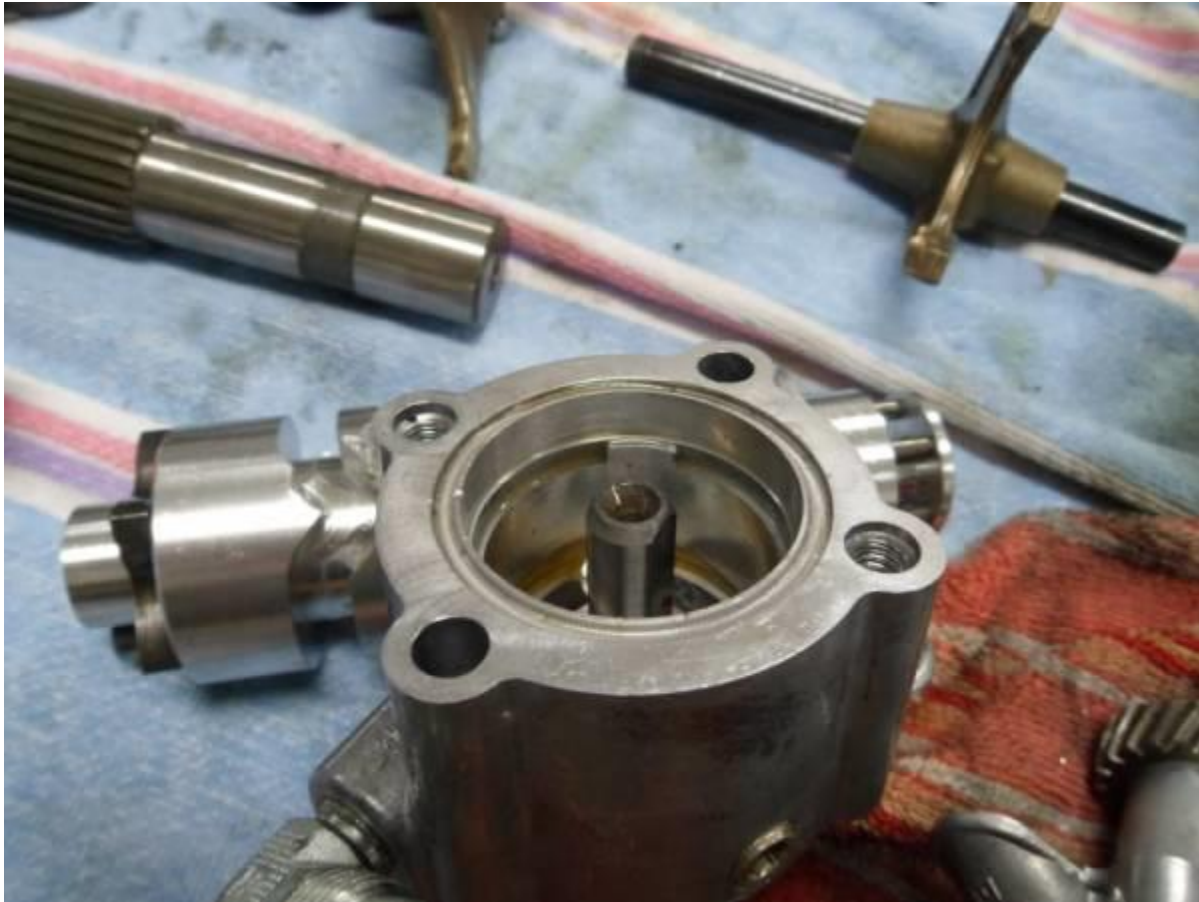
2005 Buell XB oil pump showing one of the two keys that prevent the separating washer from rotating. ³⁾

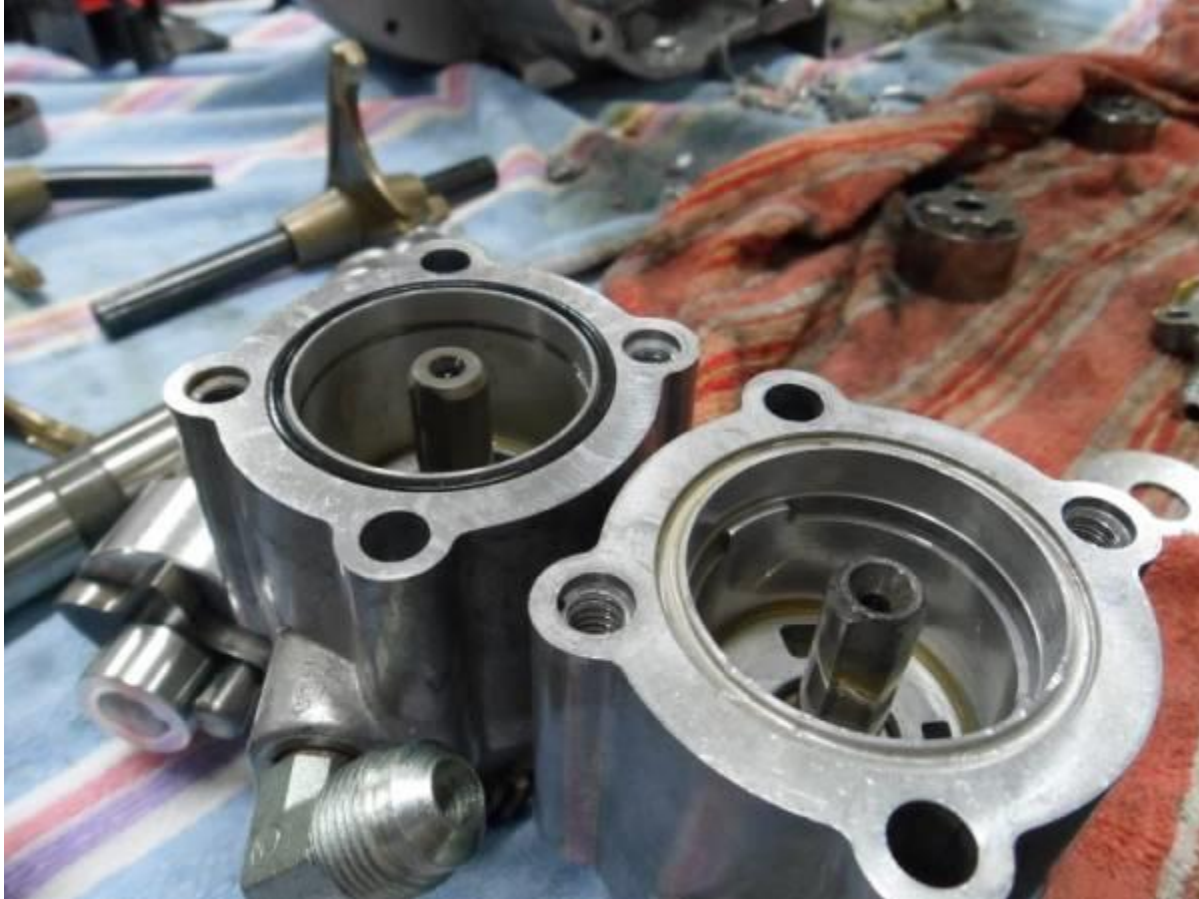
Here are the two pumps, 2007 on left and 2005 on right. ¹⁾

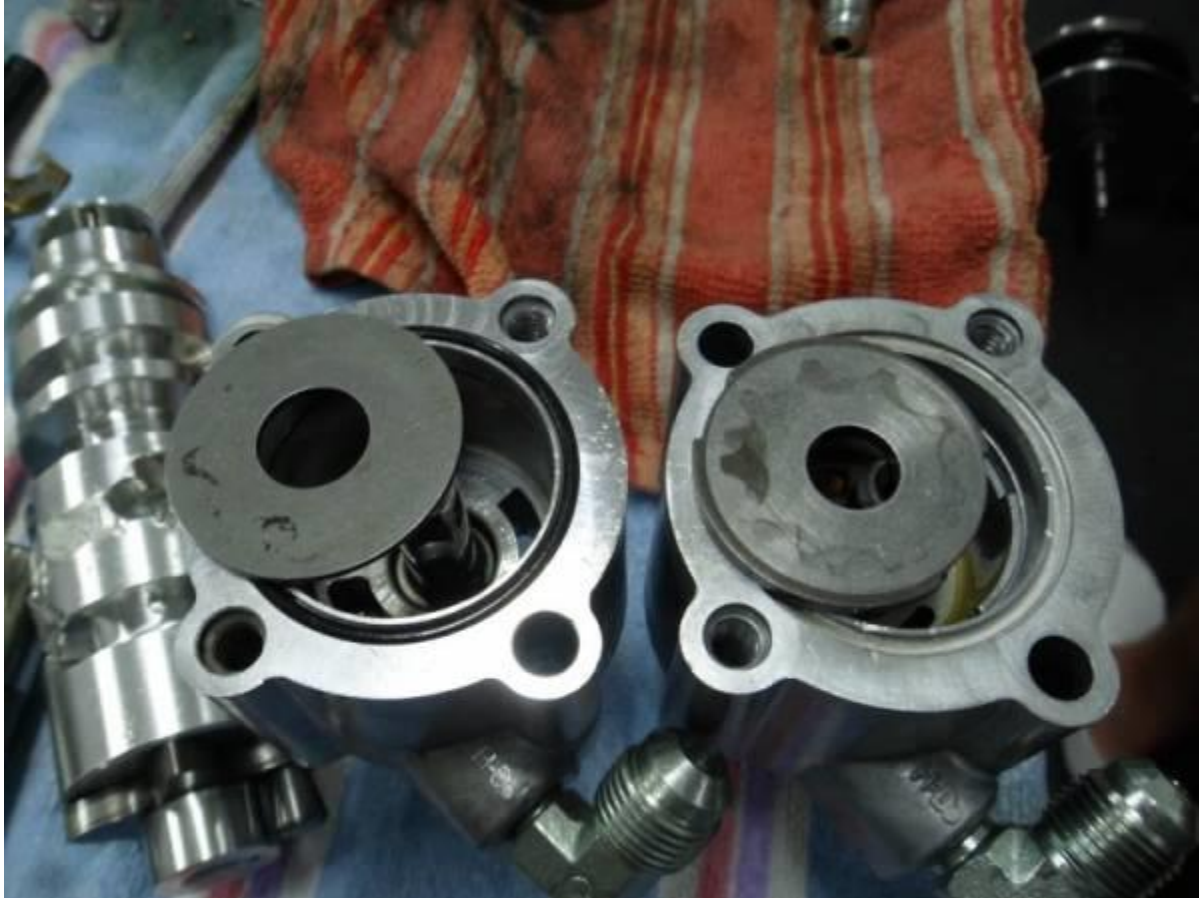
Both pumps shown with their respective separating plates. ⁵⁾
