PRIMARY DRIVE CHAIN CARE - ELECTRA-GLIDE

**NEW DESIGN CHAIN FOR REPLACEMENT**

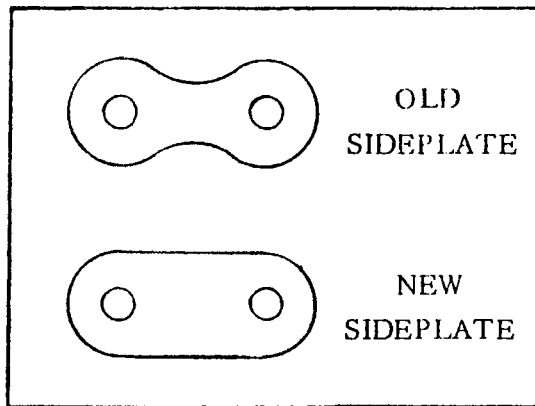
Starting on September 2, 1965 all Electra-Glide motorcycles shipped from the factory will have Duckworth primary drive (double width) chains with plates having straight sides.

This design change was made to improve the operation of the nylon tensioner shoe on the Electra Glide model.

The straight side link chain provides much more bearing surface on the nylon shoe material resulting in quieter operation and longer chain and shoe life. It is recommended that only new type Duckworth chain be used for replacement chain on Electra-Glide motorcycles — order under Part No. 40007-36A (solo) and Part No. 40009-36A (sidecar).

Service recommendation on chain adjustment remains the same, which is to check chain tension every 2000 miles and adjust tensioner shoe as necessary to provide 1/2 inch of play in upper strand midway between sprockets. Do not overtighten front chain because it will cause the shoe to wear excessively.

If chain is worn beyond range of adjustment, or is otherwise damaged, install a new chain. NOTE: Repairing front chain by means of a repair link is not recommended on any motorcycle having a tensioner.
