ML-271

The Service Department, in an effort to provide an informational recap of both past and present repair procedures, has assembled the attached pages of Technical Tips.

Service Letter ML-271

TECHNICAL TIPS

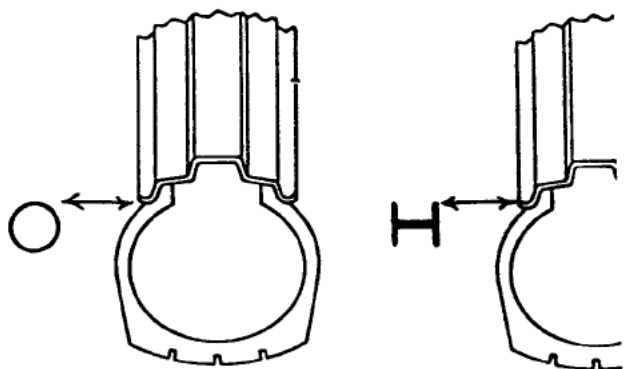
1. Is it in alignment?

Obviously it's difficult, if not impossible to measure from a round object

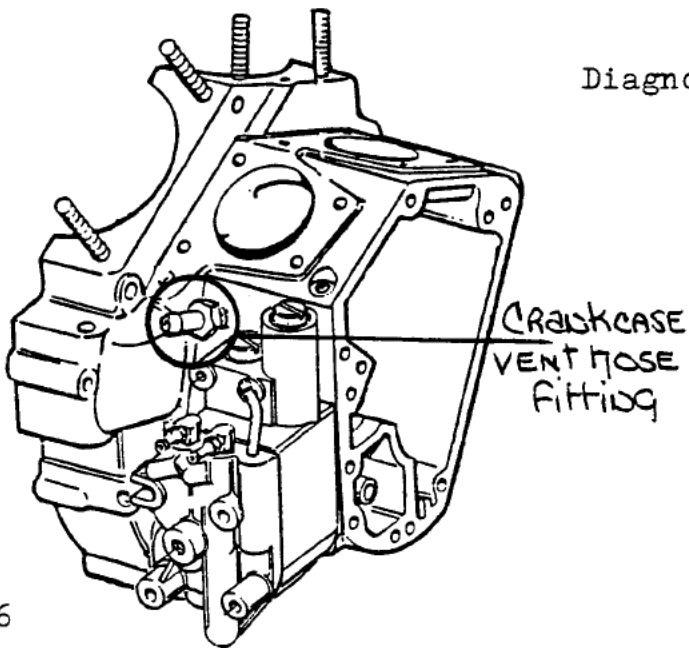
Diagnostic's 1

3.) Overfilled, short or damaged stand tube or tilted return stand tube: Carry-over will continue until the level of oil is below the top of the vent tube or the damaged portion of the tube with one exception, the tilted stand tube. It may continue as long as the oil supply exists.

With the oil tank oil level correct and the ignition off, pinch off the oil tank vent hose and remove the hose at the crankcase vent hose fitting. Direct the hose into a catch pan and unpinch the hose. (Vehicle should be upright) If oil begins to trickle out of the vent hose, allow it to run until it stops. Recheck oil level. Down a quart, hey? Must be a short or damaged stand tube. Replace the oil tank.

Now start the vehicle, remember
keep that hose pointed into the
catch pan. If oil begins to
trickle out you have a tilted
stand pipe. Try switching the
return oil hose with the oil tank
vent hose at the oil tank before
you replace it.

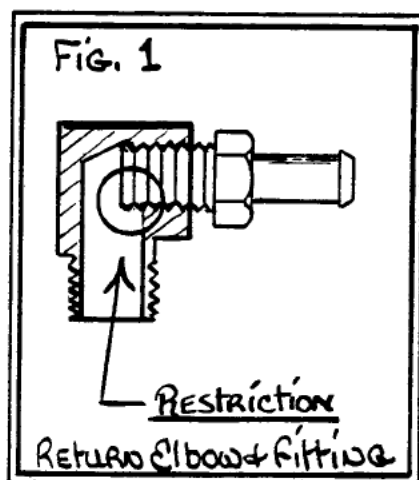
Note: Before connecting the test
hose note the number of
threads exposed on the return
fitting to return elbow
connection. Remove the fit-
ting and elbow and inspect
how far the fitting is
screwed into the elbow. The
fitting may be restricting
the return oil flow. See
fig. (1). Modify fitting as
required and reinstall.
