TECH TIP # 56

December 2002 Issue

Tech Tips #56

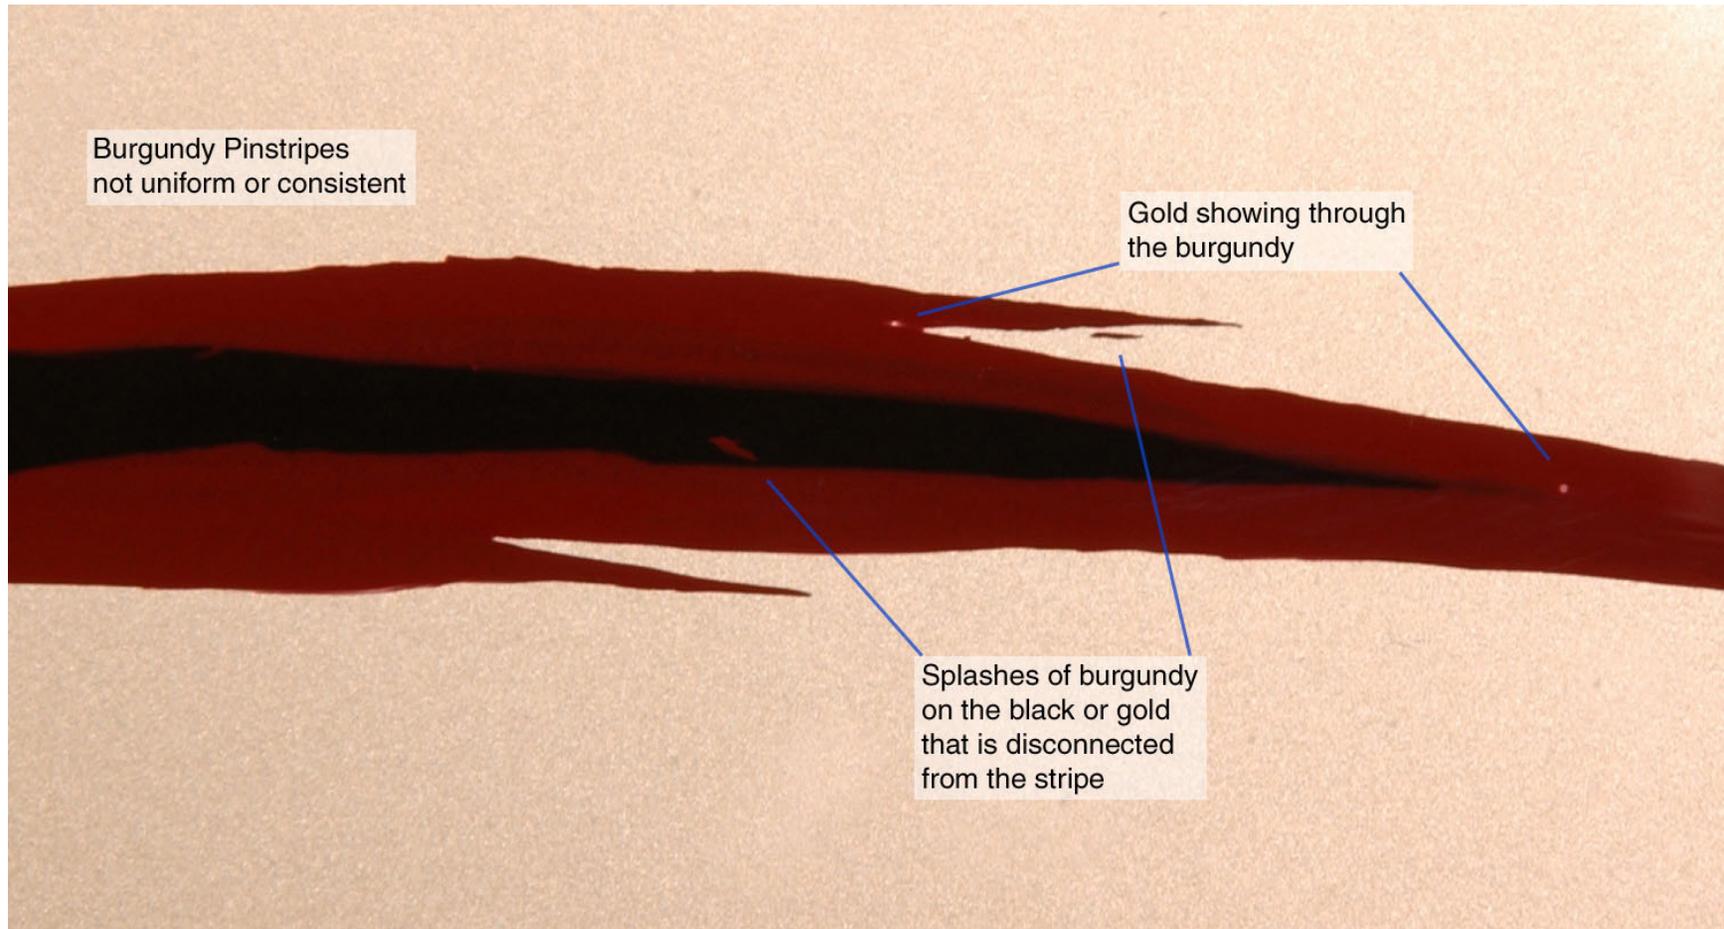
2003 FLHRSEI2 Paint

The burgundy pinstripes on this motorcycle are hand- painted with a brush. This makes each Screamin' Eagle Road King intentionally different, bike to bike, and even side to side on the individual parts. Be aware the pinstripes are not uniform or consistent. You may see gold paint showing through the burgundy. You may see splashes of burgundy on the black or gold. These variations in paint make each bike unique and are not to be considered a paint problem.
