TT345C: ADVANCED AUDIO SYSTEM INFORMATION

SB-10055746-7880

APPLIES TO	SYMPTOMS
All 2006-2013 Touring Models with Advanced Audio System	• Intermittent or Erratic Electrical Operation

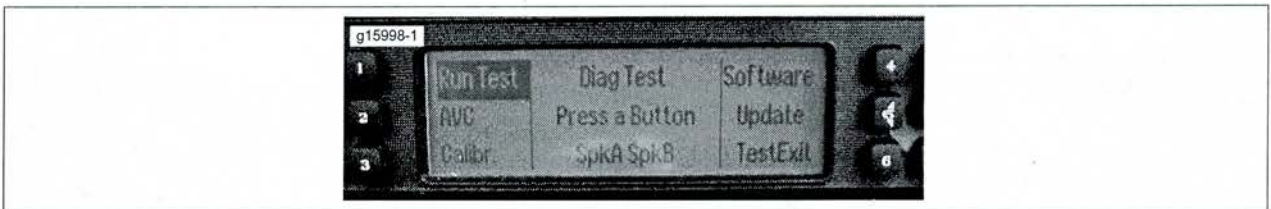
See Figure 1. Self Diagnostics provides a quick check to see if there are any current issues or DTCs recorded. It also provides the ability to check for proper operation of AAS handlebar and passenger switches.

- Radio Self Diagnostics will only show one DTC. Use DTII (Digital Technician II) to determine if multiple DTCs are present.
- When a handlebar switch function problem is suspected, it is important to remember a pinched wire on the other side of the handlebar could be causing the issue. The pink/white wire is connected to every remote rider and passenger radio switch on the vehicle.

Access by holding in any two preset buttons (1-5) while powering up the radio. Wait for the Self Diagnostic Test screen to appear, then release the buttons. Perform radio faceplate, rider and passenger switch functions and observe results on radio display.

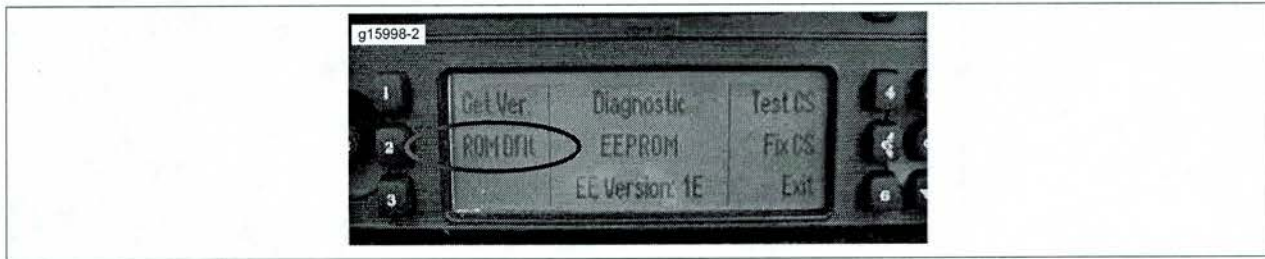
See Figure 2. ROM Default Reset returns the radio to base settings. Always perform this reset to eliminate possible user-induced issues such as low volume, low or no display visibility, etc. before ordering a replacement radio.

If the issue was a blank screen and the problem is not corrected on the first try, perform this reset a second time to ensure the proper steps were performed. If the display recovers, immediately check the software version. If it is not current, update the software.

1. With radio turned ON (AM or FM), press soft keys 1, 3 and OK at the same time and release.
2. Press the UP arrow two times.
3. Press soft key 2 (ROM Dflt) once.
4. Turn ignition off for 30 seconds.

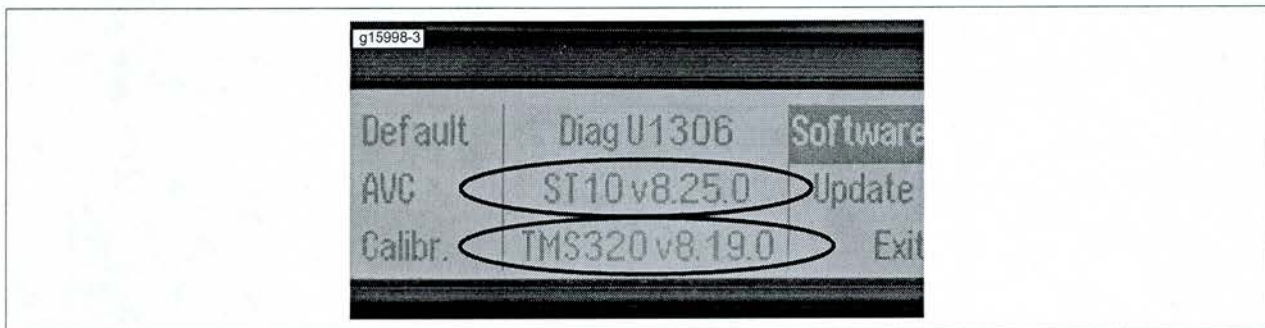
Figure 3. Software Update

In earlier software versions, both ST10 and TMS320 lines would be at the same level. Software versions above 8.19 may only change the ST10 to the higher number. The TMS320 may stay at 8.19 which is acceptable.

We recommend the technician check the software version in any 2006-2013 radio-equipped motorcycle when there is a radio issue. It only takes a few seconds to check, and if there is a newer version available, pressing the "update" button and inserting the disc is all that should be needed. The update will be completed automatically with no further attention, allowing the technician to continue with other service work.

1. See Figure 3. Access by holding any two preset buttons (1-5) in while powering up the radio. Wait for diagnostics screen to appear, then release the buttons.
2. Press button 4 to see the current software version in the radio.

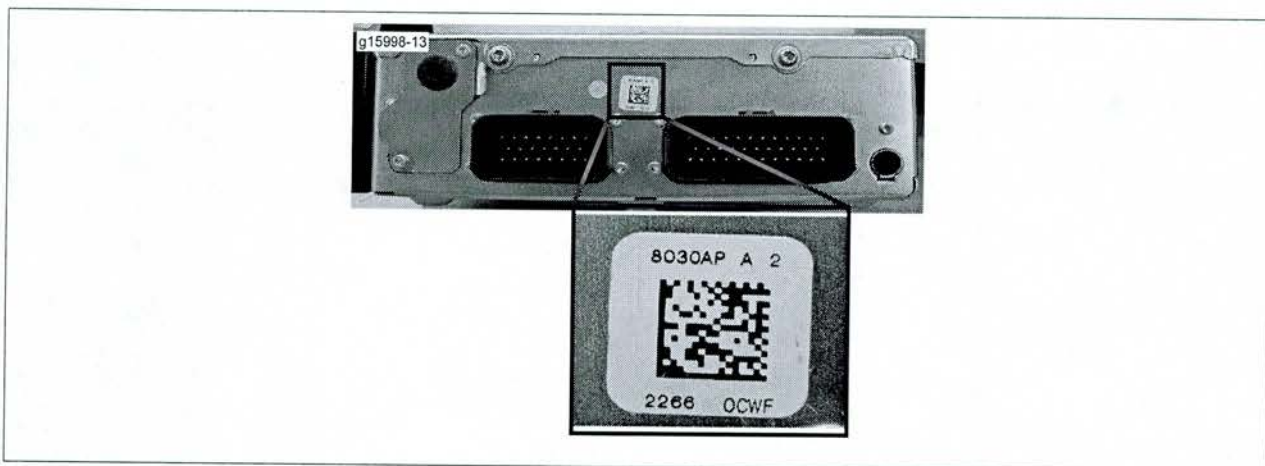
Figure 5. Serial Number Location

- Refer to the latest revision of Warranty Bulletin W132 for a comprehensive return process.
- See Figure 5. The serial number of each unit is located on a small square decal on the radio case. It is advised to record the serial number on the repair order prior to removing the radio from the motorcycle to eliminate any confusion as to which radio was removed from which motorcycle.

When sending a radio for repair or warranty replacement, it is recommended that the serial number from the tag on the defective radio be recorded and kept with the vehicle repair records. Figure 5 shows a serial number of 8030AP A2 2266 OCWF
