REF: Service Procedures 11D

What Causes the 1991-2003 Shift Drum Pins to Walk Out of the Drum

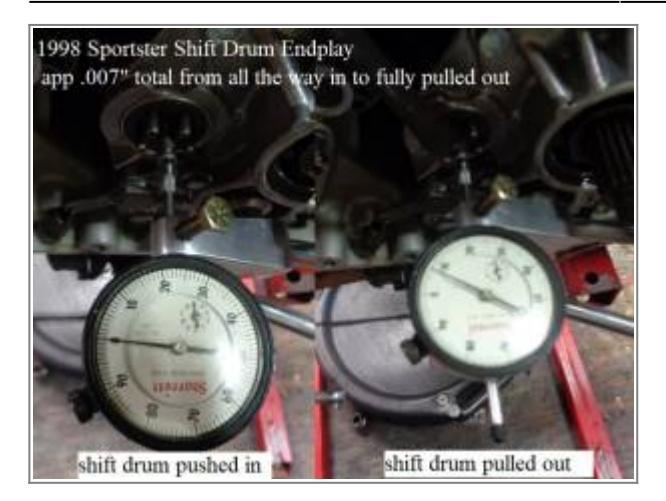
Shift drum end play ¹⁾

There is plenty of clearance in the arm to pawl connection to allow the angle needed to keep the pawl from being pushed on the pin(s).

When the drum slides either way, the arm (should) stay in alignment based on it's varying constrained forces acting on it.

However, the pawl is designed with much clearance which allows compensation for changes in drum endplay and shaft play.

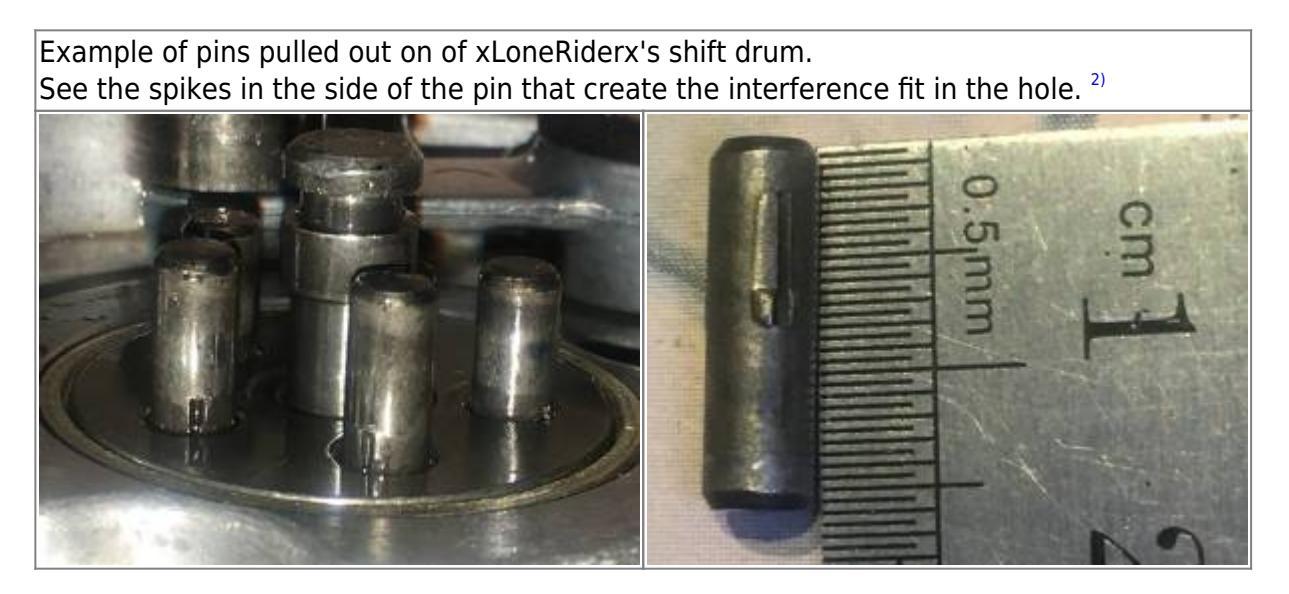
The drum pins are not a full bodied press fit (the pin OD is smaller than the hole they go in).

The pins are spiked in a few places in circumference and the spikes create the interference to keep them in place.

(3 small bulges of metal protruding at the end of 3 small grooves in the middle of each pin)

These small bulges are not enough to keep the pins in place during extreme conditions.

But they are forgiving enough to keep them midway in their holes after protruding, creating that side force on the detent plate.

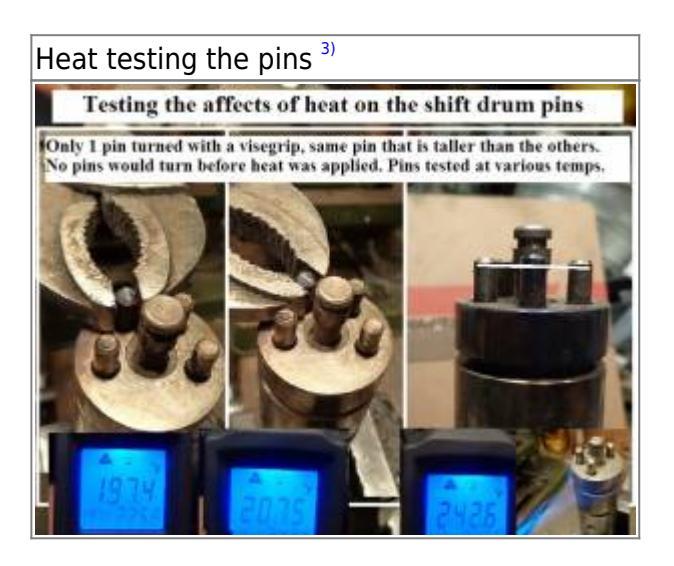
Heat testing was done on the shift drum pins below.

In the third pic below, heat was applied to the old shift drum to find what operating temps may be when a pin pulls out.

At ambient temp, none of the pins would turn or move being clamped in vicegrips.

The drum was clamped in a vise, heat applied to it with a propane torch and the heat from the drum was measured with an infrared thermometer.

At various temps (197°F, 207°F and 242°F), all the pins were clamped with an attempt to turn them and only 1 of them ever moved.

Coincidently, it was the same pin that had previously been found to have pulled out from the it's bore making the detent plate skew.

Anywhere before and after the 200° mark, the one pin could be turned.

So that is the heat range where that certain pin will no longer hold.

The other three pins took 242°F but did not move. So it appears it's not just heat that makes the pins move.
