SERVICE BULLETIN

2020-02-03

M1506: RECALL 0175 - 2019-2020 TRIKE - TRACTION CONTROL

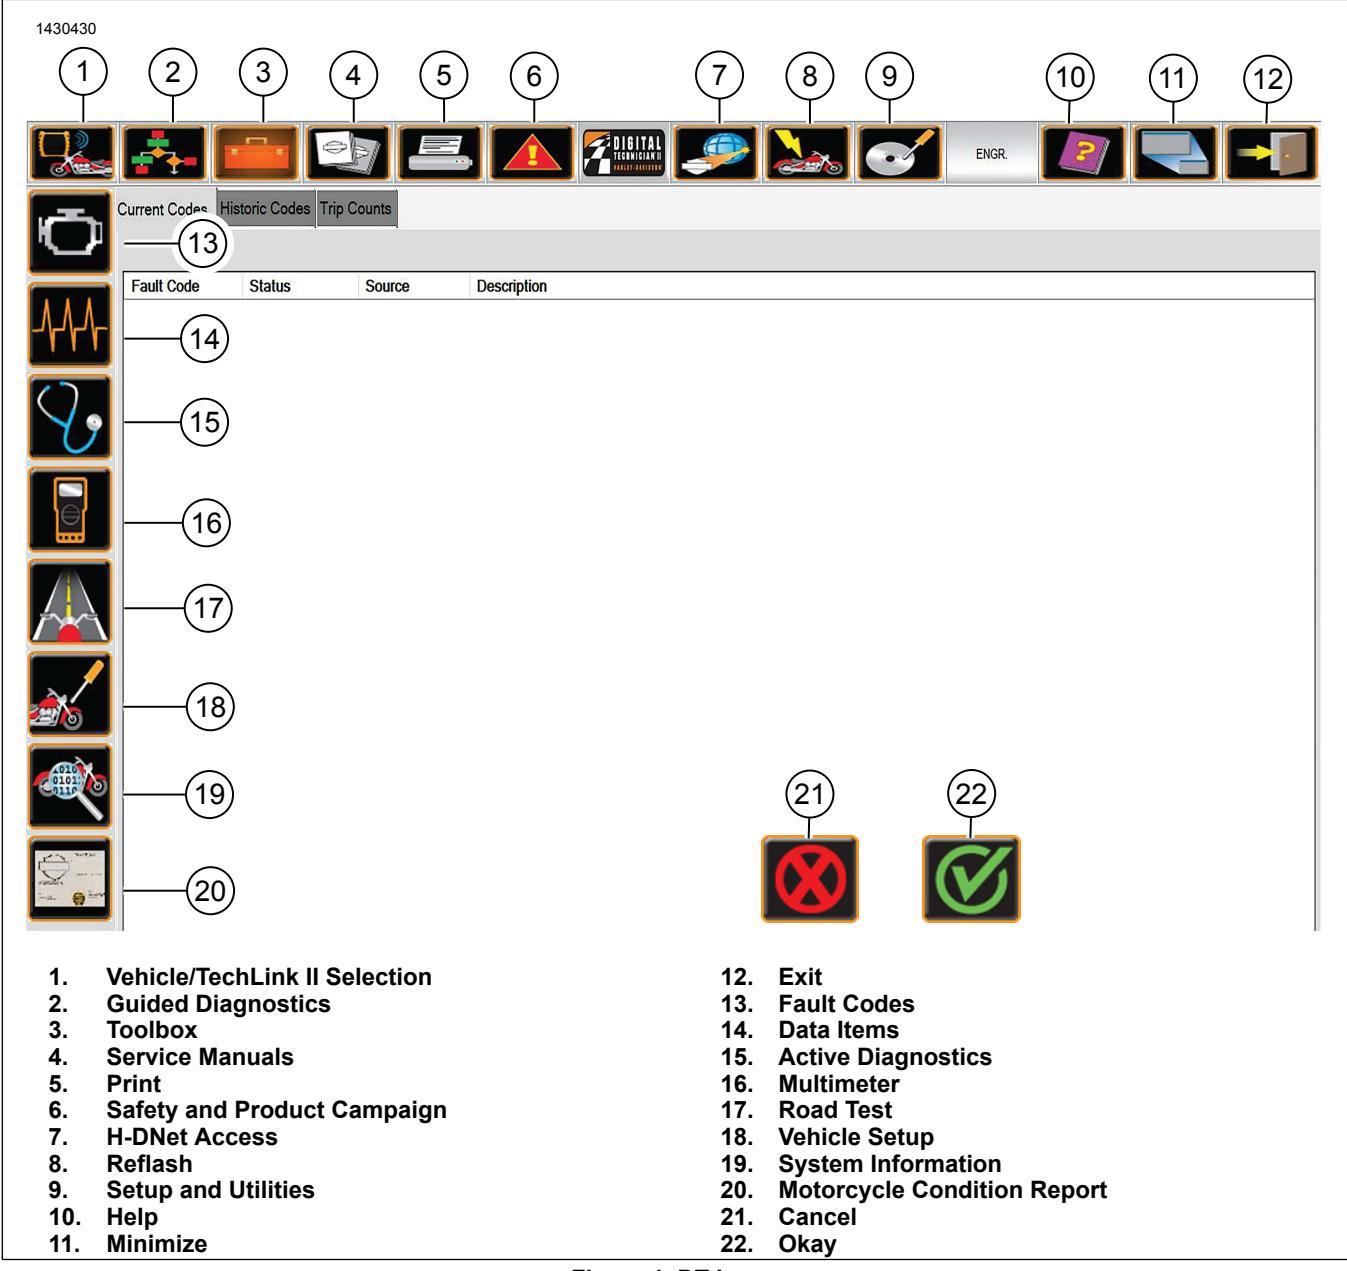
Figure 1. DT Icons

- b. **Keyless Vehicle:** With fob present, switch RUN/STOP switch to RUN.
- Connect DT II to vehicle.
 Special Tool: DIGITAL TECHNICIAN II (HD-48650)
- 5. Upload vehicle information.
 - a. See Figure 1. Click Vehicle/TechLink II Selection (1).
 - b. Upload vehicle information.
 - c. Click Okay (22).
- 6. Click Reflash (8).
- 7. Verify software number.
 - a. If the software current and the available numbers are different, update is needed. Go to Step 8. Refer to Table 3.
 - b. If the software current and the available numbers are the same the update has been completed. Stop Recall. Refer to Table 4.
- 8. Proceed to update.
 - a. Click ABS.
 - b. Click Okay.
- 9. Click on update.
 - a. Click 40800140_Recall Trike ABS Calibration
 - b. Click Okay.

- 10. Verify software update installation.
 - a. Click Reflash (8).
 - b. Verify software current and the available numbers are the same. Refer to Table 4.
- 11. Clear all DTCs (Diagnostic Trouble Codes).
