EVO: Engine Mechanicals - Sub-09A

Sequence of Installing Rigid Evo XL Motor Mounts

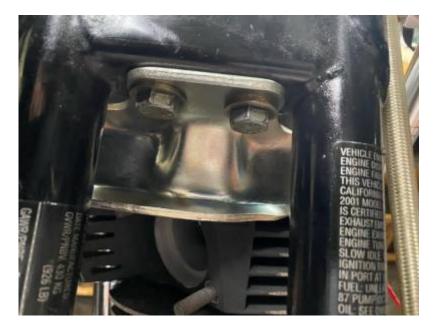
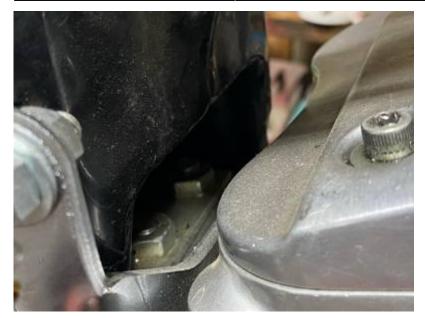
Upper Front Mount

Here is how the upper front mount looks as installed.

The washers in the 1st pic aren't OEM matches but as you can see in the 2nd pic, that's Ok.³⁾

- Factory bolts and washers: ⁴⁾
 - Bolts (4716W) 3/8"-16 x 1-1/4" Hex Head Grade 5
 - Washers: (6701) 3/8" x 13/16" x 1/16"

- 1. Install rear mount bolts.
- 2. Install the lower front mounts.
- Install the upper front mount.
 It is not suggested to leave it off. It adds rigidity to the entire engine/frame structure. ¹⁾
 Tighten the bracket to the head before you tighten the bracket to the frame to keep from introducing any additional stress. ²⁾
- 4. Install the top center mount.

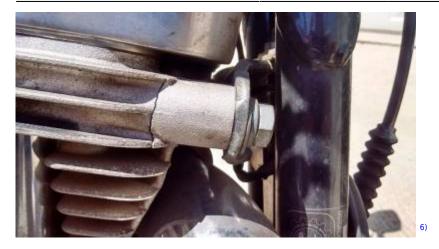
Cracked head at the front mount threads

Unfortunately, this is not an uncommon problem. It was especially a problem on Buells, which don't have a frame under the motor and therefore those two bolts were supporting the entire weight of the engine. But even on solid mount Sportsters, these cracks happen sometimes. The top end of the motor grows with heat and the frame doesn't grow near as much, so this spot gets progressively more stressed. Add in a little vibration and you can see the result.

The Motor Company pulled that bolt inboard on the Buell XB's in 2003 to get some more material around it and make it stronger. Then they did the same with the rubber mount Sportsters in 2004. So all the new heads have that bolt hole relocated inboard a little.

I've seen people cause this failure themselves, too, by using a bolt that's too long for the hole. Once that bolt bottoms in the hole, continuing to tighten it just pushes the threaded portion away and causes the failure.

As far as fixing goes, I've seen it hold up after welding, and I've seen it just crack again. So that's an iffy repair. The head needs to come off regardless and that vintage heads are generally pretty darn common and not expensive in the used market, so I personally would just replace it. But that's just me.
