# EVO: Primary Drive & Clutch

## Clutch Design & Operation

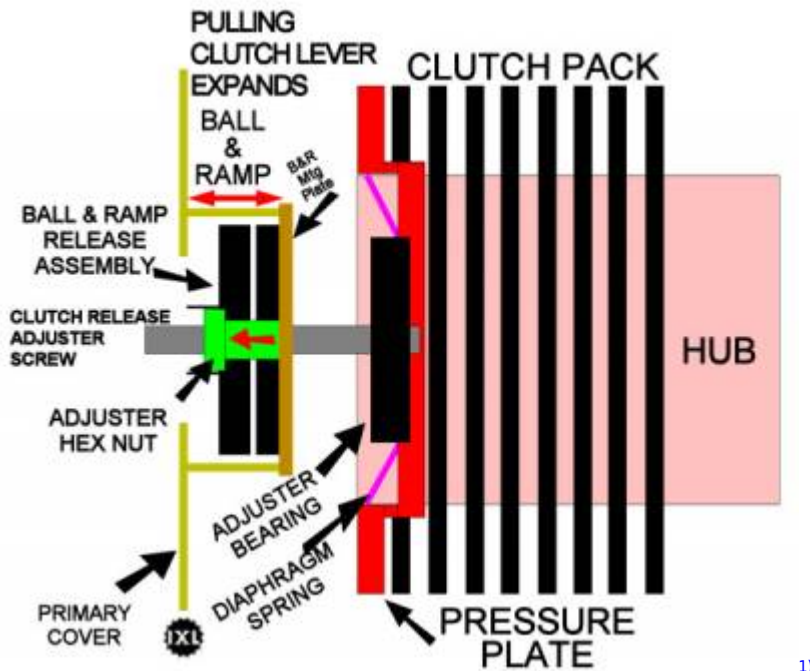
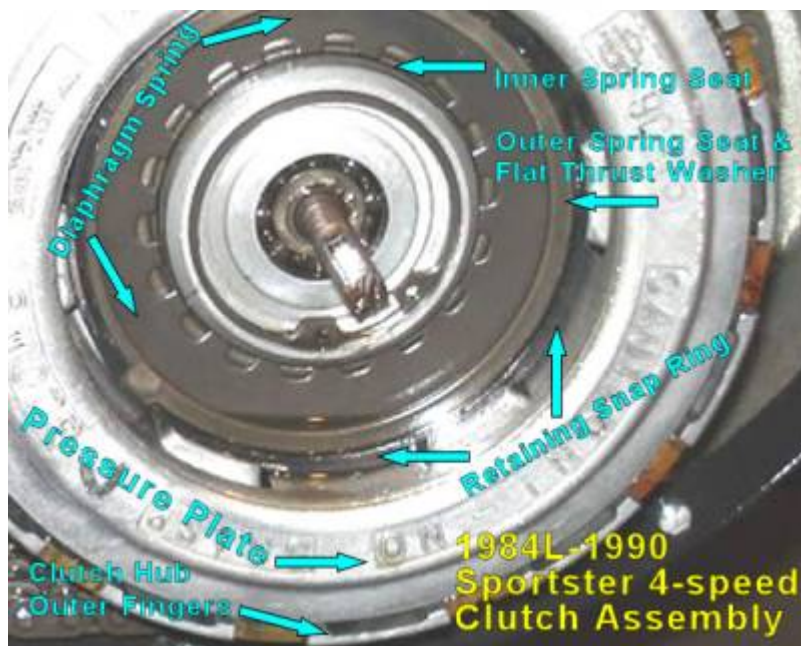
### 1984L-1990 Sportster Clutch Diagram (Rough Idea)

Here's the re-assembly sequence of the 1984L-1990 clutch diaphragm spring & pressure plate according to InsaneShane:

- Here is the best way I can explain the direction (orientation) of all the parts.
- Stack the clutch steels & frictions and install the pressure plate.
- Then install the **inner spring seat** - the dome facing outward - the grooved side against the pressure plate.
- Next install the **diaphragm spring** - the point of the cone facing the already installed inner spring seat.

- Then comes the **outer spring seat** - the dome facing inside against the outer edge of the clutch diaphragm spring.
- The **flat thrust washer** goes in next - against the grooved side of the spring seat.
- Finally, you compress the clutch and install the **retaining ring**.

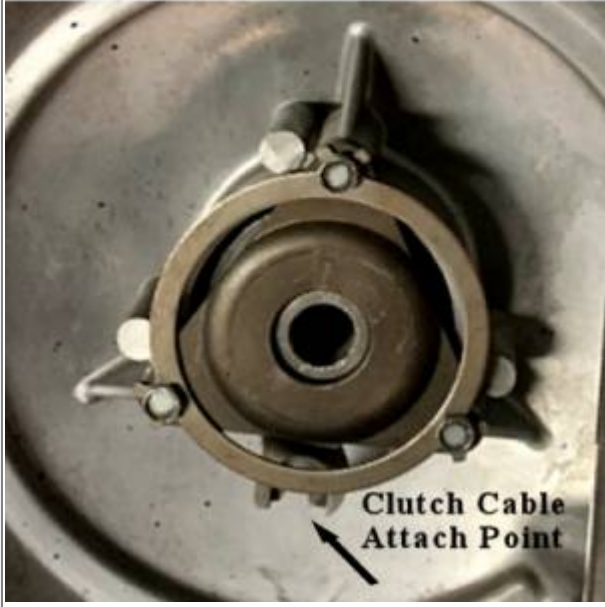
| <p>On the 4-speed models, the Ball &amp; Ramp Assembly is mounted to the inside of the Primary Cover. This necessitates the removal of the Primary Cover in order to replace either the B&amp;R unit or the Adjuster Bearing unit.</p> <p>This same Ball &amp; Ramp mounting design was carried forward and used on the 1991-1993 5-speed model engines.</p> <p>The 1994 models were the first to place the B&amp;R assembly behind the larger derby cover.</p> | <p><b>Ball &amp; Ramp Mount (1986 Example)<br/>Inside Primary Cover (Pre-1994)</b></p> <p>Clutch Cable Attach Point</p> <p>2)</p> |

On the other hand, for 1991-1993 models, which also have five-speed transmissions, while the clutch operation is the same, the Ball & Ramp Assembly is mounted to the inside of the Primary Cover (as illustrated for 1984L-1990 four-speed models). This necessitates the removal of the Primary Cover in order to replace either the B&R unit or the Adjuster Bearing unit on those models.

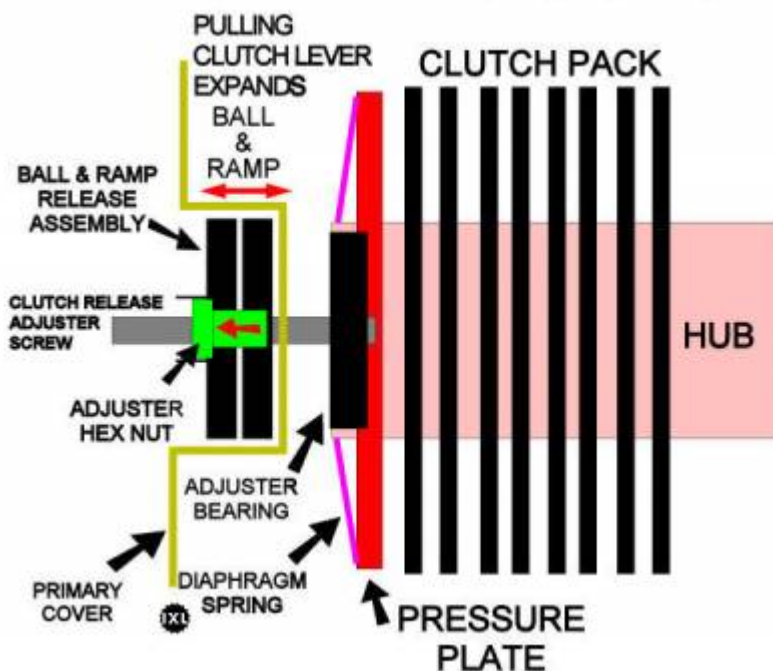
### 1991-later Sportster Clutch Diagram (Rough Idea)

The 1994-later models have the Ball & Ramp unit mounted in a cavity of the Primary Cover (as shown above). This cavity, accessible under the 'Derby Cover', allows the replacement of the B&R unit and the Adjuster Bearing unit without removing the Primary Cover.

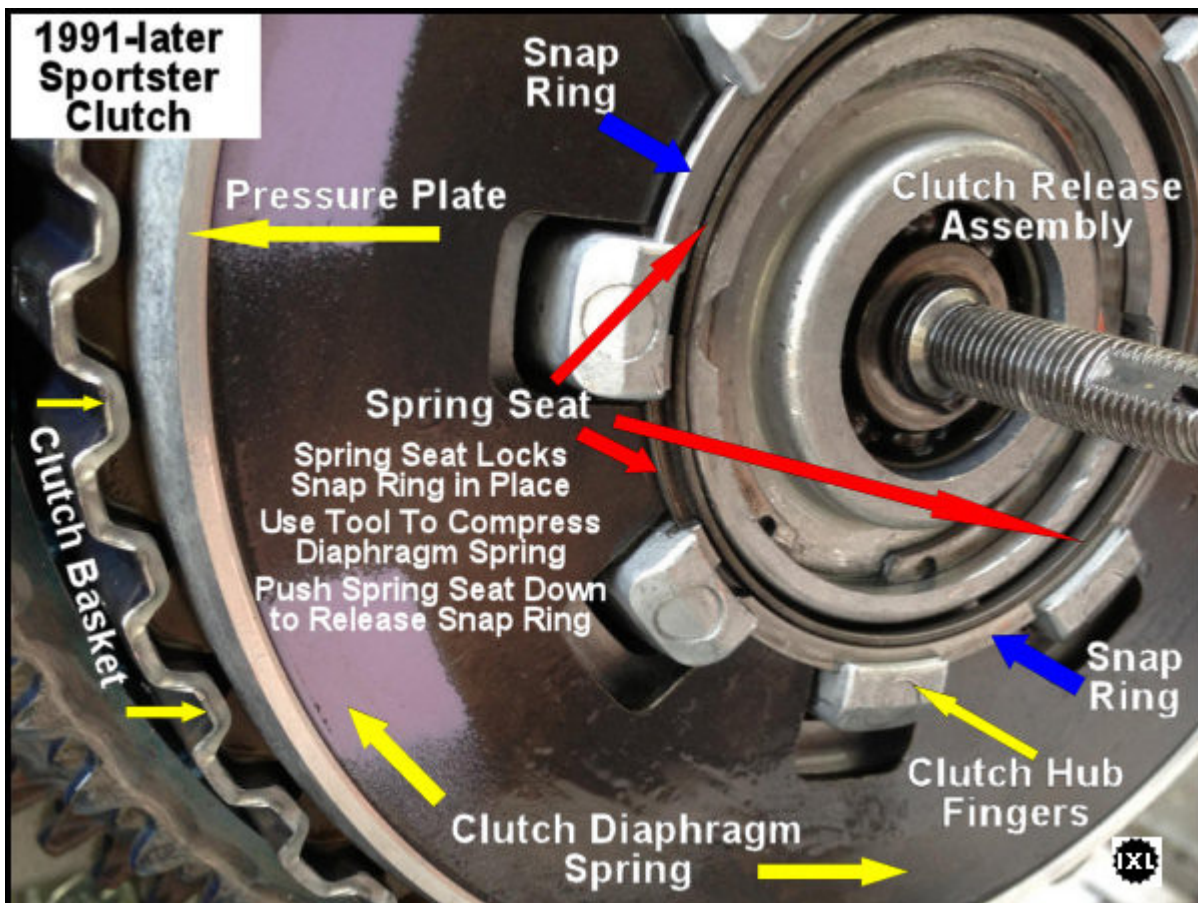
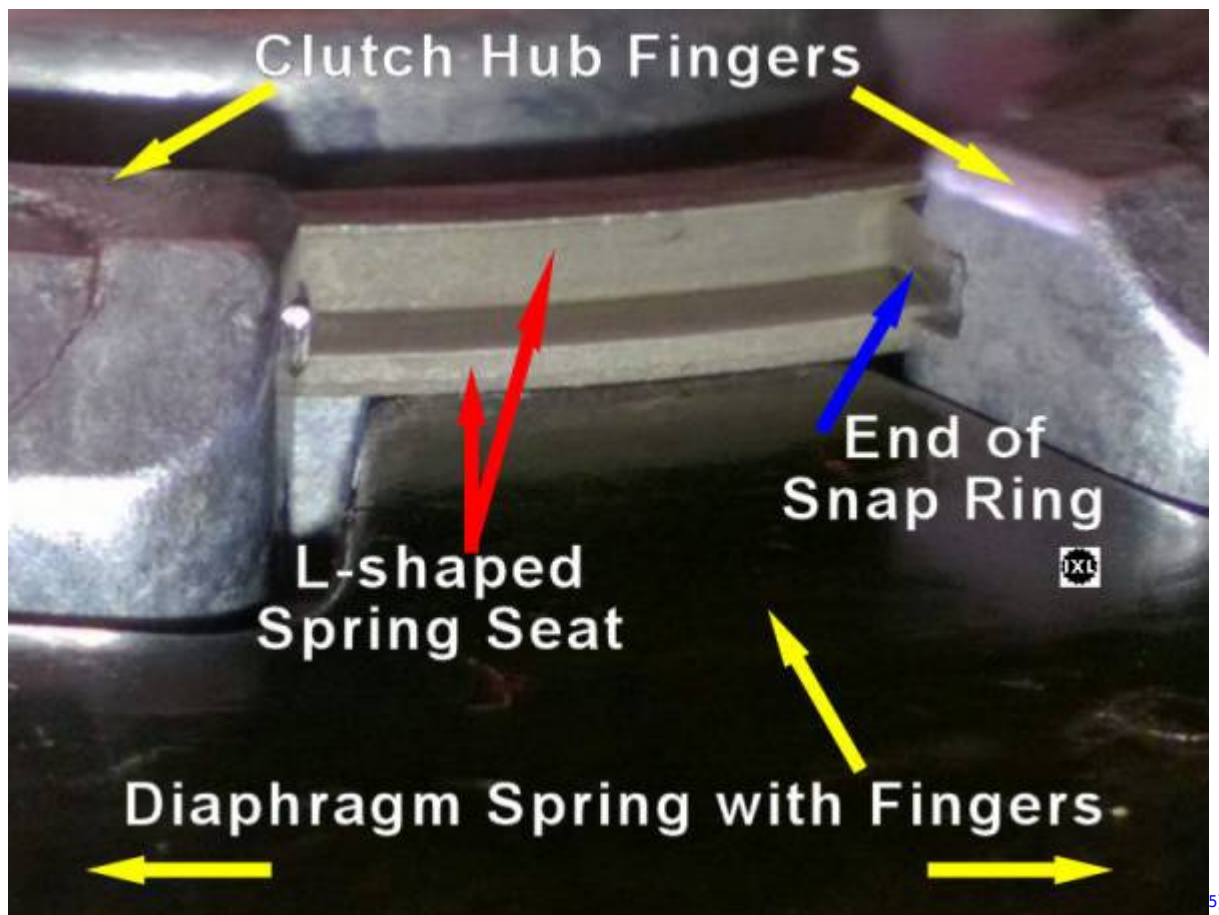
**REASSEMBLY** - The Pressure Plate sits up against the clutch pack - the Diaphragm Spring sits on top of the Pressure Plate - The Locking Ring sits on top of the fingers of the Diaphragm Spring - The Snap Ring sits on top of the Locking Ring in the notches of the Hub Fingers.

**CRITICAL** - After compressing the Diaphragm Spring, be sure the Spring Seat (locking ring) is on top of the Diaphragm Spring fingers (not behind them). Then place the Retaining (snap) Ring in place. When releasing the compressed Diaphragm Spring, make sure the locking ring is on top of the fingers and in the proper place to keep the snap ring from coming loose.

When you compress the Diaphragm Spring, it must be compressed deep enough for the L-shaped Locking Ring to slide down the collar of the Pressure Plate far enough (to be out of the way) that the Snap Ring will go into the notches of the Hub Fingers. Then, when you release the pressure, the fingers of the Diaphragm Spring will push up (out) on the L-shaped Locking Ring until it seats (taking it's place under & inside of the Snap Ring). In this way, the Locking Ring holds the Snap Ring from coming out of place & the fingers of the Diaphragm Spring holds the Locking Ring tightly in place between the fingers & the snap ring.

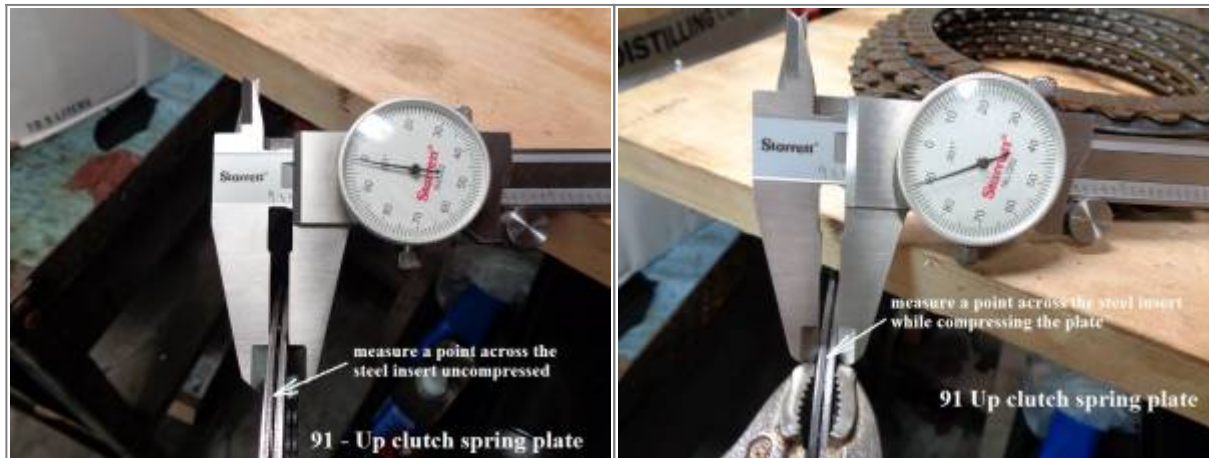
Measuring the spring plate <sup>6)</sup>

The Spring Plate measurements are:

Compressed: 4.826mm (0.190")

Uncompressed: 5.283mm (0.208")

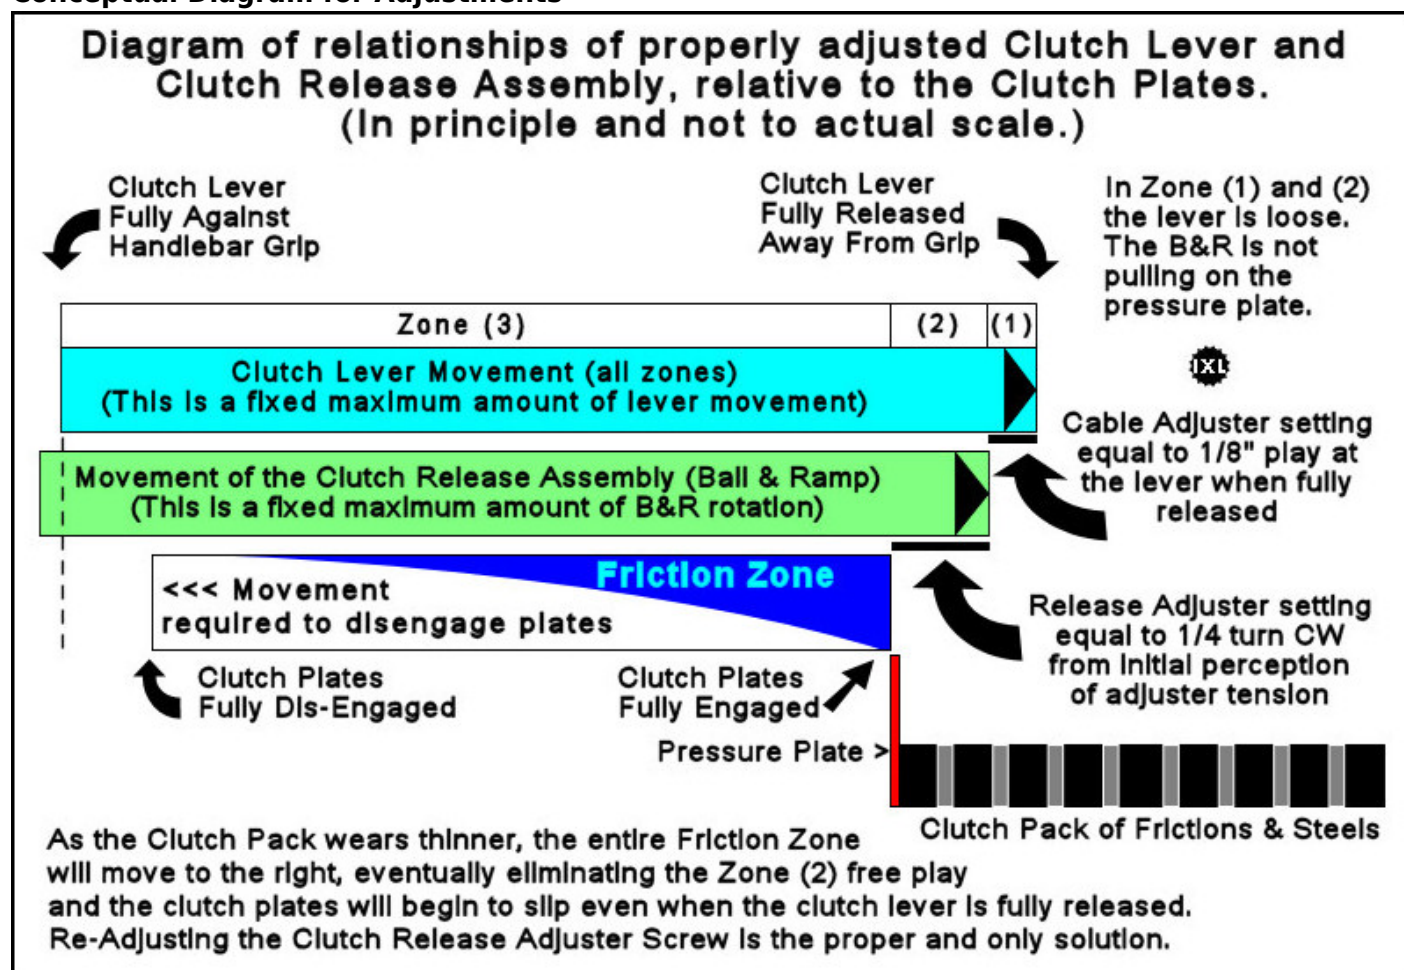
### Conceptual Diagram for Adjustments

The diagram illustrates three zones on the Clutch Lever - When fully released, Zone(1) is the 1/8" Cable Free Play where there is no tension whatsoever from the cable pulling on the lever - The lever just sorta dangles there in its mount... As you pull the Clutch Lever toward the handlebar, you reach Zone(2)<sup>9)</sup> which is the Adjuster Free Play - The cable is now pulling on the Ball & Ramp, rotating it to expand, but it is not pulling on the clutch pressure plate, yet. This brings us to Zone(3)<sup>10)</sup> which occurs when the Ball & Ramp has expanded far enough to actually begin pulling the Clutch Pressure Plate away from the Clutch Pack. Zone(3) continues all the way until the Clutch Lever reaches the handlebar. If adjusted correctly, you will have these three distinct zones in the movement of your Clutch Lever and the Clutch Pack will be

fully dis-engaged before the end of Zone(3) - before the lever is against the handlebars.

Zone(2) diminishes as the plates wear. The actual lever free play (Zone(1)) should not change as the clutch plates wear - Here's why:

The clutch lever, once set with the cable adjuster, is in a fixed position (with a fixed length to the cable). The Ball & Ramp Assembly is mounted to the Primary Cover, so it, too, is in a fixed position. The cable (fixed length) runs between the clutch lever (fixed position) and the coupling on the Ball & Ramp Assy (fixed position).

The adjuster bearing is mounted to your pressure plate and the adjuster hex nut (around the adjuster screw) is mounted on the Ball & Ramp Assy. When the Ball & Ramp Assy is rotated, it expands the distance (ball up the ramp) between each side of itself, pushing against the Primary Cover on one side and the adjuster hex nut on the other side. This is how it pulls the clutch pressure plate away from (pushing on the adjuster screw/nut) the Clutch Pack in order to fully dis-engage the plates.

BUT, since the Ball & Ramp Assy is mounted to the Primary Cover, there is no change in the position or movement of that assembly with which the lever interacts. Therefore, Zone(1) does not change - The lever will continue to move 1/8" before starting to tug on the Ball & Ramp coupling.

Eventually the friction zone begins to slide past the point on the clutch lever where Zone(2) meets Zone(1), and the bearing is now fully active, laterally, all the time (since the pressure plate is moving inward as the plates wear) and the Clutch Pack is slipping because the Pressure Plate can no longer fully compress the pack...

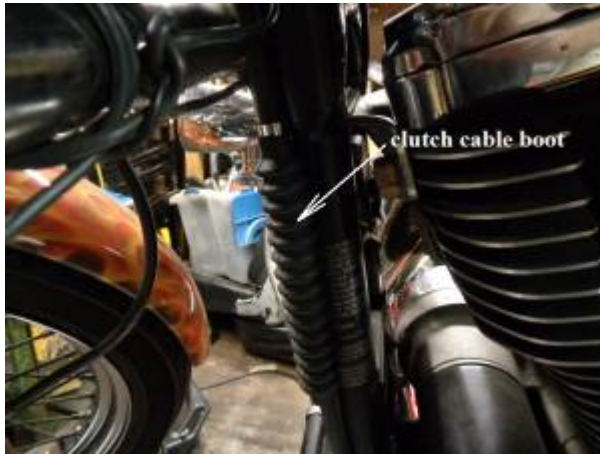
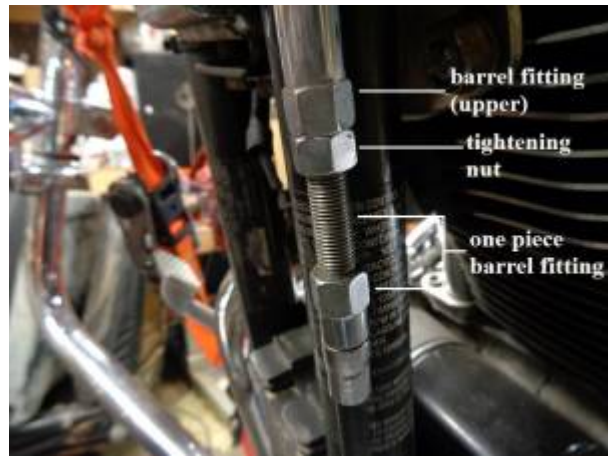
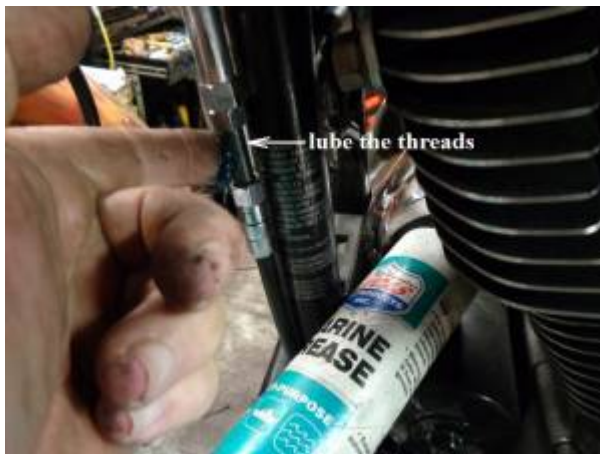
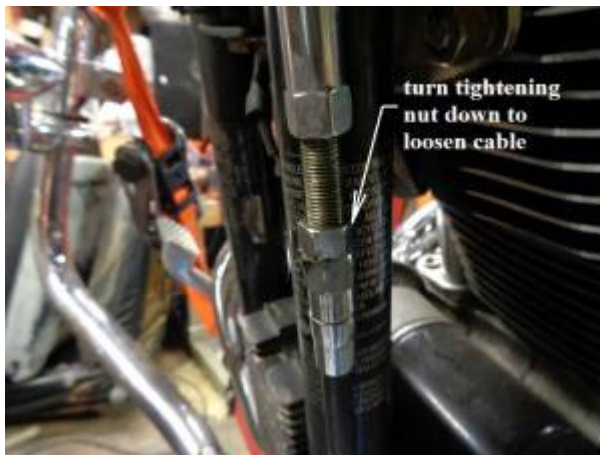
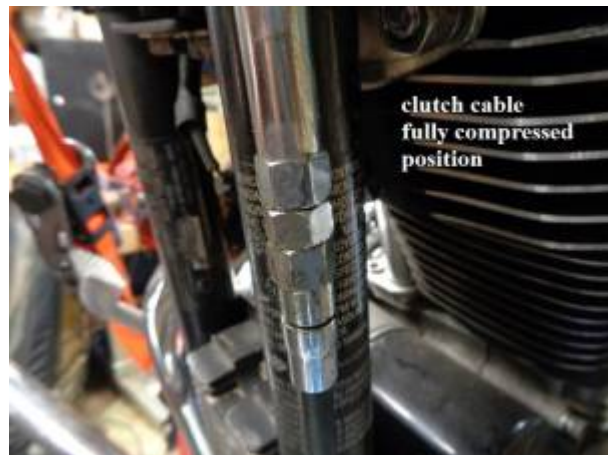
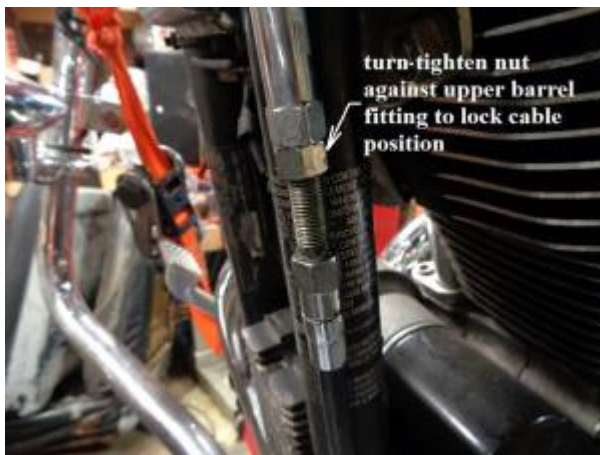
**Pics - Adjusting the clutch cable on a 98 model**

Now find the Clutch Cable Adjuster - Move the boot & loosen the Jam Nut - Fully loosen the tension by screwing the two parts of the Clutch Cable Adjuster together, thus making the adjuster shorter - thereby the cable (and lever) becomes loose.

Now, go back to the Clutch Cable Adjuster - Unscrew the two parts to lengthen the Adjuster just enough that there is still 1/8” of free play in the clutch lever movement BEFORE IT BEGINS TO ENGAGE THE CLUTCH RELEASE (check this at the cable connection to the lever) - Now tighten the Jam Nut on the cable adjuster and move the rubber boot back over it...

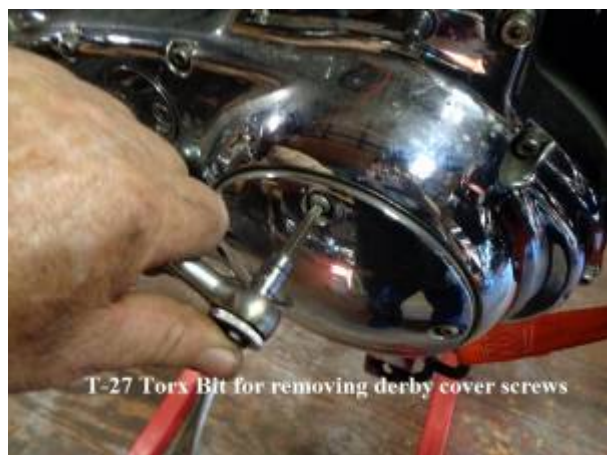
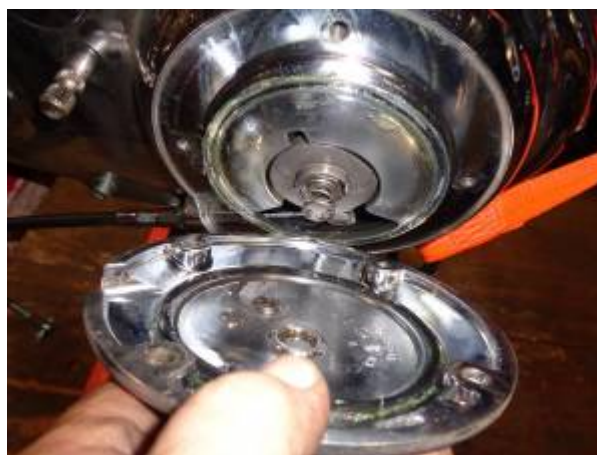
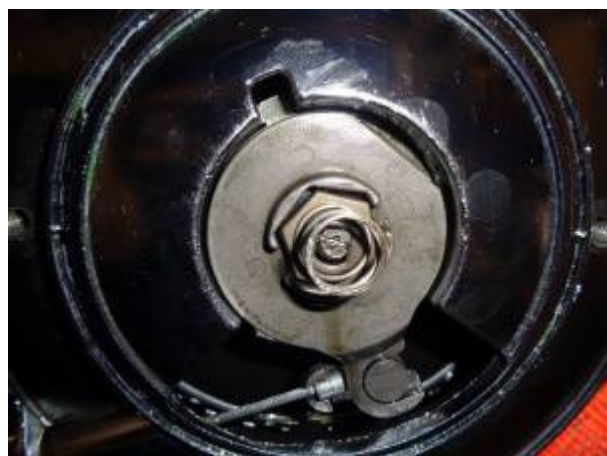
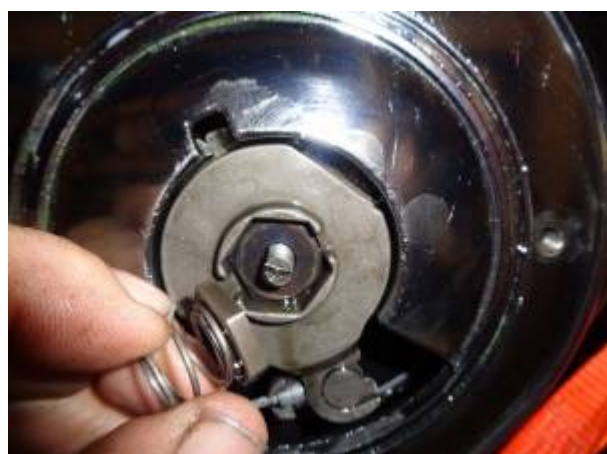
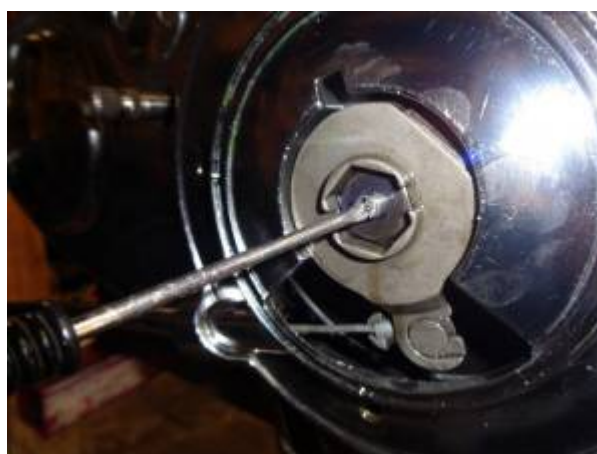
## Pics - Adjusting clutch release screw on a 98 model

Turn the center screw of the Release Adjuster clockwise one turn away from the original position to be sure you are fully unloading any pressure - then **slowly turn the Release Adjuster screw COUNTERCLOCKWISE until you feel ANY CHANGE IN TENSION** - Do this a few times to be sure you feel the right spot where tension begins - When you're satisfied you have the right spot, turn the adjuster screw back clockwise 1/4 to 3/8 of a turn to be sure no preload tension is on the Diaphragm Spring & Pressure Plate.

Place the Release Adjuster Position Lock Nut back in place (turning the screw farther **CLOCKWISE ONLY - JUST ENOUGH** to get the nut to fit in the nearest position - Do not turn the screw more

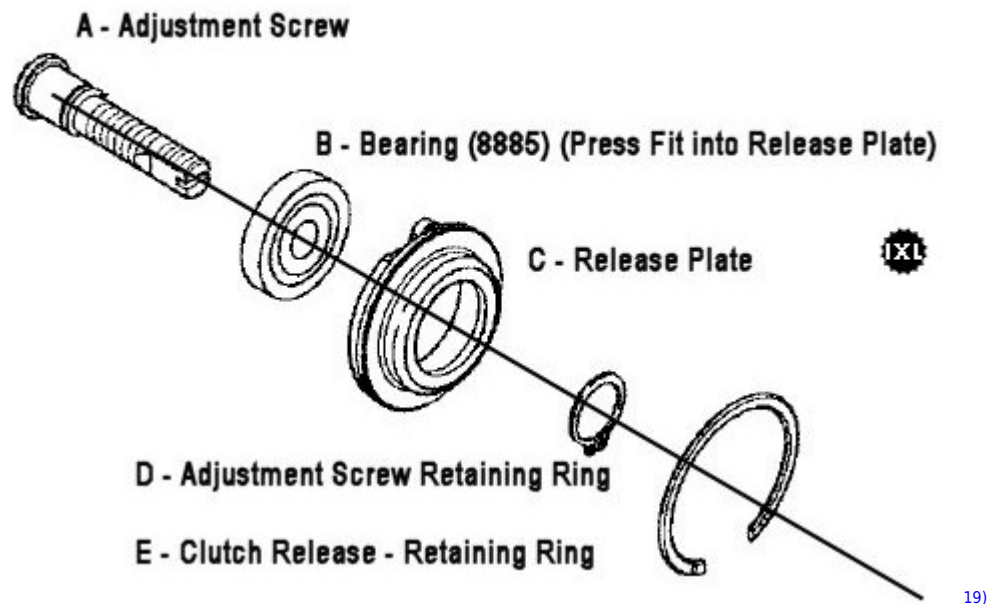
# Clutch Release Bearing Assy

The 8885 bearing dimensions are Outer OD = 30.00mm, Center ID = 10.00mm & Outer Race Width = 9.00mm

NOTE: The stock Bearing(B) and Release Plate(C) can be purchased already assembled. Part number 36731-91 is the release plate assembly, which includes both the 37918-91 release plate and the stock 8885 bearing.

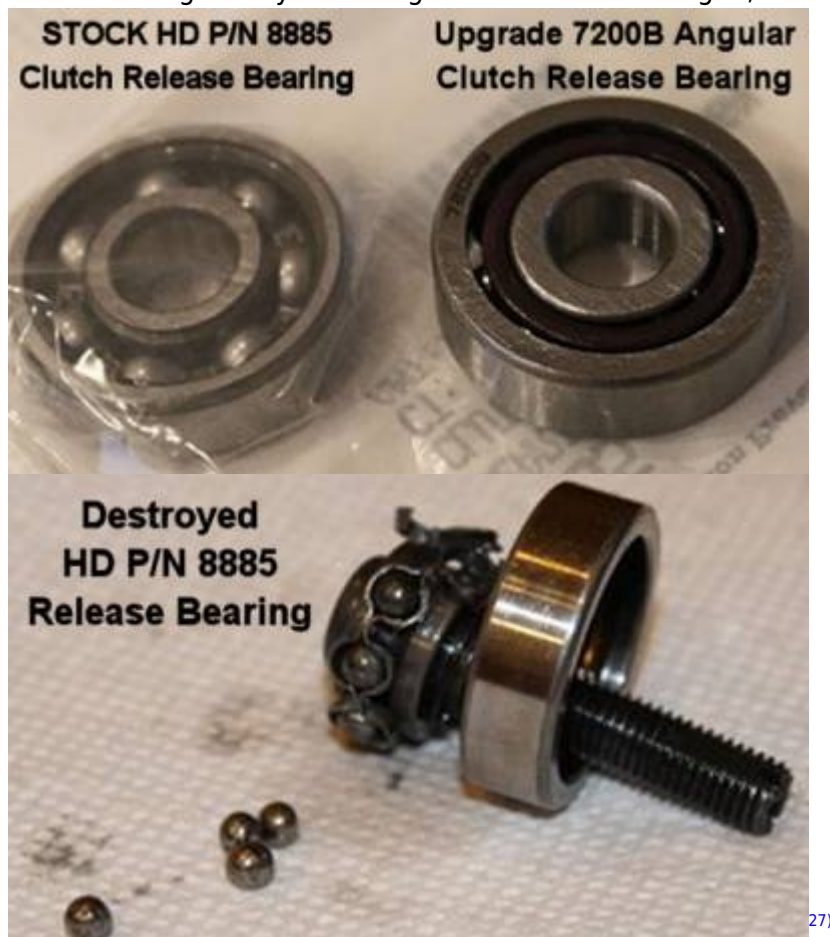
You might consider replacing the stock bearing, P/N 8885, which is a standard ball type bearing (equiv. to 6200). Using an angular contact bearing (FAG 7200B), which provides additional support in the axial direction, is a better alternative for this application.

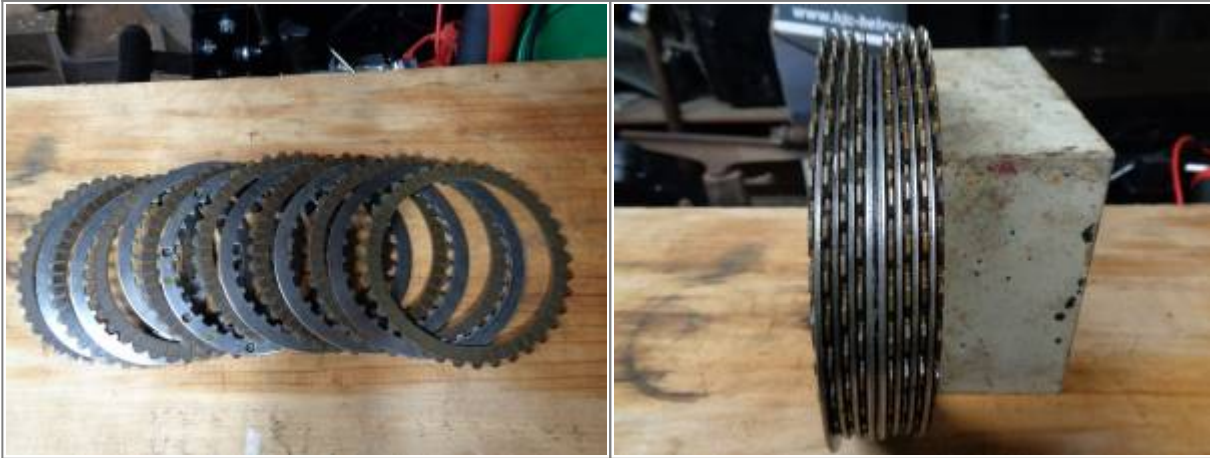
91-up clutch plates and spacing (F-St-F-St-F-St-F-SP-F-St-F-St-F-St-F). <sup>42)</sup>

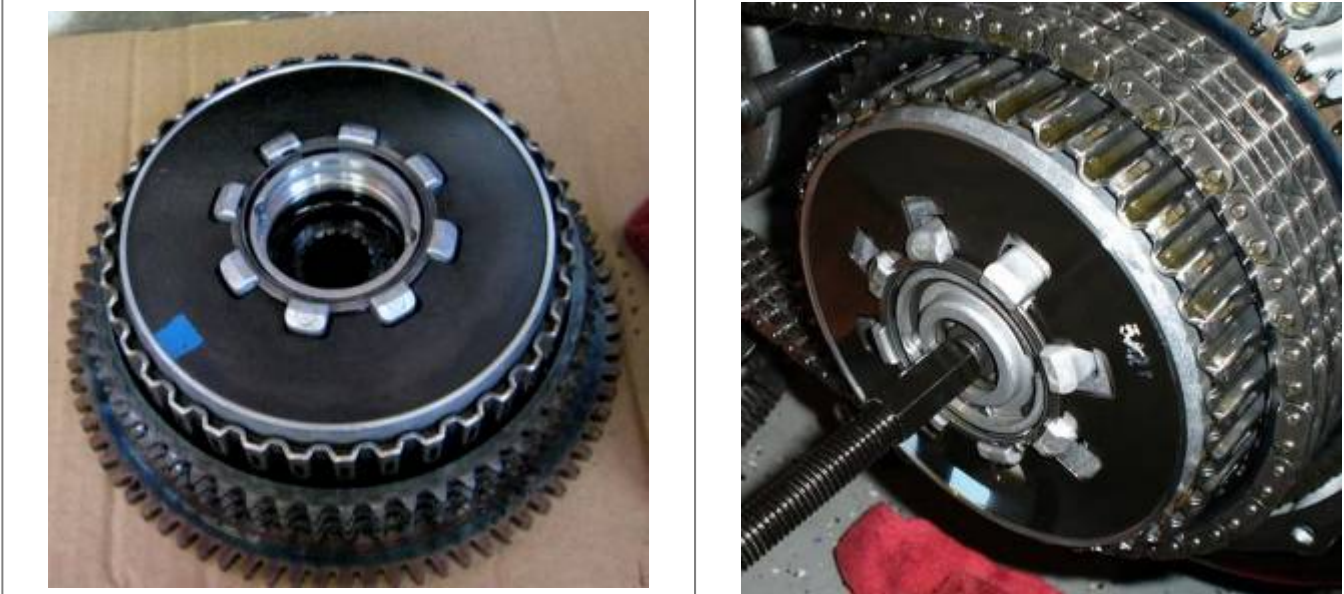
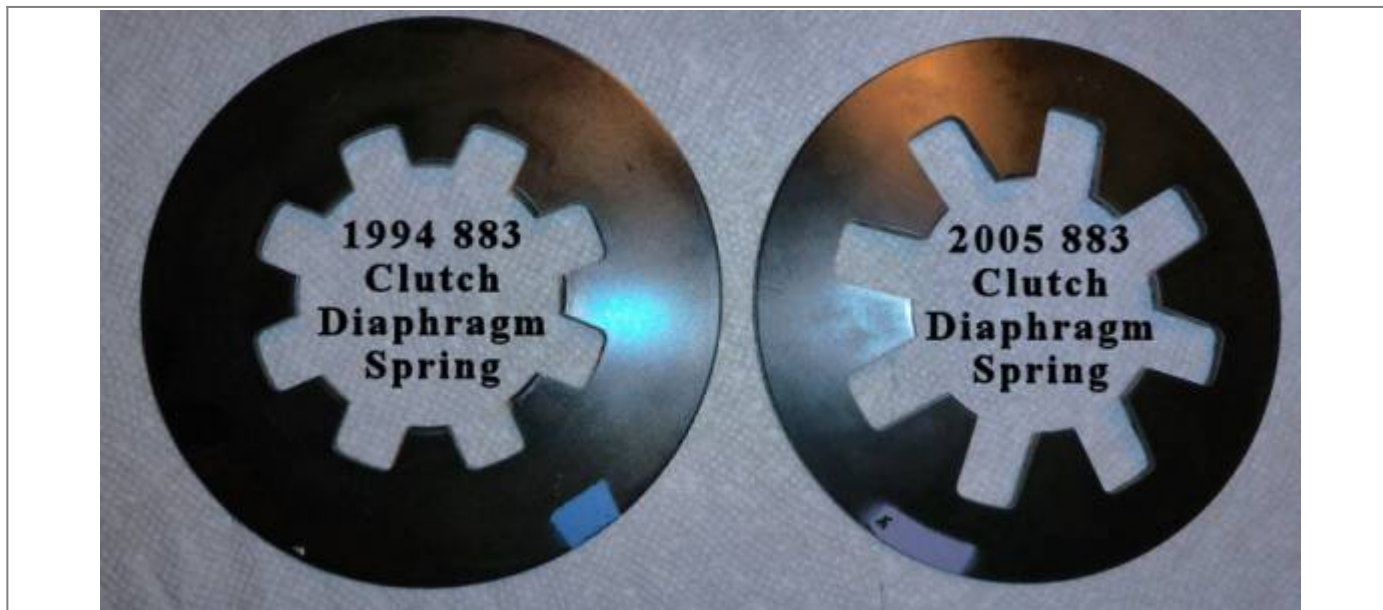
"Beginning in 2004, the 883 models started coming with a lighter clutch spring than the 1200's."<sup>43)</sup> This was to reduce the effort required to pull the clutch lever. There was also a change in the clutch cable in 2007 to help reduce the clutch lever effort.

Notice the difference in the slots between the Diaphragm Spring fingers of '91-'03 and '04-later springs. Above left is an '01 example and on the right is an '06 example. Both are 883 model springs.<sup>44)</sup><sup>45)</sup> Below are two more examples of diaphragm springs.<sup>46)</sup>

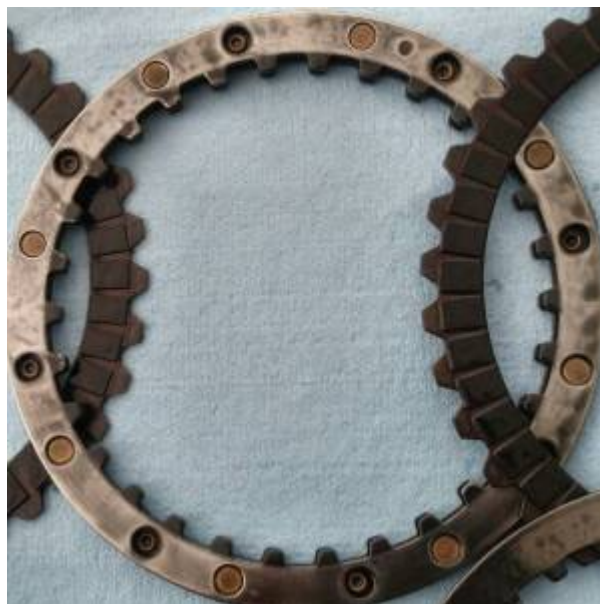
As mentioned above, the Spring Plate is located in the middle of the clutch pack. It consists of two separate steel plates attached together with riveted, movable, flat springs sandwiched between the two steel plates. There is a friction plate on either side of the Spring Plate. The idea is to absorb some of the instantaneous force of the clutch engagement and release it over a few microseconds of spring energy transference. [See this Post#44](#)

While the functional goal is a good idea, this Spring Plate has caused untold headaches for many riders. When the rivets fail they get caught in between the friction & steel plates, causing the clutch to malfunction, damaging the plates & the clutch basket. <sup>47)</sup>

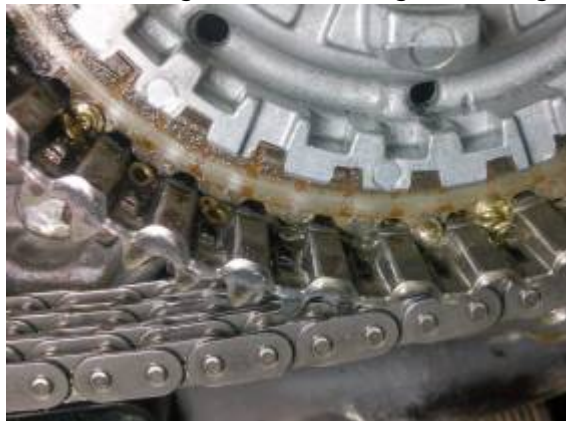
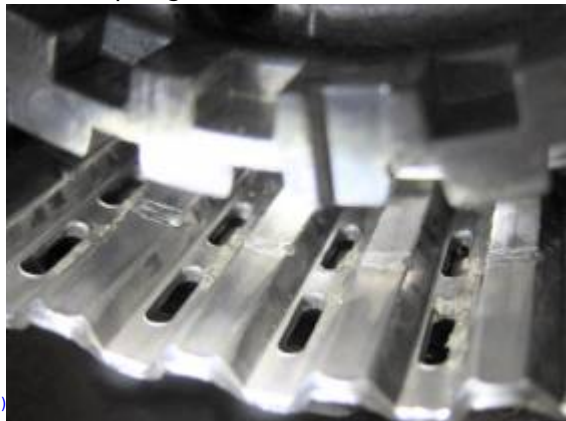
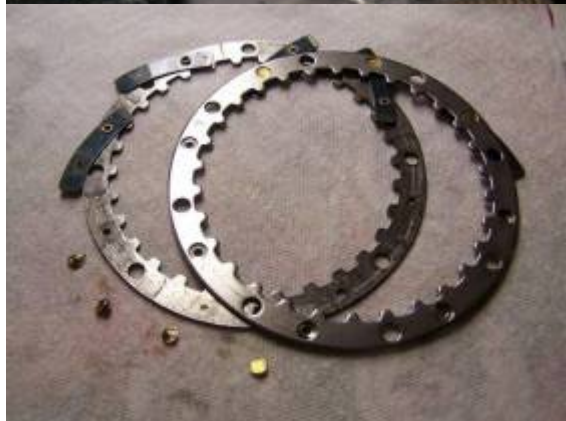
scored by the failure. When the rivets fail, the spring strips that the rivets were holding will now slip out from between the steel plates of the spring plate. Exactly where the spring plate is located in the stack these spring strips make a gouge in the clutch basket (and in the clutch hub). This will require careful filing to remove any burrs created by the gouging or, if bad enough, may require replacing the clutch basket & hub.

Also, the existing clutch plates (either steels or frictions) may have been warped or otherwise damaged during the spring plate failure. If the Spring Plate failed, it is best to replace all the steels & frictions to avoid carrying damaged parts forward to damage new parts. You should also carefully check that the Pressure Plate & Release Plate have not been damaged, nor any other primary components (chain, sprockets, etc).

Here are images of the carnage resulting from the Spring Plate Failure:
