# Table of Contents

# IH: Engine Mechanicals

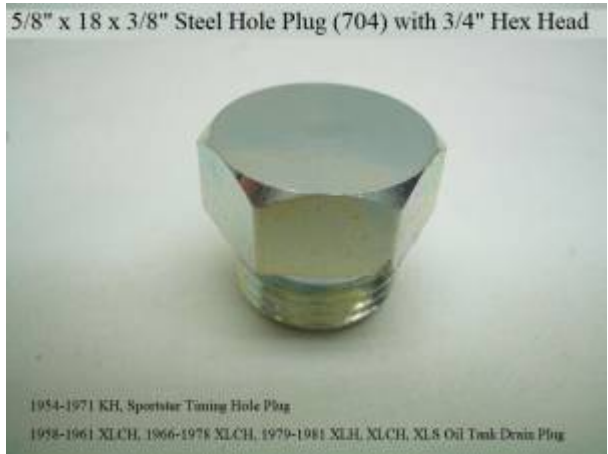
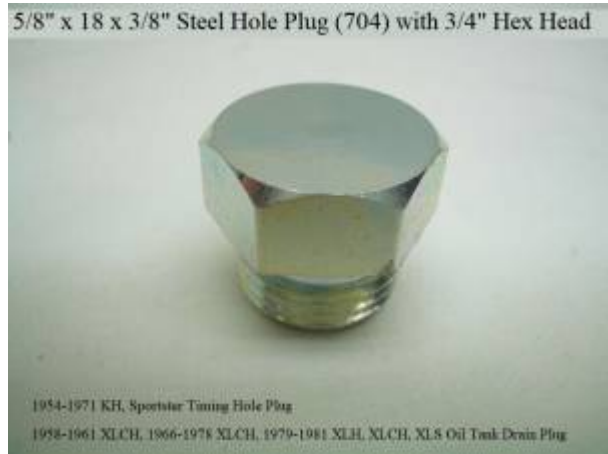
### **1954-1971 KH / Sportster Timing Hole Plug (704).**

This plug was also used as an oil tank drain plug for 1958-1961, 1966-1978 XLCH and 1979-1981 XLH, XLCH, XLS Sportsters.

Threads: 5/8"-18 x 3/8" with 3/4" Hex Head.

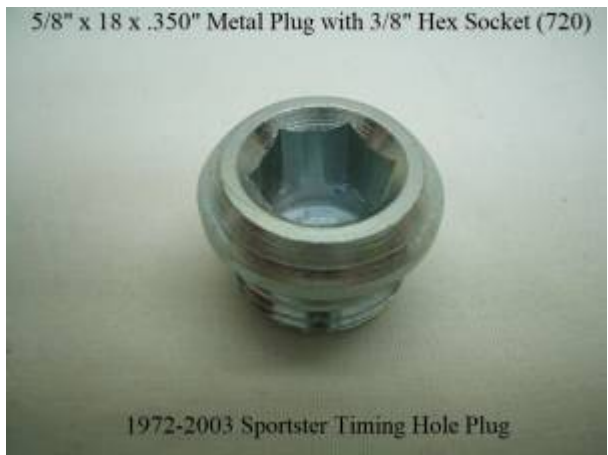
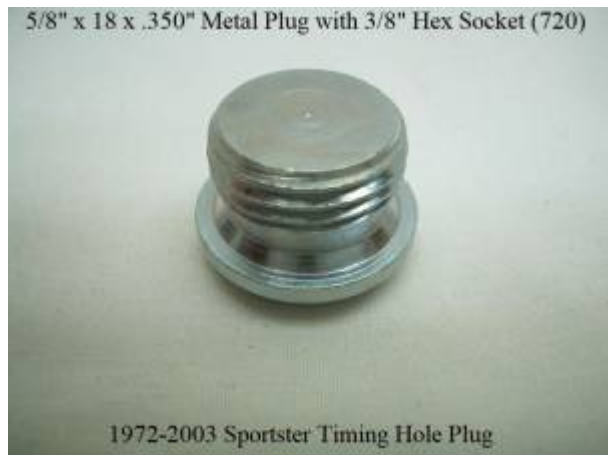
**1972-2003 Sportster Timing Hole Plug (720).**

Threads: 5/8"-18 x .350" with 3/8" Hex Socket (Allen) Head.

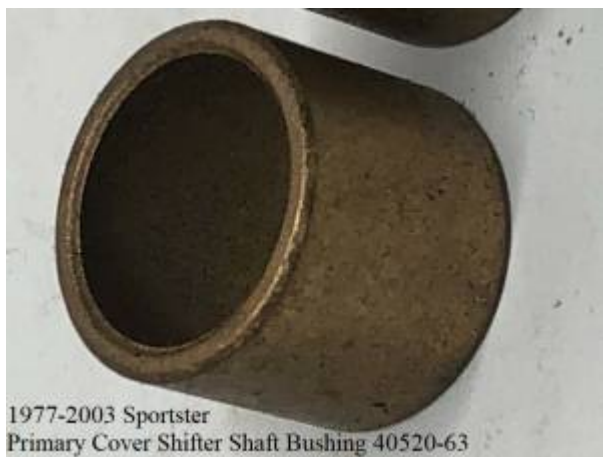
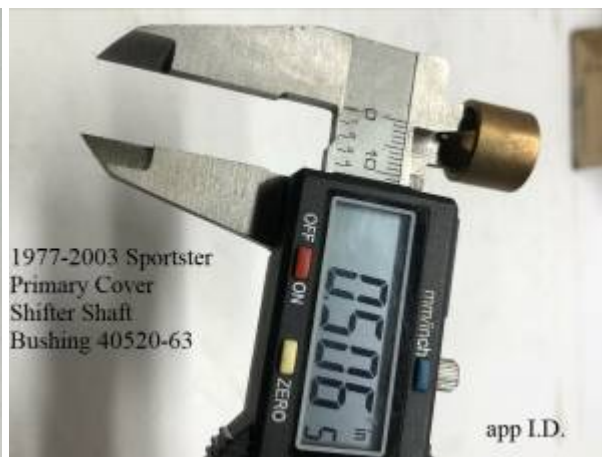
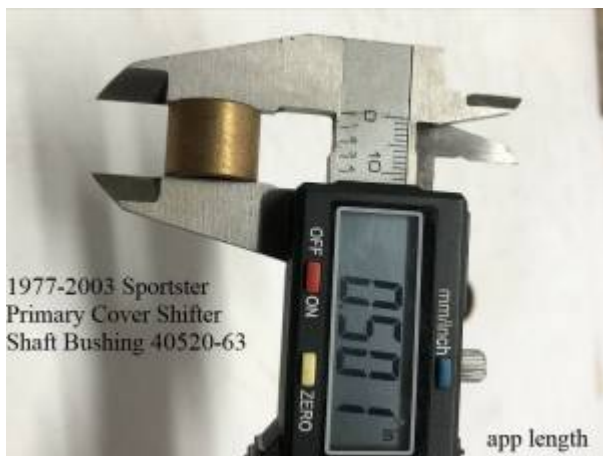
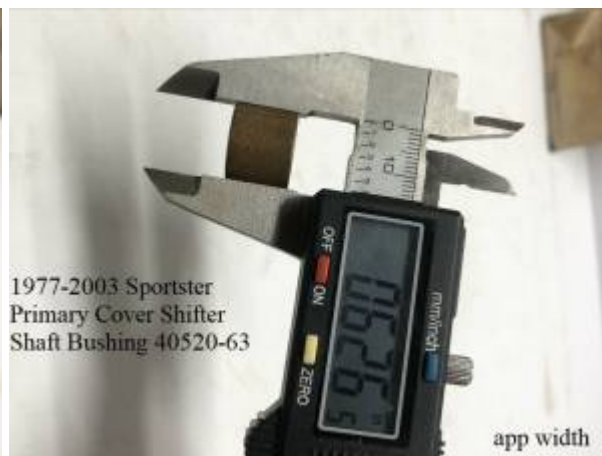
1977-2003 Sportster Primary Cover Shifter Shaft Bushing 40520-63. Bushing is open ended. Below are approximate (only) dims. <sup>8)</sup>

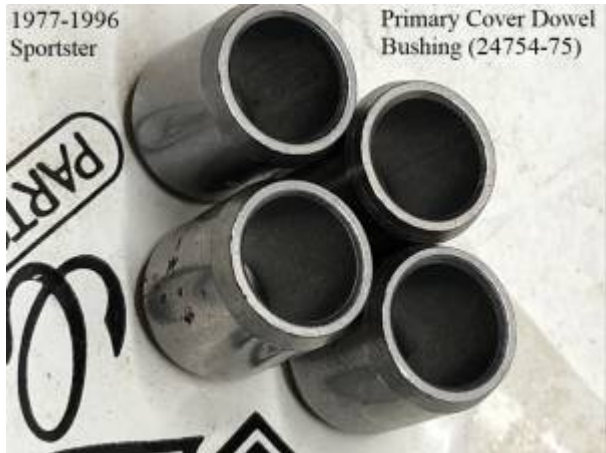
Dowel bushing part# (24754-77).

1977-1985 covers used 3 dowel bushings to locate the primary cover to the left case. (same bushing used through 1996 covers)

The mounting bolt hole in the cover is drilled for the OD of the bushing with the ID of the bushing sized for the mounting bolt.

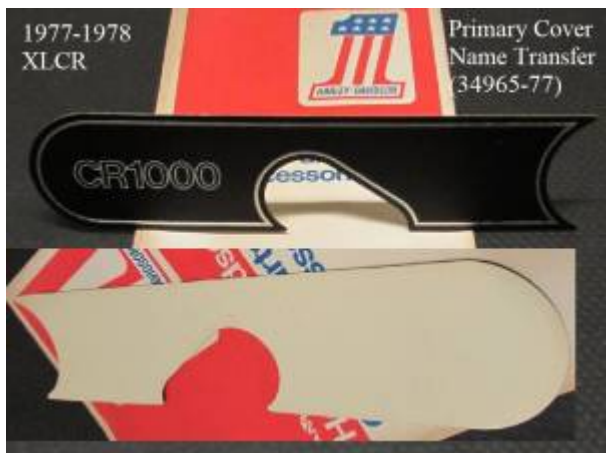
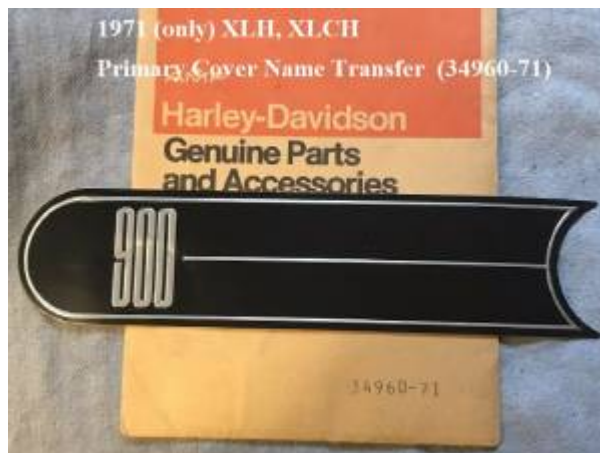
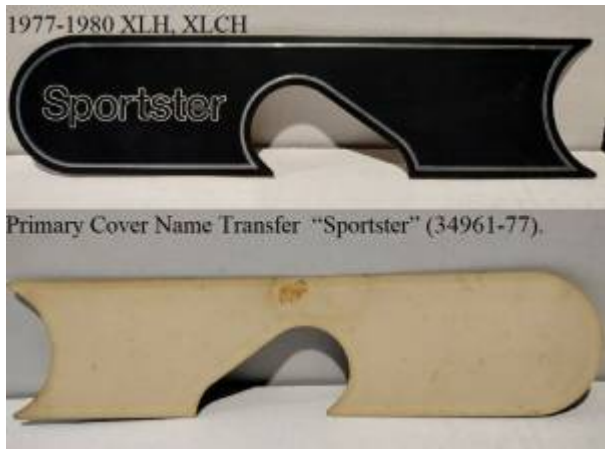
These are used in the "pocket" in the center of the primary cover.

1971 XLH, XLCH used the transfer labeled "900" (34960-71).

1972-1976 XLH, XLCH used the transfer labeled "1000" (34960-72).

1977-1978 XLCR used the transfer labeled "CR1000" (34965-77).

1977-1980 XLH, XLCH used the transfer labeled "Sportster" (34961-77).

1979-1980 XLS used the transfer labeled "1000" (34962-79).

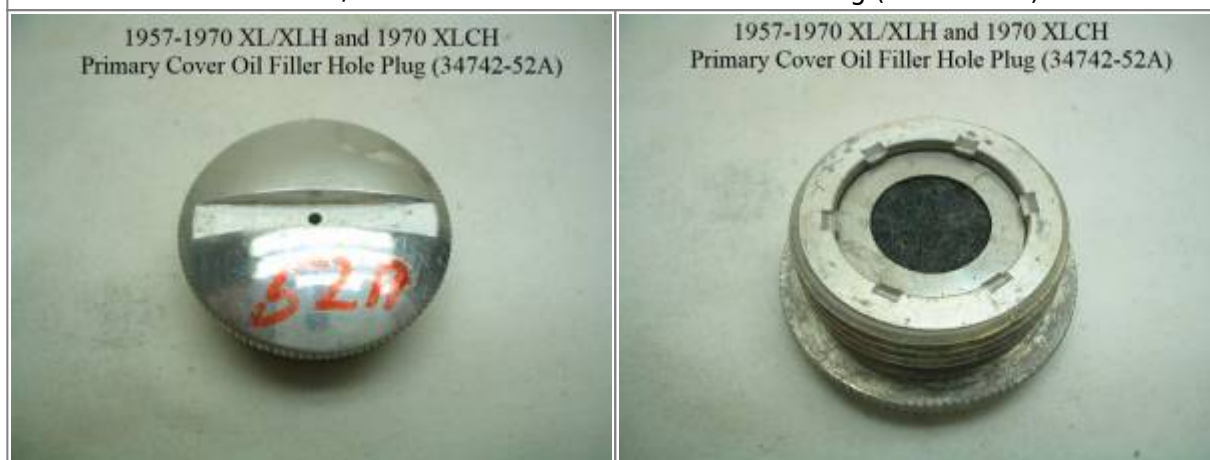
#### 1957-1970 XL/XLH and 1970 XLCH Oil Filler Hole Plug (34742-52A) <sup>13)</sup>

The plug cap is threaded for removal to add oil to the primary case.

The plug is polished and knurled with a small hole through the center and filter mesh staked in place on the inward side of the plug.

It screws into the hole in the primary cover with no seal. The small hole with filter mesh serves as primary air intake.

The plug has a slot milled out across the face as a socket for removal/installation and the tool is similar to and fits into the slot.

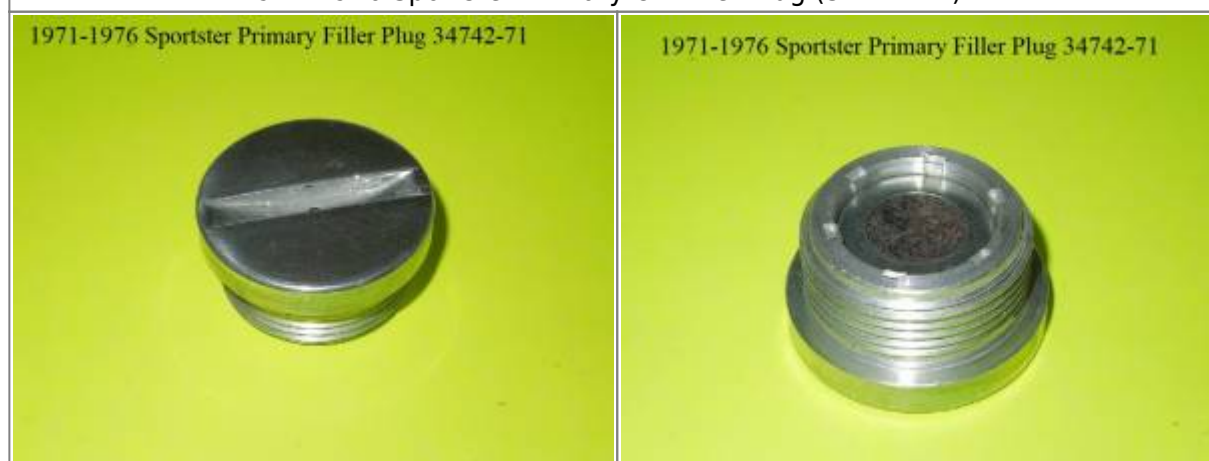
1971-1976 Sportster Primary Oil Filler Plug (34742-71) <sup>14)</sup>

Changes made to the 57-70 hole plug include no knurling and now using a sealing O-ring (11106).

The plug has a small hole through the center and filter mesh staked in place on the inward side of the plug.

It screws into the hole in the primary cover and seals with the installed O-ring. The small hole with filter mesh serves as primary air intake.

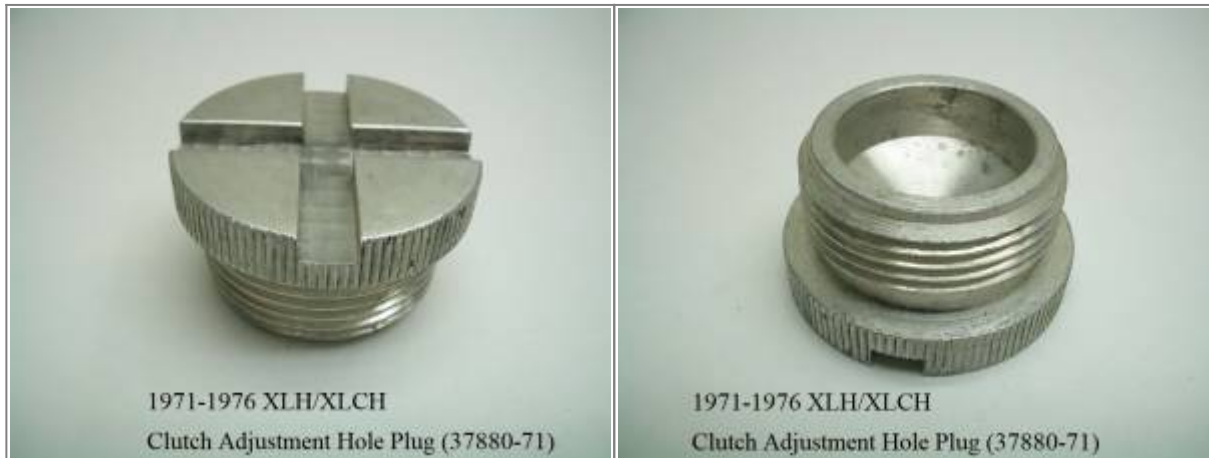
1971-1976 Sportster Clutch Adjustment Hole Plug (37880-71) <sup>15)</sup>

This cap plug was introduced on the primary cover with the redesigned wet clutch models and installs over the clutch adjuster.

The cap plug is polished, has knurled edges and doesn't install flush with the cover.

The clutch adjustment hole plug also uses O-ring (11106), has no through-hole vent and has overlapping slots cut into the face in a "cross" pattern.

No vent is needed in this cap since the oil filler plug has the vent controlling air intake.

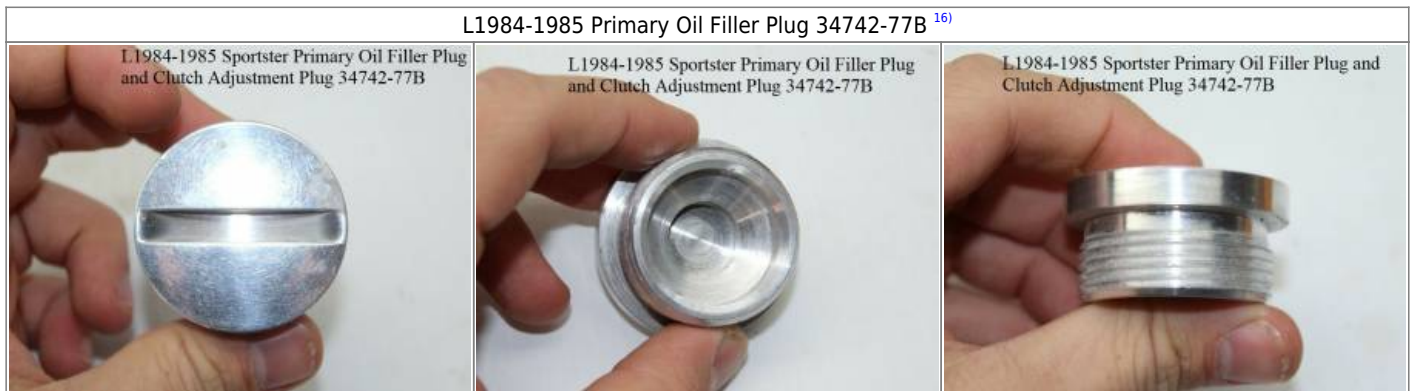
1977-1985 models use 2 identical hole plugs for the oil filler hole and the clutch adjustment hole. It looks the same as the 1971-1976 oil filler hole plug but it has no vent hole.

The plug went through a couple revisions but any of these will fit and function on 1977-1985 primary covers.

1977 models used (34742-77)

1978-E1985 models used (34742-77A)

L1984-1985 models used (34742-77B)

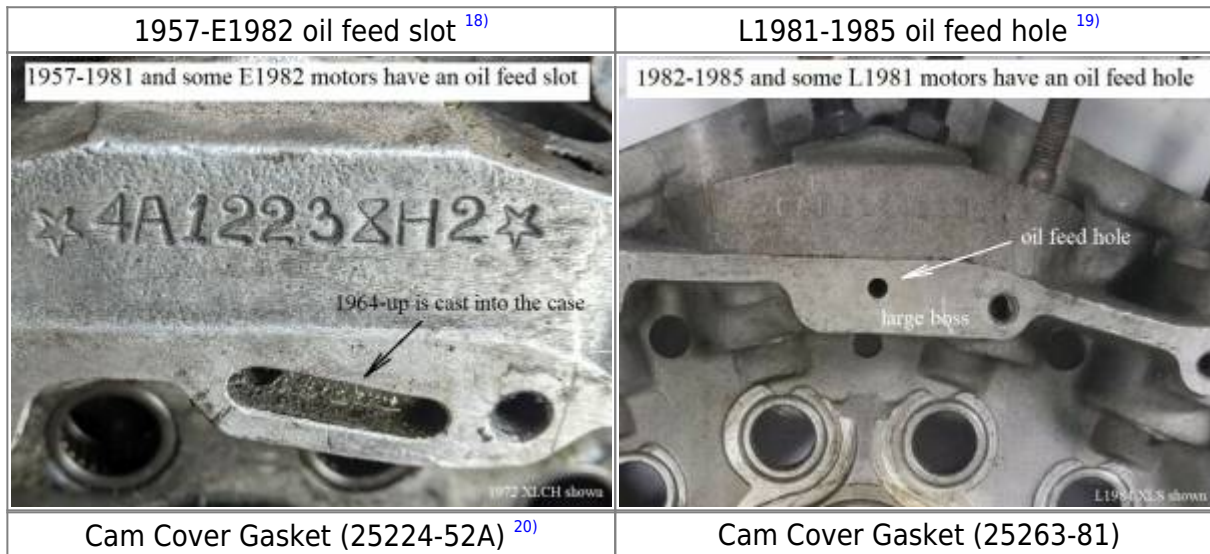
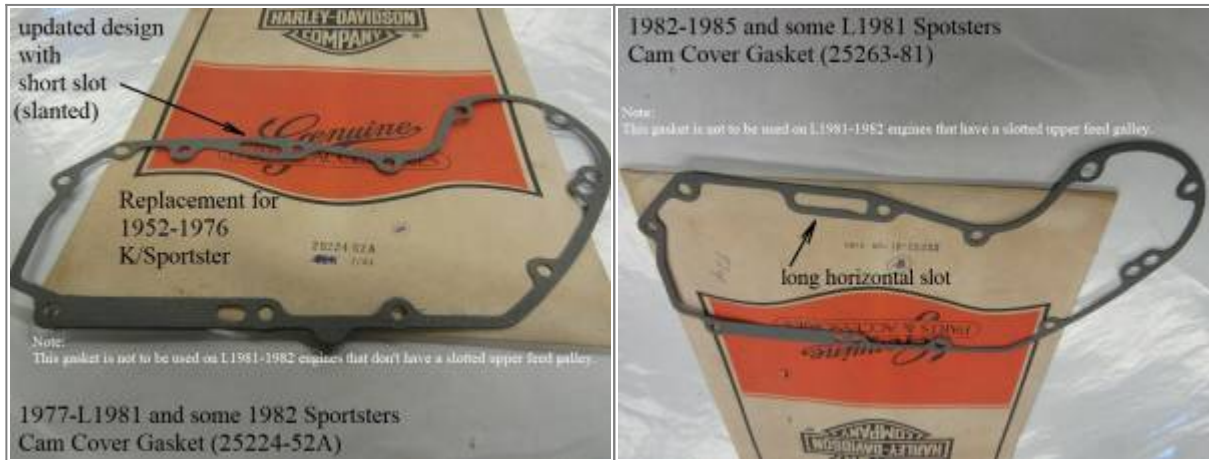
1952-1976 K and Sportster original gasket (25224-52), designed with an upper feed oil hole. Updated gasket (25224-52A).

1977-L1981 and some E1982 Sportsters original gasket (25224-52A) original had a single for the upper feed galley passage.

The original gasket was updated in Nov. 1979 with a short slanted slot added to match the gearcase modification in L1979-E1980 models. <sup>17)</sup>

L1981-1985 Sportsters use gasket (25263-81), designed with a long horizontal slot.

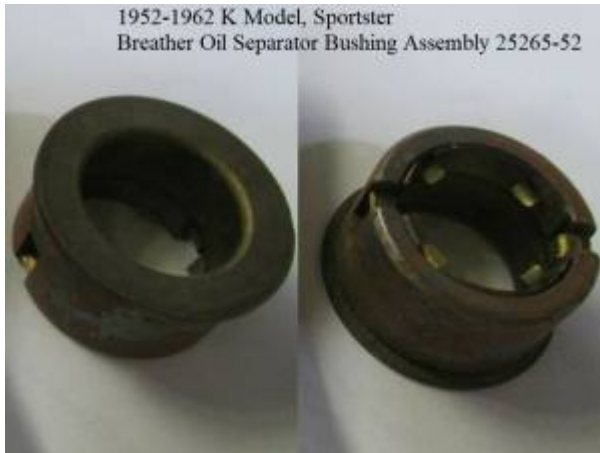
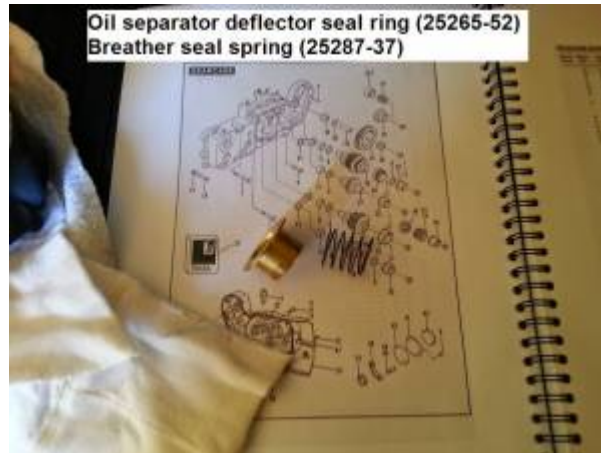
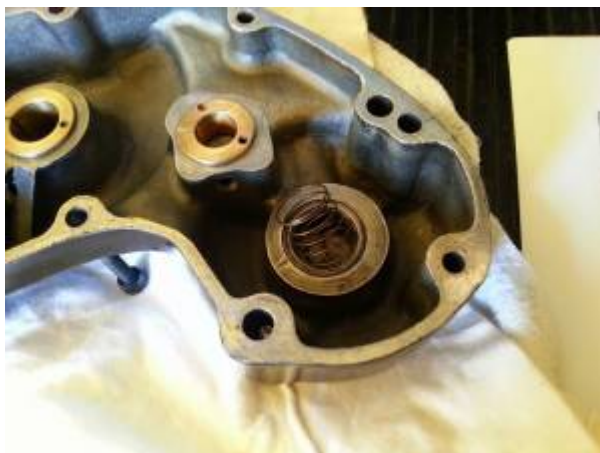
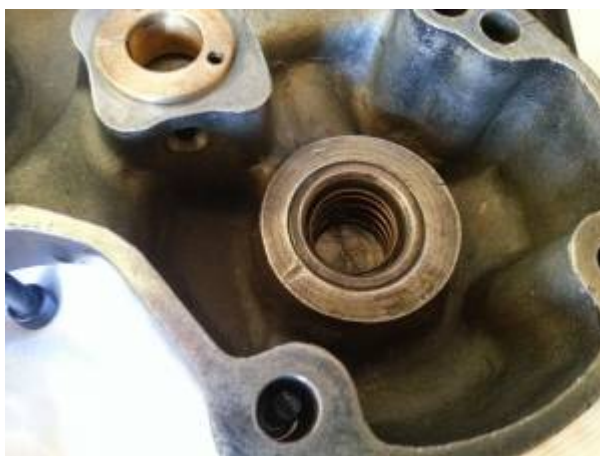
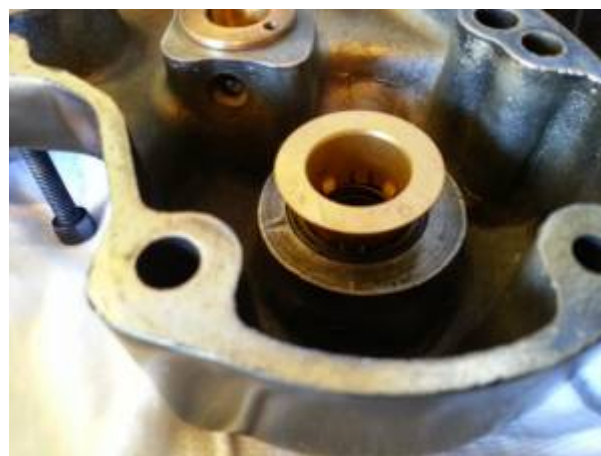
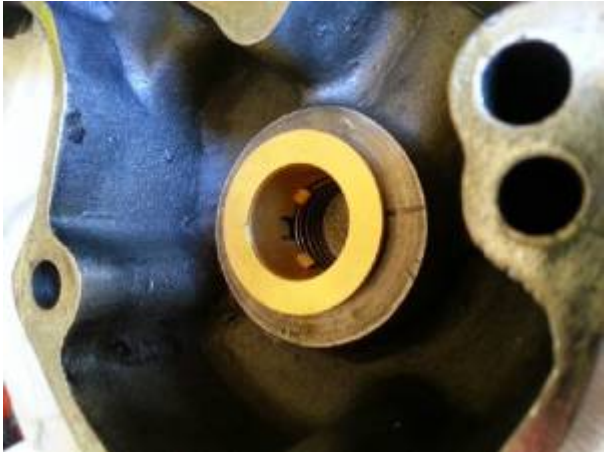
Looking at the brass part, you can see how the spring catches on the inward bent tabs. There are also unbent tabs on the brass. <sup>22)</sup>

These, when bent outward just a little, fit into slots on the far side of the steel bushing pressed into cam cover.

They had pre-assembled the brass to the steel before the steel was pressed into the cover.

Then dropped the spring into the cover and pressed the brass/steel assembly into the cover as a unit (and manipulated the spring to sit correctly if needed).

You can bend the tangs out without having to remove the steel bush with a screwdriver and a hammer to bend the 2 locating tabs out.

The tabs must be bent outward enough that the brass stays keyed to the steel at full spring compression. You don't want the brass hat to 'unkey' when the generator compresses spring. The brass needs to be able to 'plunge' in and out under the spring pressure once the tags are bent.

These outward bent tangs do 2 things.

- They keep the brass hat and spring captive in the cover upon generator removal.
- More importantly, they key the brass to the steel to prevent the brass from rotating with the

The brass is unable to rotate by the tangs keying into the slots.

Check the operation of the oil separator bushing assembly.

The spring should have free action and be fully extended in the gearcase cover.

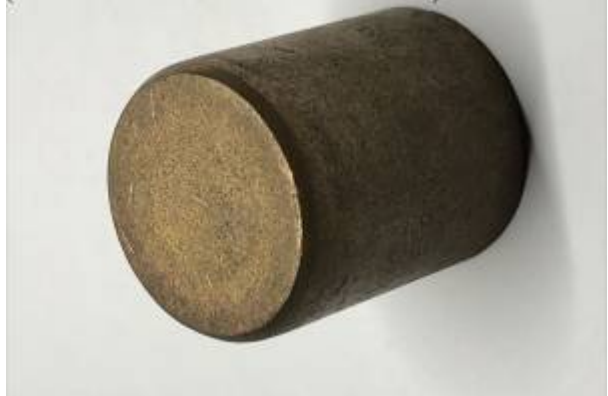
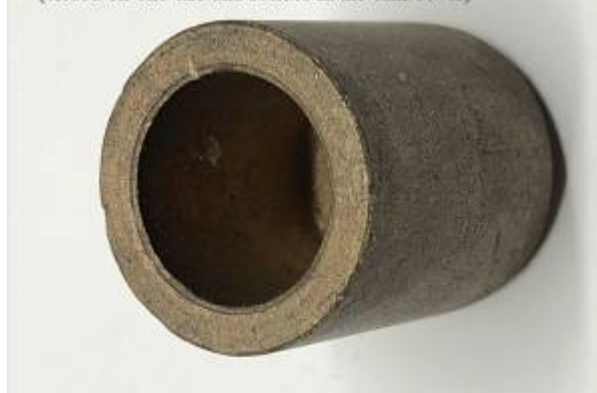
**1975-1976 Sportster cam cover shifter shaft bushing:** <sup>34)</sup>

This bushing has one closed end which is installed on the outside of the cover.

1975-1976 Sportster Shifter Shaft Bushing 34037-75  
(closed on one end and resides in the cam cover)

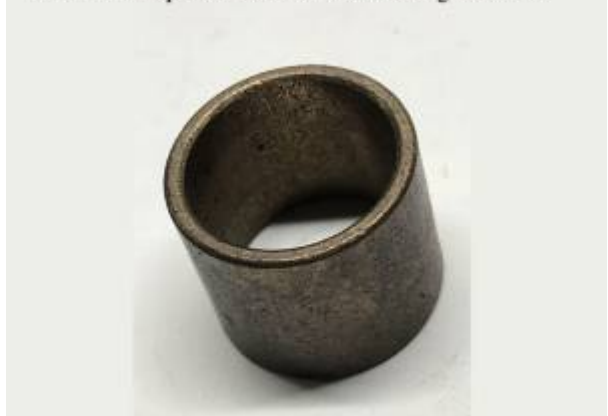
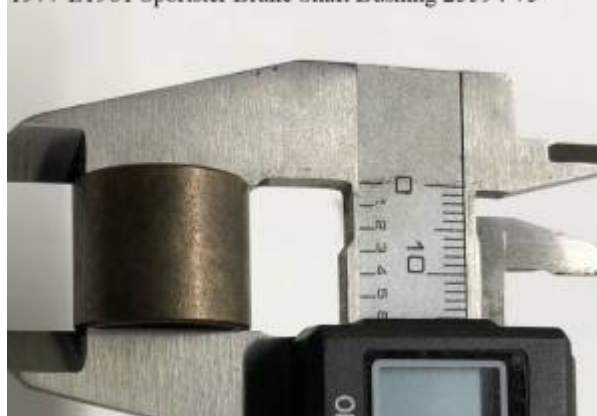
**1977-E1981 Sportster cam cover brake shaft bushing:** <sup>35)</sup>

Cam Cover Bushing Bore: .7450" <sup>30)</sup>

Bushing OD (before installing): .752" <sup>31)</sup>

Bushing ID (before installing): .6250" <sup>32)</sup>

Bushing Length: .625" <sup>33)</sup>

1977-E1981 Sportster Brake Shaft Bushing 25594-75

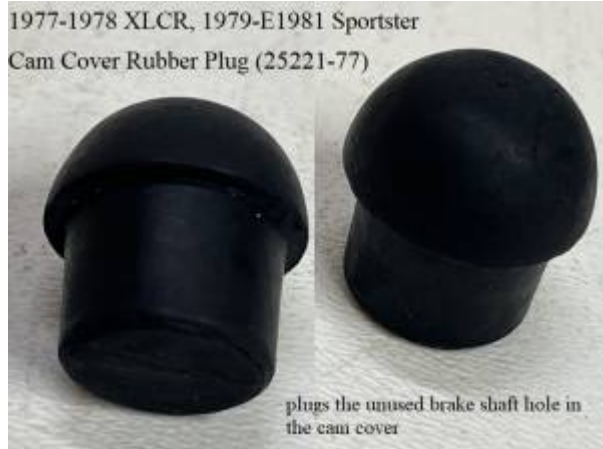
**1977-1978 XLCR, 1979-E1981 cam cover brake shaft hole rubber plug:** <sup>36)</sup>

In 1980, the MoCo used a rubber plug (25221-77) in the now unused brake shaft hole in the cam cover. The brake shaft bushing was still installed presumably to allow later covers to be used on 1979 models. The rubber plug inserts into the bushing.

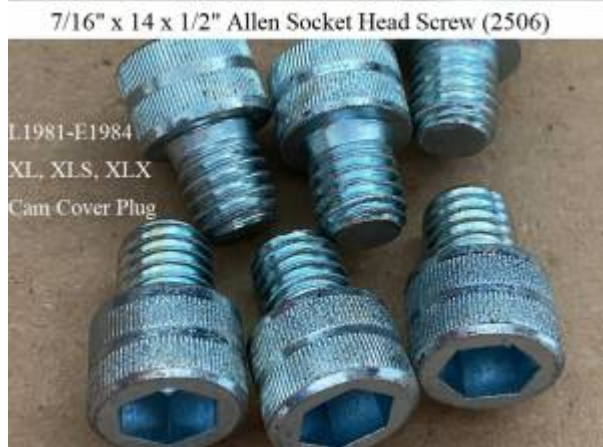
### L1981-E1984 Sportster cam cover screw plug: <sup>37)</sup>

The hole was still there but threaded for metal plug (2506), 7/16"-14 x 1/2" hex socket bolt, which screws into the cam cover.
