# **REF: Engine Mechanicals - Sub-01H**

## **Clearancing For and Test Fitting Cams**

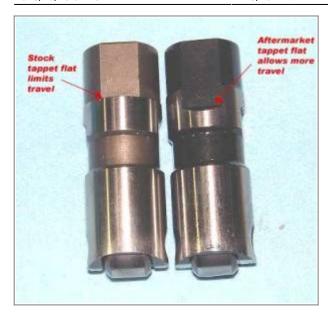
Stock vs Jims lifter tappet flat comparison. 12)

Another thing to check is tappet pin clearance. <sup>11)</sup>
The tappet pin rests against the flat on the tappet to keep the tappet from rotating in the bore. But a bigger cam lobe lifts the tappet farther and on stock lifter, it can run out of travel. Aftermarket lifters as shown below sometimes have longer flats.

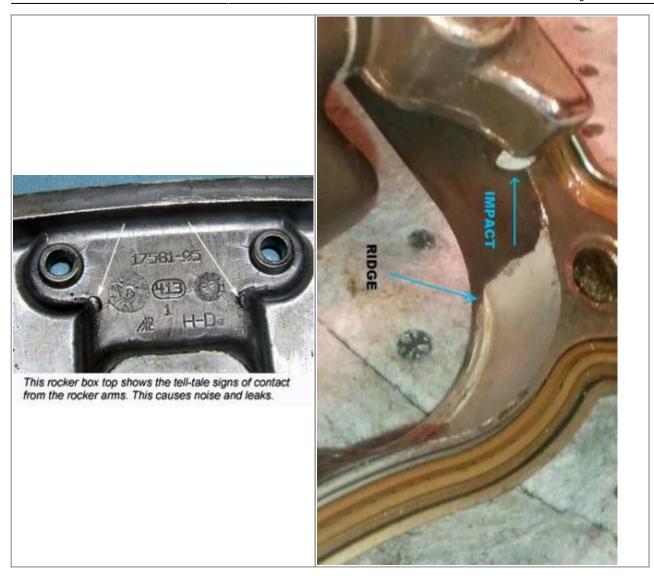
Rocker box top damage <sup>20)</sup> Lower rocker damage from valve spring impact <sup>21)</sup>

The most critical clearance in the rocker box is the clearance between the valve springs and all areas of the rocker box around it. <sup>19)</sup>

If the valve spring or retainer is allowed to touch the rocker box, it forces the valve to land sideways on the seat.

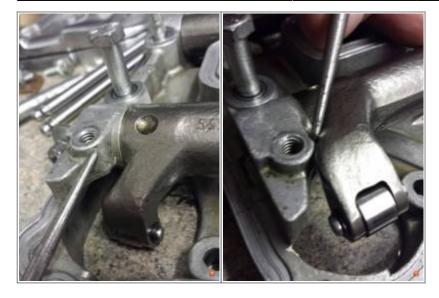
You can see where the contact occurs. 22)

This condition was noticed when using S&S roller rocker arms and big cams. But these areas can be checked while using stock or other rocker arms also. Symptoms were a ticking noise on the top end on cold starts. 32) The roller rockers were just grazing the rocker box assembly. All 4 were just barely nicking the box. It stopped when the bike got warm and stretched. Clearance can be done with a die grinder or Dremil Tool.
