IDLE MIXTURE ADJUSTING NEEDLE ELECTRA GLIDE, SPORTSTER

HARLEY-DAVIDSON MOTOR CO., INC.

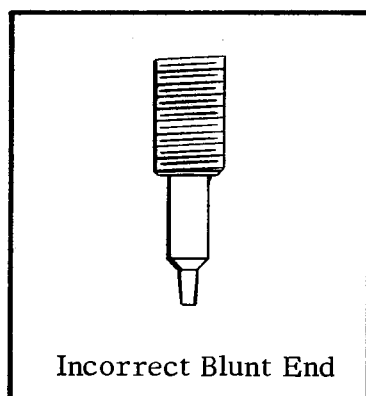
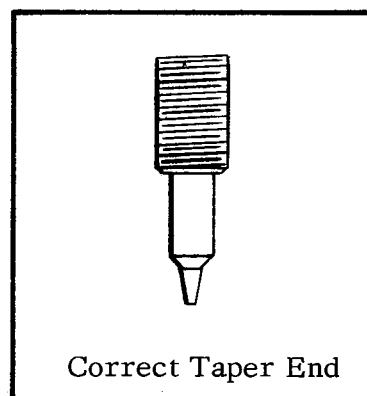
A quantity of Tillotson HD carburetors with defective idle mixture needles were received from the supplier and were used in production. These needles have an incorrectly formed blunt end instead of the correct tapered end as shown below.

If you have any 1970 Electra Glide or Sportster which has an erratic or unstable idle mixture setting, requires frequent adjustment, and requires an idle setting over 1-1/8 turns open, unscrew the needle and inspect the tip to see if it is formed correctly. Replace idle mixture needle, part No. 27688-66, if defective.
