Replaces No. 703 dated July 6, 1976

LUBRICATING OIL SUPPLY FITTING/SS, SXT-125

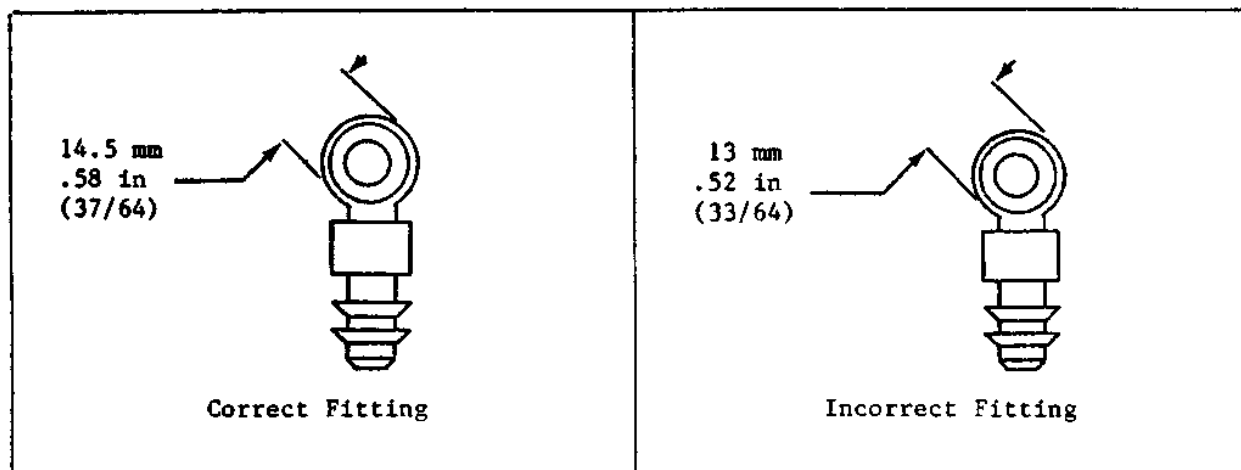
Note: This bulletin was reissued to clarify fitting dimensions shown in the illustration, and a paragraph was added giving another way to check for oil flow when engine is started.

If a leakage tester is not available, the fitting can be checked by removing and carefully measuring it. The incorrect fitting is smaller in size across large diameter as shown below.

Replacement fittings should be checked by measurement or pressure test before being installed.
