SERVICE BULLETIN

B-065

ULYSSES SERVICE LITERATURE UPDATE

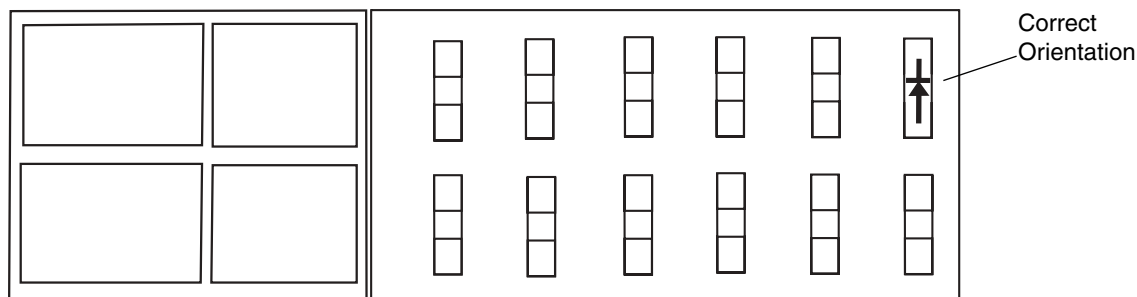
Fuses, Relays and Diode: 2006, 2007 Ulysses XB12X

The orientation of the removable diode in the fuse block was shown incorrectly in the 2006 and 2007 XB12X Ulysses owner's and service manuals. If the diode is installed in this orientation the vehicle will only start with the clutch lever pulled in, even with the transmission in neutral.

Notify customers and service personnel of service bulletin. Recent 2007 XB12X owner's manuals will have a corrected fuse block figure as shown in this bulletin. Please correct this figure in 2006 and 2007 owner's and service manuals in your dealer stock. Following is a list of manuals and affected pages.

- **2006 XB12X Ulysses Model Owner's Manual Part No. 99477-06Y**
Page 112 Figure 48
- **2007 XB12X Ulysses Model Owner's Manual Part No. 99477-07Y**
Page 106 Figure 45
- **2006 XB12X Ulysses Model Service Manual Part No. 99494-06Y**
Page 5-11 Figure 5-5
- **2007 XB12X Ulysses Model Service Manual Part No. 99494-07Y**
Page 5-11 Figure 5-5
