Sportster Rear Brake Switch Wiring

2004-2006 Sportster printed service literatures, including Digital Technician service manuals, contain inaccurate rear brake switch connections in the wiring diagrams.

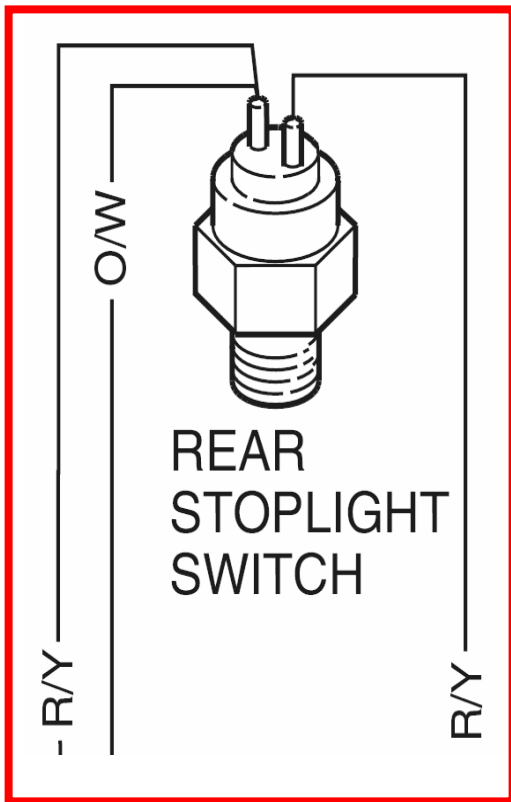
INCORRECT

The O/W wire is incorrectly shown connected to the same terminal as R/Y wire in current publications.
