Throttle Cable Installation

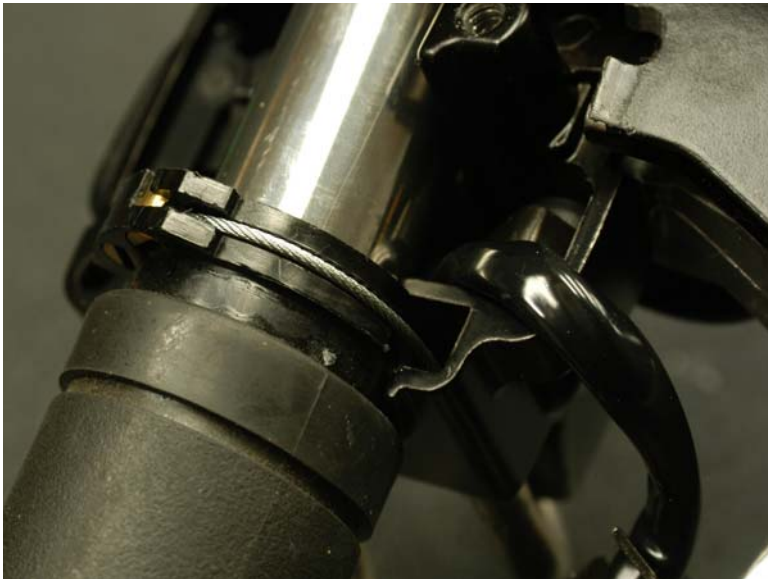
CORRECT

Recently there has been a significant number of throttle cable failures reported. Our testing cannot reproduce the failure unless we incorrectly assemble the cable to the throttle grip. If the cable is allowed to come out of the groove on the grip it will rub on the side of the sleeve and eventually fray and fail. To prevent this issue take care to make sure the cable is assembled properly and to make sure it has stayed in place during the adjustment.

When installing P&A grips the I-sheet references the Throttle Cable section of the appropriate Service Manual. However some Service Manuals omit the required step of loosening the throttle and idle cable adjusters prior to removing the brass ferrules from the throttle sleeve. Make this part of your accessory grip installation or throttle cable replacement. Additionally there is no need to use pliers of any sort on these cables.

When lubricating cables as part of regular maintenance, make sure to inspect the cables for correct installation to prevent future failures.
