IH: Oiling & Lubrication - Sub-03P

77-85 Oil Pump Inspection

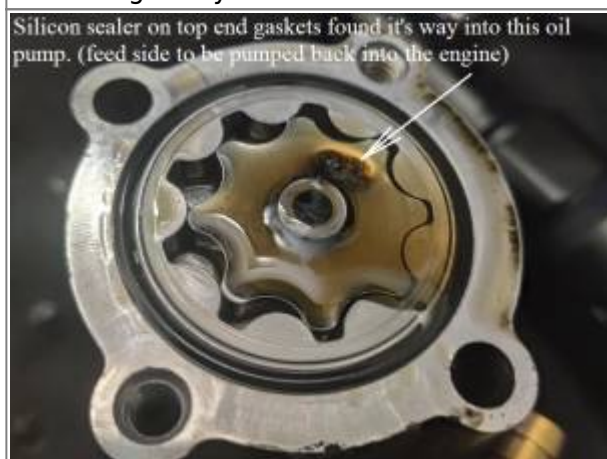
Silicone 'gummy bear' sheet found in the feed side ²⁾

- Silicone should not be used anywhere on a Sportster motor.
If so, you may find pieces of it in the oil pump or in the small orifices and oil galleys within the motor.
The push / pull of crankcase pressure can implode gaskets and especially sealants like silicone.
This will stop up the oil paths in the motor and if caught early enough, can be flushed out before catastrophic damage happens.

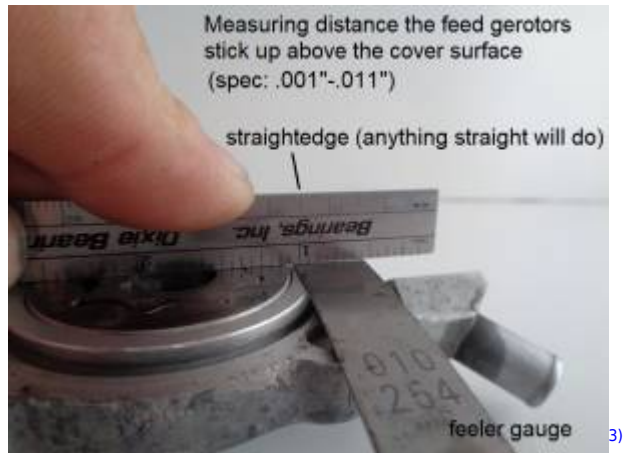
Inspect the ridge in the cover

- Using a straightedge across the feed gerotor set (installed) surface;
Measurement should be taken with a feeler gauge from the gerotor surface to the ridge of the edge of the aluminum cover.
The thin, feed gerotors (26492-75) in the oil pump cover (26486-75) should extend .001"-.005" above the cover's aluminum ridge.
The later feed gerotors extend up to .011" above the ridge.
If the feed gerotors do not extend above the ridge within the specified range,
Remove and sand the ridge evenly until the gerotors extend properly when inserted.
Lay some sandpaper on a flat surface (#280 grit then #400 grit to finish).
Invert the cover and sand the ridge then check the measurement with a micrometer.
Make sure that both the inner and outer gerotors are the same thickness also.

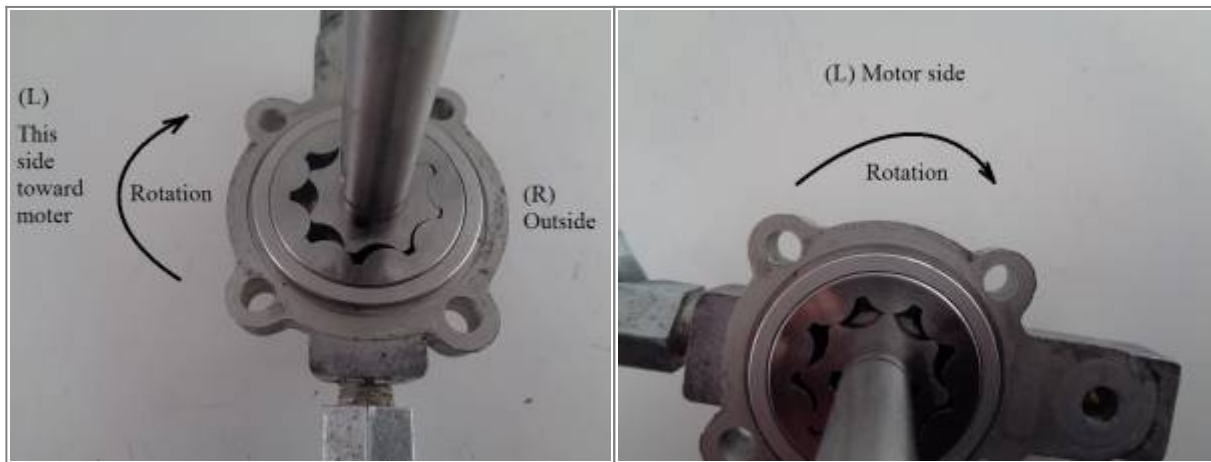
| Gerotor rotation (cover shown) ⁵⁾ ||

When a tooth first enters the rather long inlet cavity, pressure starts building as it rotates around the end of that cavity.

Until the feed tooth is fully over the big pad in the cover, some oil squirts back into the inlet cavity from backpressure.

Once the tooth is fully on top of the big pad, pressure builds from there as it rotates toward the outlet cavity.

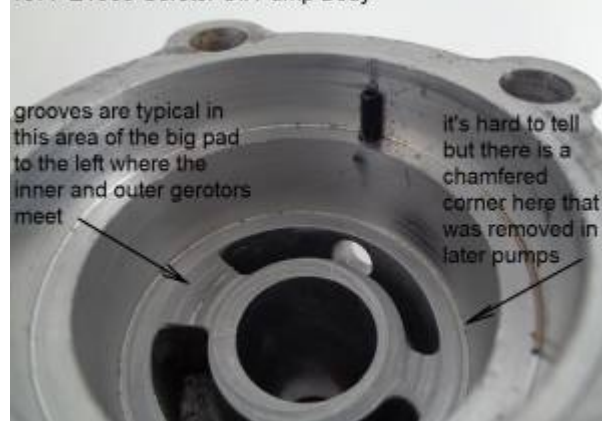
1977-E1983 Gerotor Oil Pump Body

It's on the larger of the two pads in the pump body and the cover seem to usually have more wear.

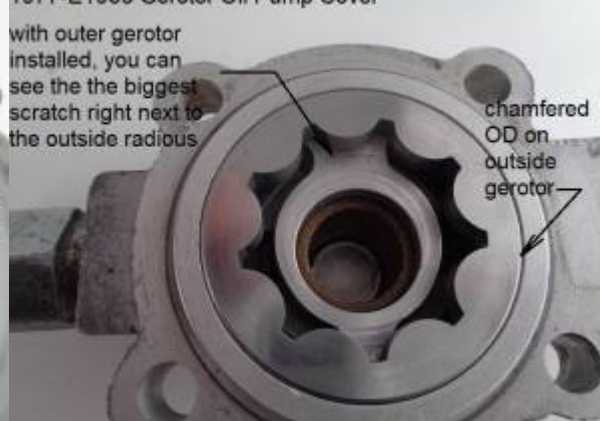
1977-E1983 Gerotor Oil Pump Cover

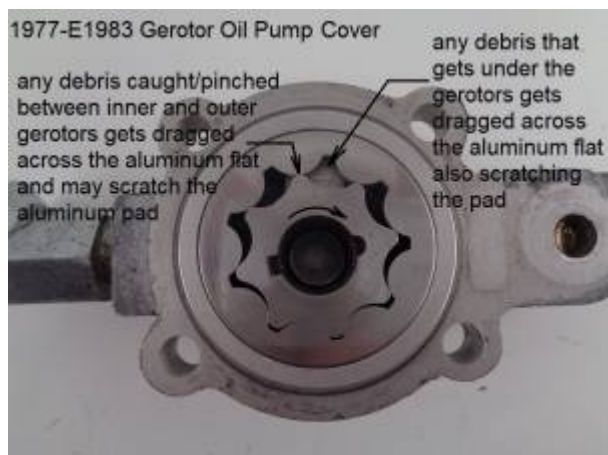
Classifying Scratches in Gerotor Surfaces

HD says that if there are any notable scratches on the gerotor riding surfaces in the oil pump housing or cover, then they should be replaced.

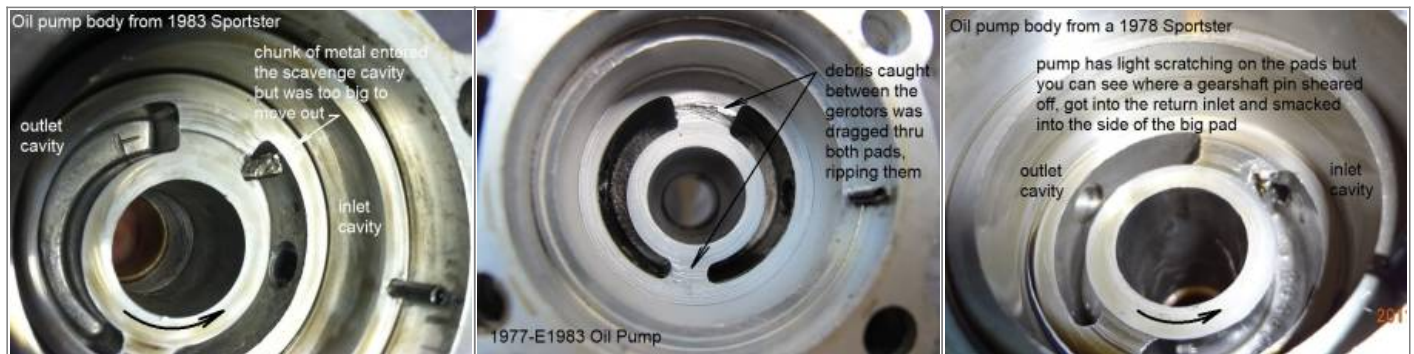
[Metal chunk lodged in return inlet.

The one medium scratch on big pad is some concern.

Small amount of recirculation oil internally.

Metal debris lessens amount of pickup oil at once.

May be reusable with further observation ⁷⁾ | Deep and wide channel ripped into big pad.

Light scratches across small pad.

High possibility of recirculating oil internally,
(feed outlet to feed inlet thru big pad scratch)

Owner said oil was not returning.

Should be replaced. ⁸⁾ | A gearshaft pin sheared and got into the return cavity.

It broke out a corner of the big pad.

The remaining flat surface of pad is undamaged.

Should be reusable with further observation. ⁹⁾ |

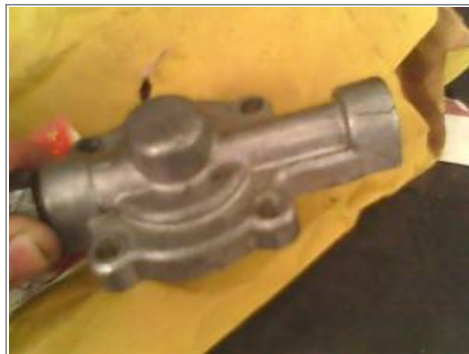
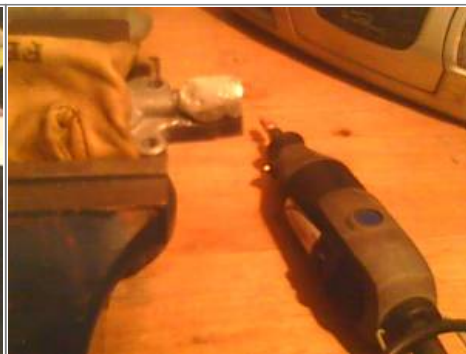
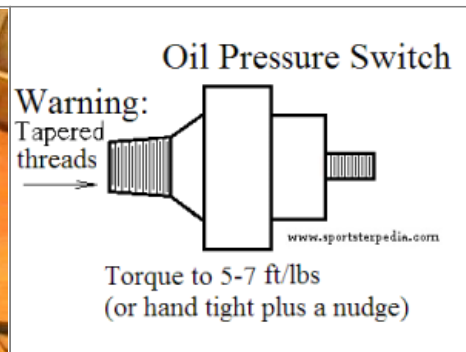
The cover below was cracked at the oil pressure switch end from tightening the pressure switch too tight. The crack was welded over and a Dremil tool was used to reshape the cover.

Due to warpage during welding, the threads need to be chased with a tap to straighten them back out.

Repair on oil pump cover ¹⁰⁾ </sup>

Oil Switch Torque ¹¹⁾ </sup>

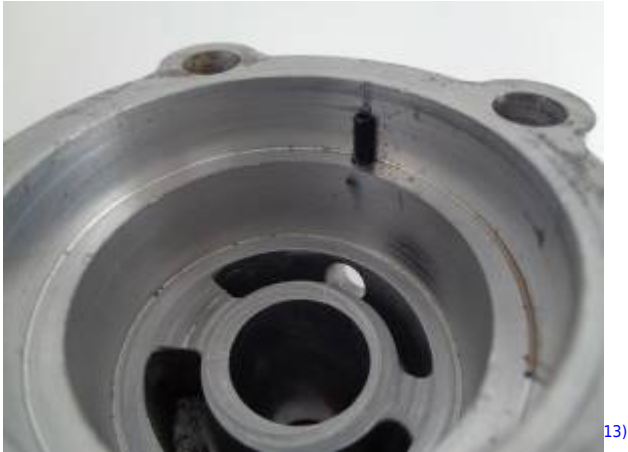
Give the roll pin a slight tug with needle nose pliers to make sure it is good and pressed in and doesn't want to wiggle.

There is nothing wrong with the roll pin in this photo.

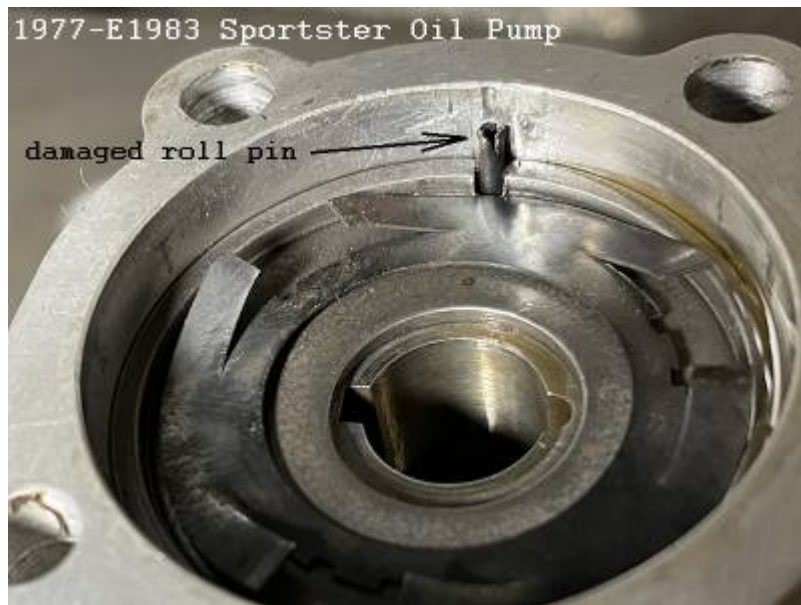
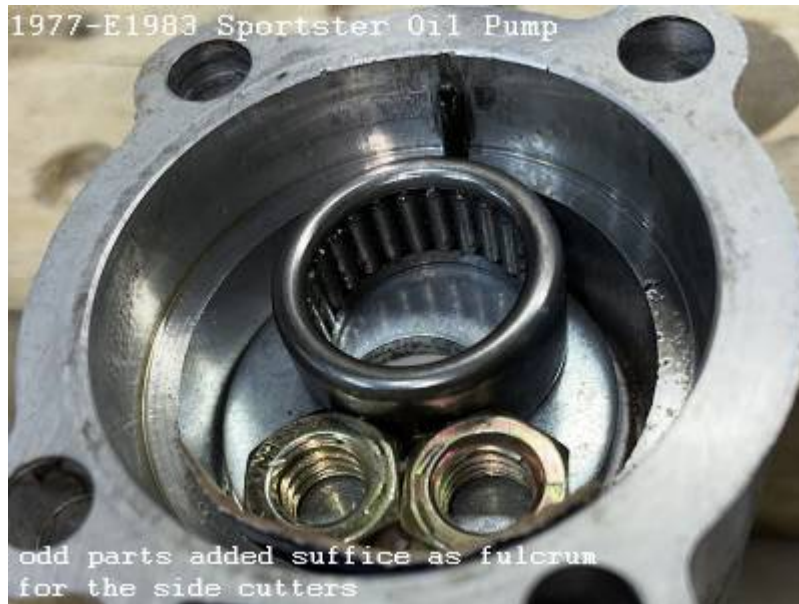
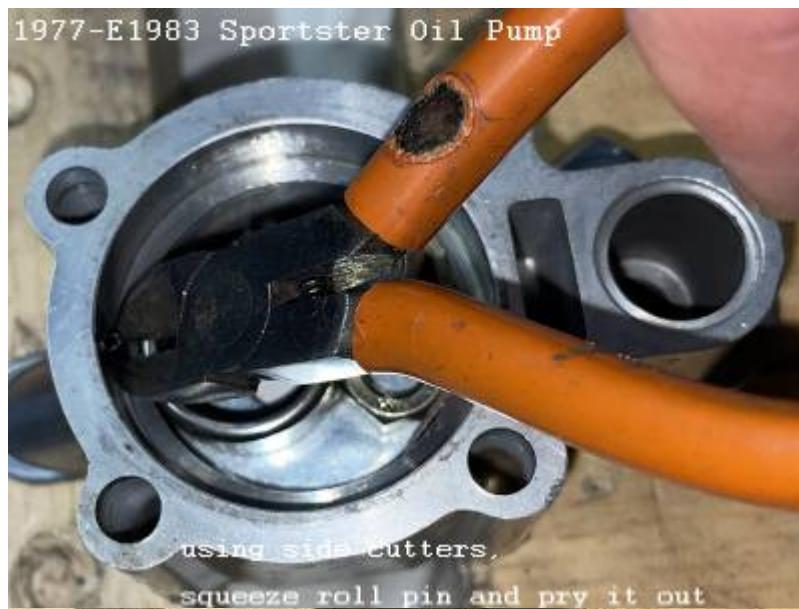
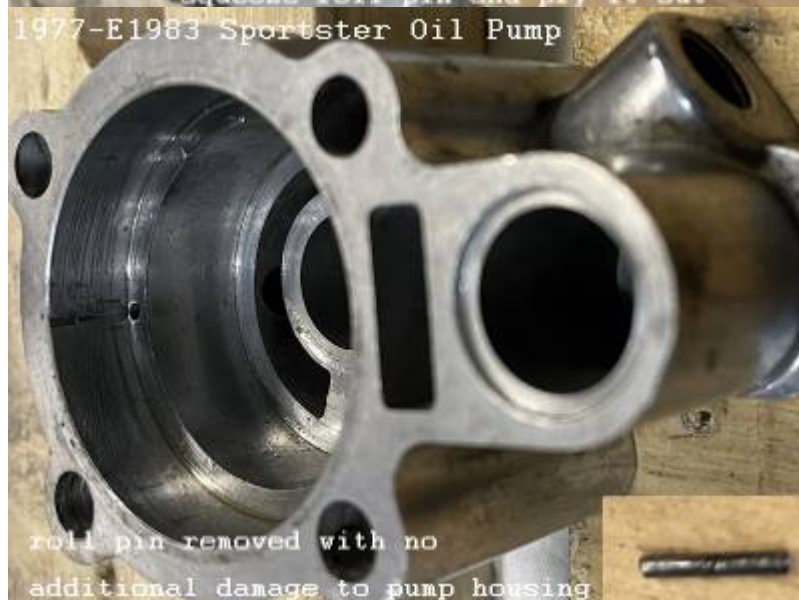
The roll pin below was damaged by trying to remove it.

It was removed using electrical side cutters by XLF member, billeuze. ¹⁷⁾

Carefully protect the base and sides of the pump body.

Odd parts were put inside the pump for a nice height for a fulcrum for the side cutters.

I squeezed and pried it out. It took 4 or five pries to walk it all the way out. ¹⁸⁾

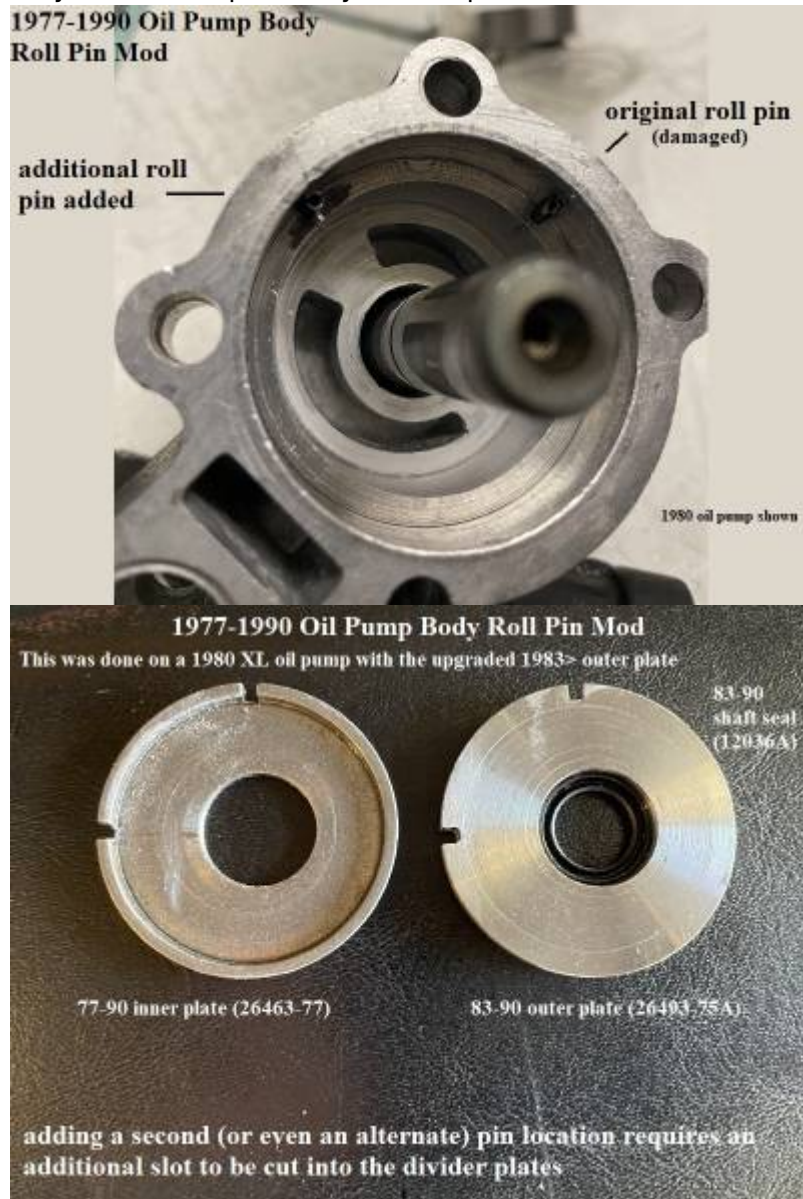
The roll pin below was damaged and a second roll pin was added to keep from removing the original pin.

In order to add the second pin, additional slots have to be cut into both the inner and outer plates since they are both captured by the roll pin.

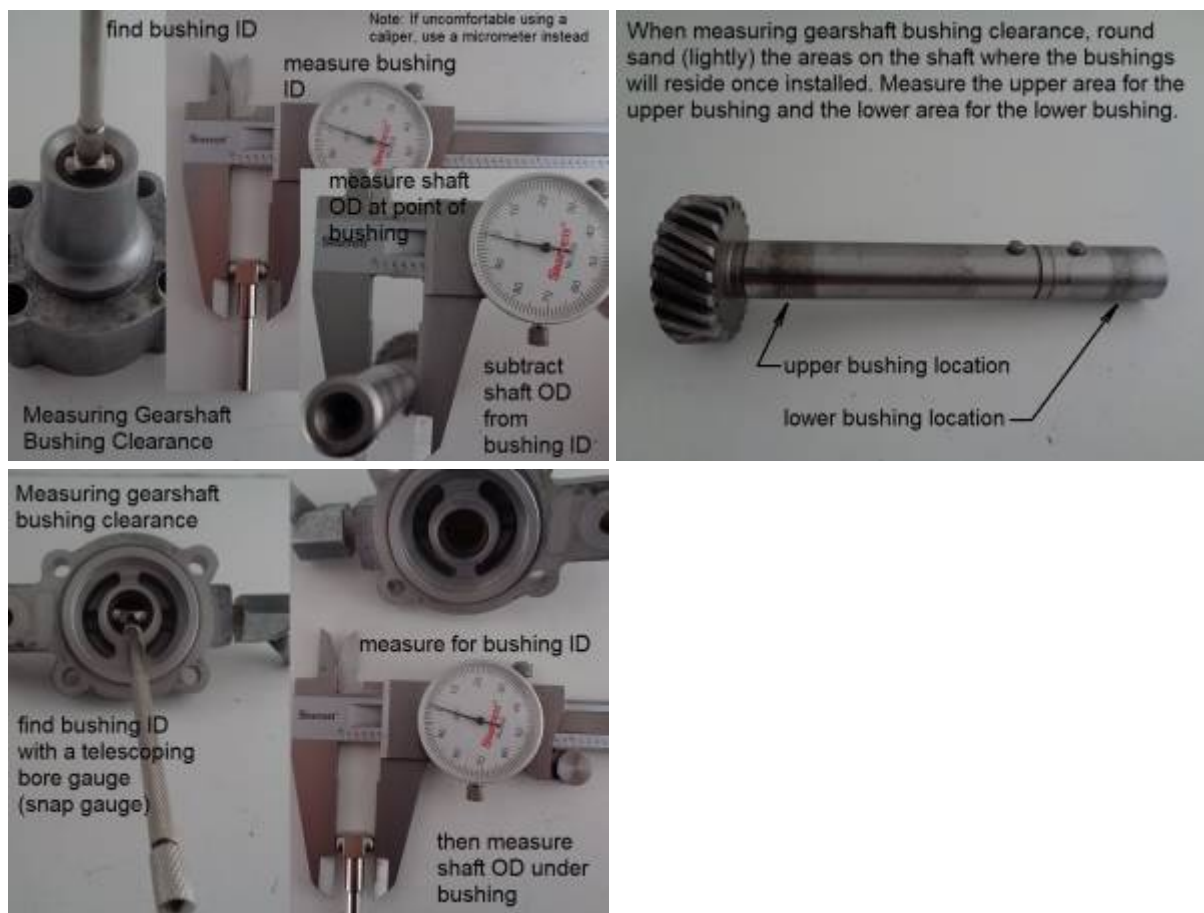
- Check the gearshaft teeth for pits, breakage or wear. Replace the gearshaft as necessary. Also do not forget to check the teeth on the oil pump drive gear on the pinion shaft. If the teeth on it are thin, replace the drive gear. Pinion shaft runout can wear the drive gear teeth down thin enough to break off and float with the oil.
- Clean areas where the shaft sits in a bushing with steel wool if needed. If it's not possible to smooth the areas out, replace the shaft.
- Inspect the gearshaft bushings both the housing and the cover.

Look for scoring, excess wear and noticeable damage. Replace as necessary.

- Check for a warped or seized bushing around the gearshaft.

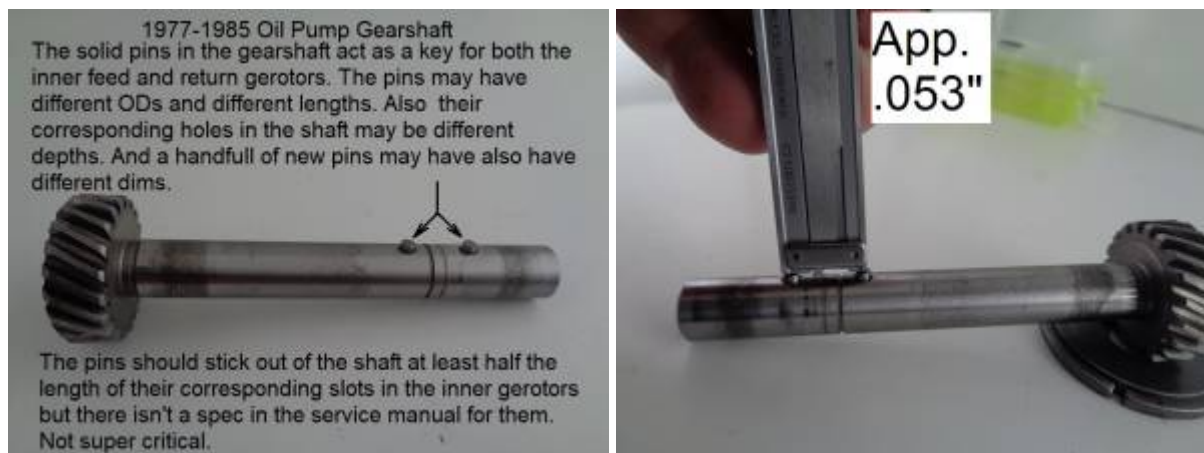
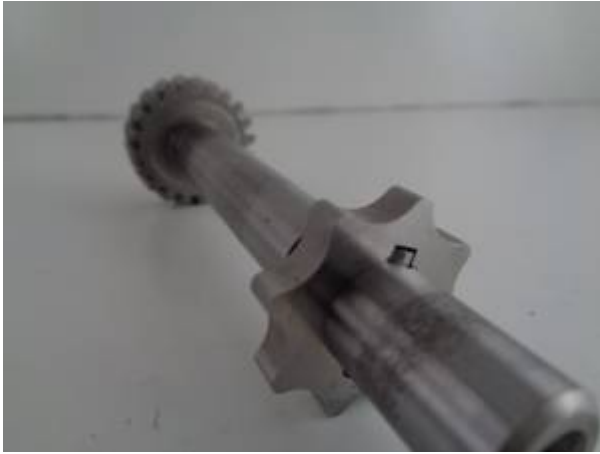
The pics below are used parts but show the pin locations and how they look installed with a gerotor on the shaft.

Pins align with the square slot in the gerotors. ²¹⁾

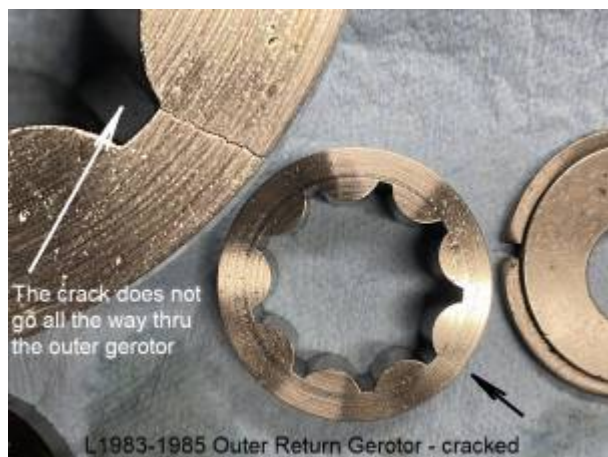
(L - below) The outer return piece below was cracked but not all the way through. Being cracked at all is still a problem (could result in lower oil pressure).

Replace any gerotors with damaged teeth, nicks or cracks.

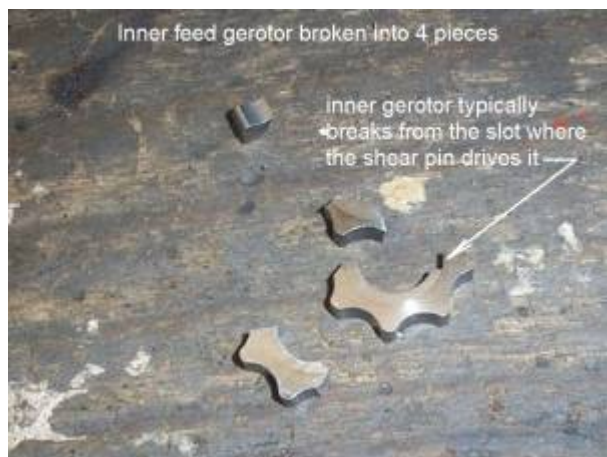
(R - below) The inner feed gerotor broke into 4 separate pieces starting from the slot in the gerotor where the gearshaft pin catches it.

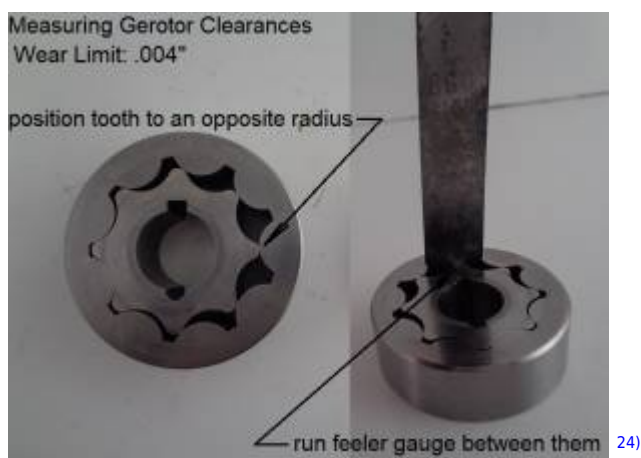
- Arrange so there is 1 inner tooth facing the center of the wide outer radius.
Use a feeler gauge between the inner tooth and outer radius there for a maximum of .004" clearance between them.
If the clearance is larger than .004", replace the affected gearotor set. Repeat for the other gerotor set.

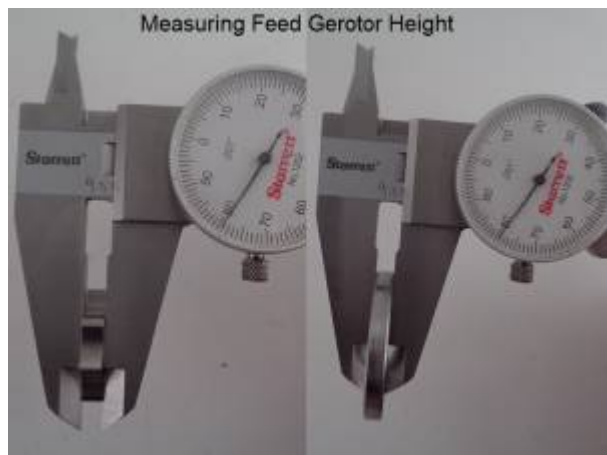
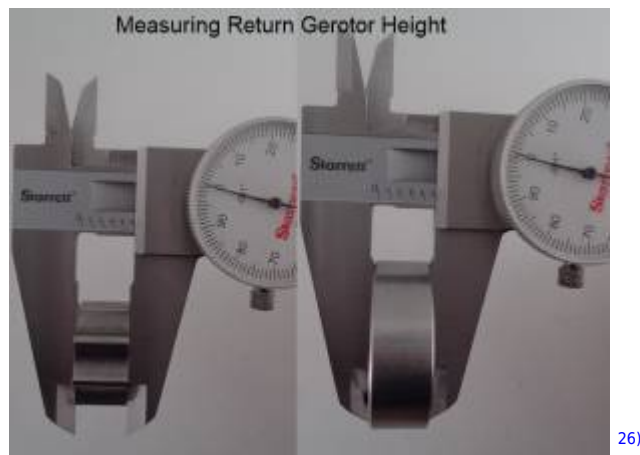
• Measure the height of each inner and outer gerotor set.

Replace gerotors as a set respectively if the inner and outer pieces are not the same height.

A micrometer will reveal tighter measurements rather than the caliper used below.

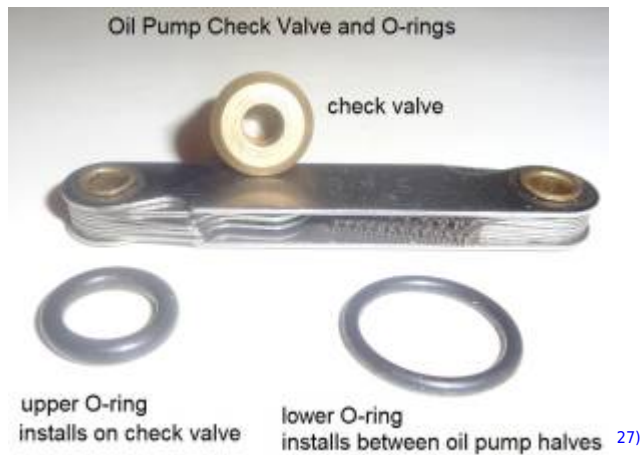
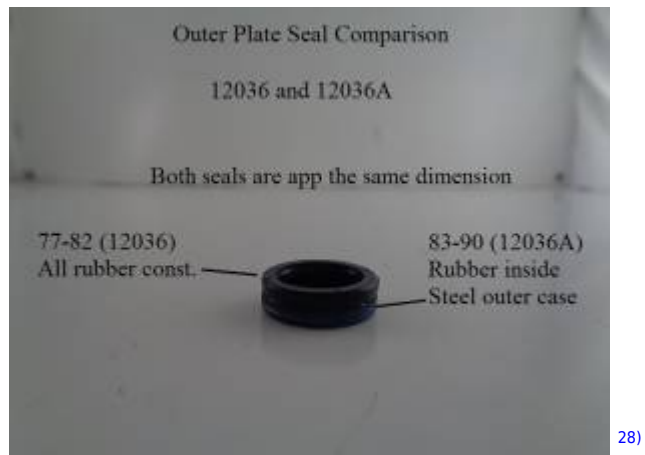
- Inspect the check valve and cover to housing O-rings and make sure they are not damaged/deformed/out of round.
The upper O-ring should fit tightly around the check valve and show some resistance when installing the assembly in it's bore.
The lower O-ring should fit naturally in it's seat without bending.
- Inspect the gearshaft seal for deformity and / or wear.
There were 2 different type outer plates that each require their own type shaft seal.
The early rubber shaft seal just sits there between the plates and hugs the shaft. It always needs to hug the shaft.
If it's deformed or easy to slide off the shaft, replace it.
The later shaft seal is rubber inside with a steel outside that presses into the late outer cover.
Check to make sure it's properly seated in the plate and it's ID hugs the shaft all the way around.

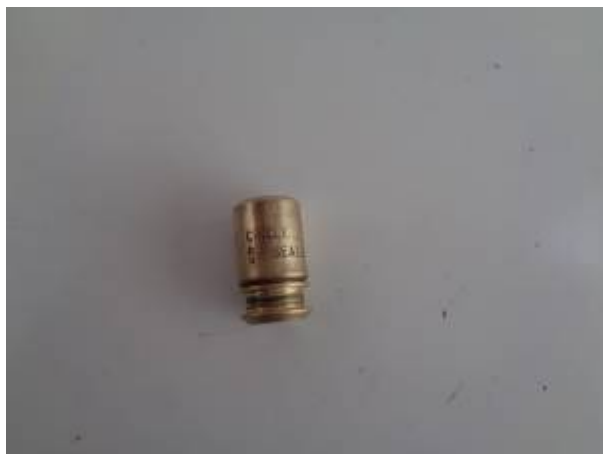
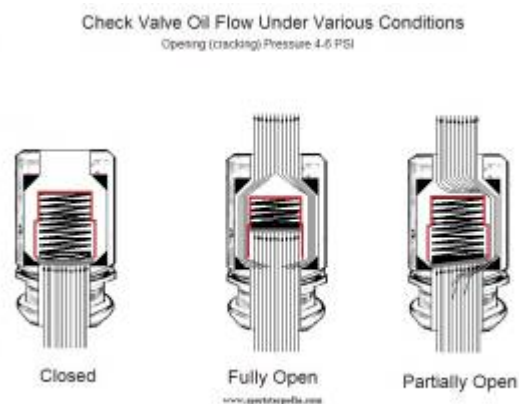
- Make sure it's not clogged and the internal spring closes the cup / disc properly.
The spring loaded cup inside the valve should be free to move and should return to it's closed, seated position.
If the check valve is damaged in any way, the complete valve assembly should be replaced.
There are no replaceable parts to it.
- Loose metal particles can get stuck between the disc and the valve body keeping the disc from closing.
If you find metal debris in the check valve, there may also be metal that made it's way past the check into the motor.

(R) below, the check valve was stuck open with metal debris.

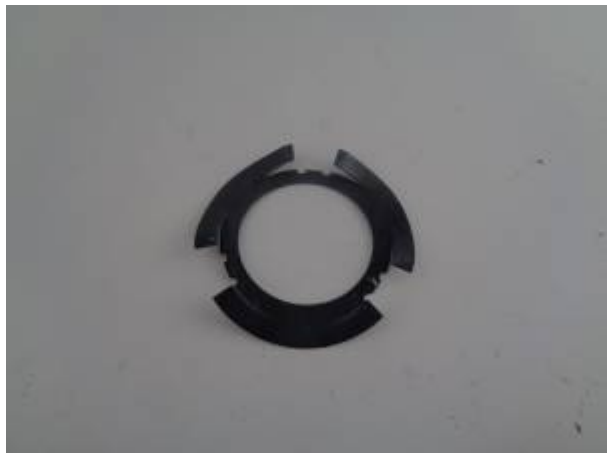
The spring resides between the separator plates (between the feed and scavenge gerotors) and is supposed to keep pressure against both plates.

Replace the spring if broken or there are any “fingers” broken off.
